**MEMORANDUM**

**TO:** Landis Hershey, Conservation Agent/Stormwater Coordinator, Town of Walpole

**DATE:** September 9, 2021

**RE:** Dry-Weather Outfall Screening Results

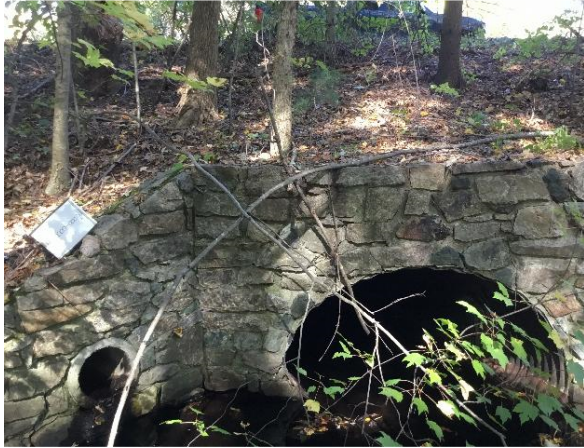
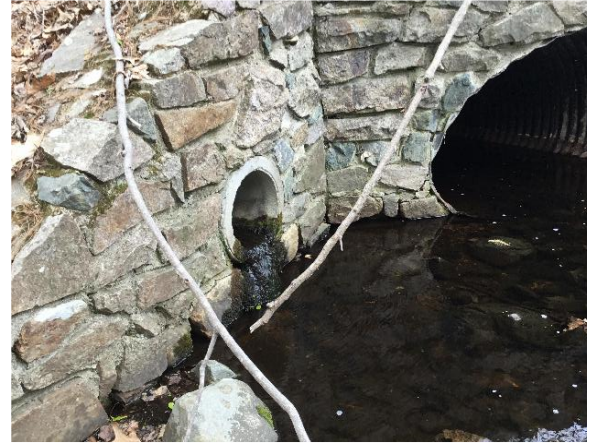
While no sampling results indicate outfalls with likely sewer input, the following outfalls were observed to have sewage odor: 06-0000-0002, 17-0000-0011, 20-0000-0011, 25-0000-0015, 38-0000-0006, and 46-0000-0002. Visual evidence of sanitary waste was observed at outfalls 46-0000-0009 and 55-0000-0006. This visual and olfactory evidence meets the permit criteria for likely sewer input.

Trash at outfall 06-0000-0002

At the time of inspection, the following outfalls, or their upstream structures, were observed to have excessive amounts of trash: 06-0000-0002, 07-0000-0001, 14-0000-0002, 26-0000-0017, 41-0000-0001, 42-0000-0004, 46-0000-0009. We recommend providing educational messaging in these outfall catchments, or town-wide, explaining the impact of litter on local water bodies and how it ends up in storm drains and outfalls.

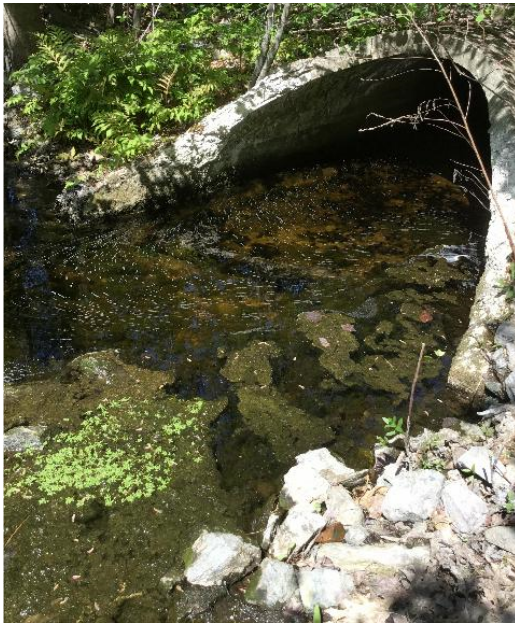
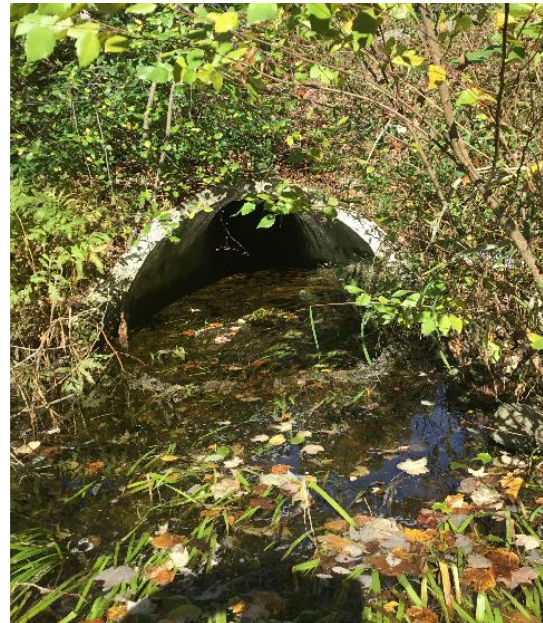
Samples from outfall 08-0000-0006 showed elevated surfactant levels, with visual observations of foam and excessive algae. Samples collected from outfall 14-0000-0008 detected chlorine and had excessive algae growth both inside and downstream of the outfall. A significant amount of algae and an oily sheen were observed downstream of outfall 18-0000-0006.

Excessive algal growth and foam at outfall 08-0000-0006

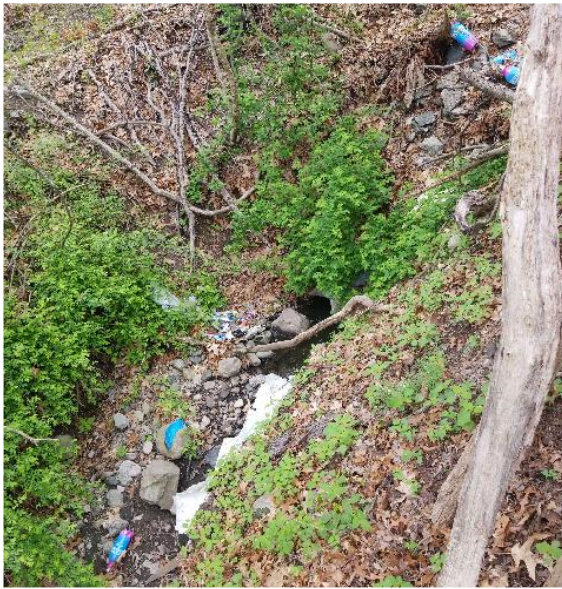
Numerous pet waste bags were found at outfalls 14-0000-0002 and 55-0000-0002. Pet waste bags were also observed at outfalls 18-0000-0001, 26-0000-0008, 33-0000-0003, and 39-0000-0003. We recommend targeting neighborhoods in or near these catchments with educational campaigns (e.g., flyers, letters, etc.) explaining correct pet waste disposal practices and the path that discarded pet waste bags take into local water bodies.

Pet waste bags and trash at outfall 14-0000-0002

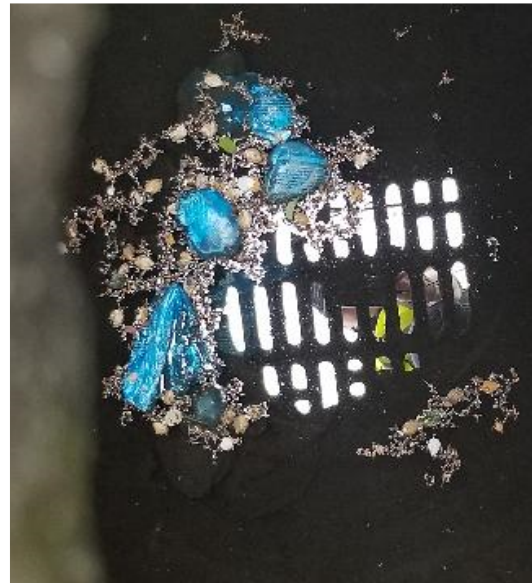
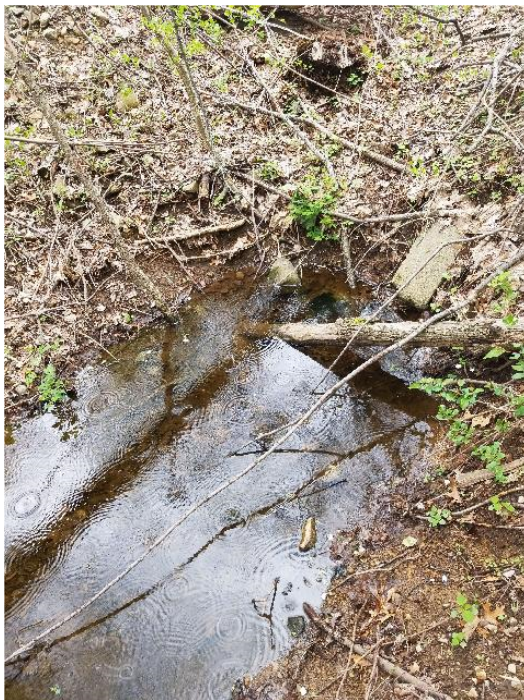
Sampling results at outfalls 14-0000-0003, 20-0000-0007, 34-0000-0011, and 34-0000-0013 indicate elevated levels of *E. coli*. In addition, surfactants were detected at outfalls 14-0000-0003 and 34-0000-0013 and chlorine was detected at outfall 20-0000-0007. Although these results do not meet the permit definition of likely sewer input, the higher *E. coli* concentrations indicate a higher priority level is warranted in catchment investigations.

Algae at outfall 14-0000-0003

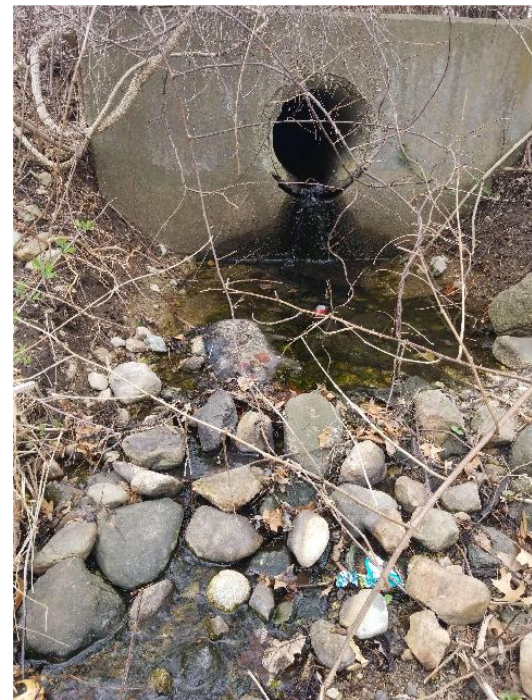
Excessive algal growth at outfall 14-0000-0008

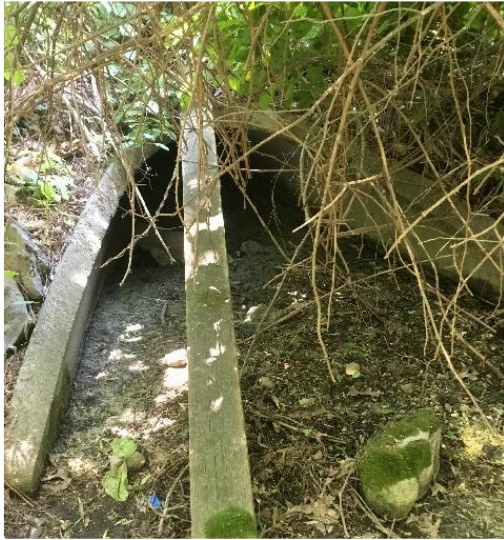
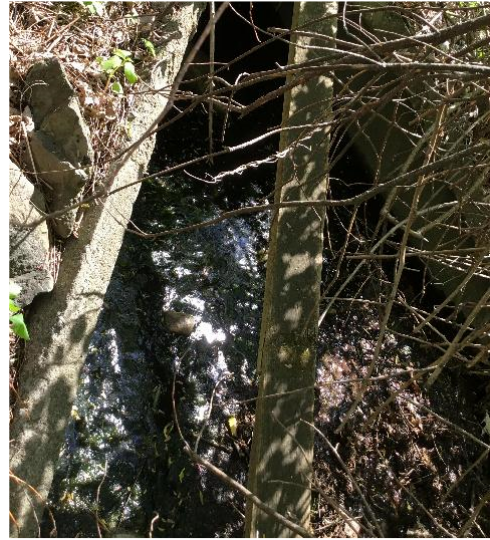
Pet waste bags and algae at outfall 18-0000-0001

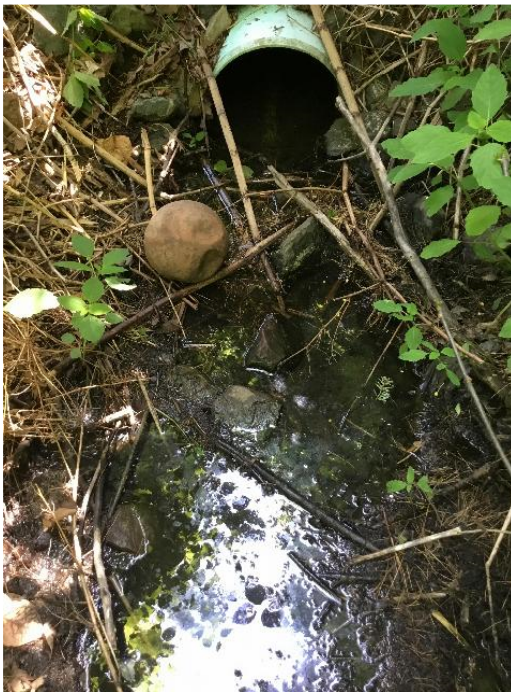
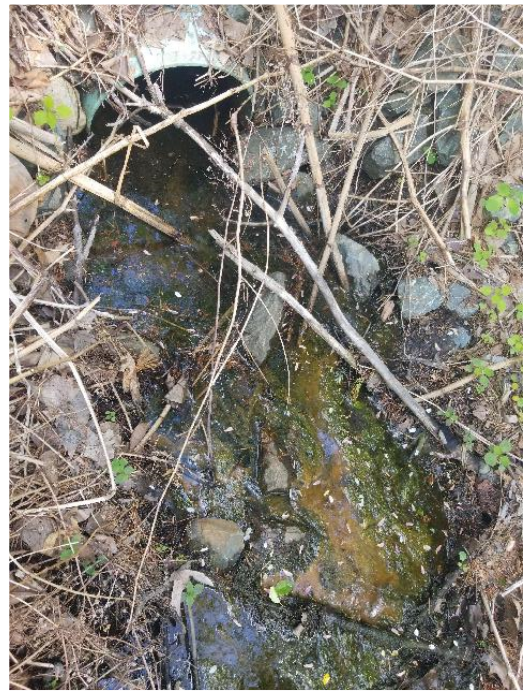
Excessive algae and visible sheen at outfall 18-0000-0006

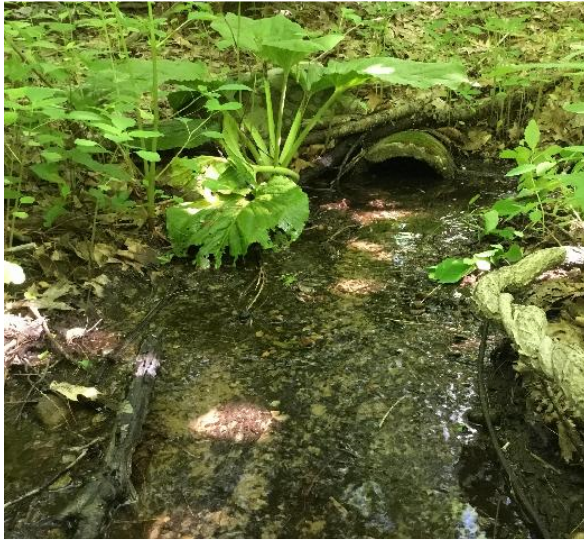
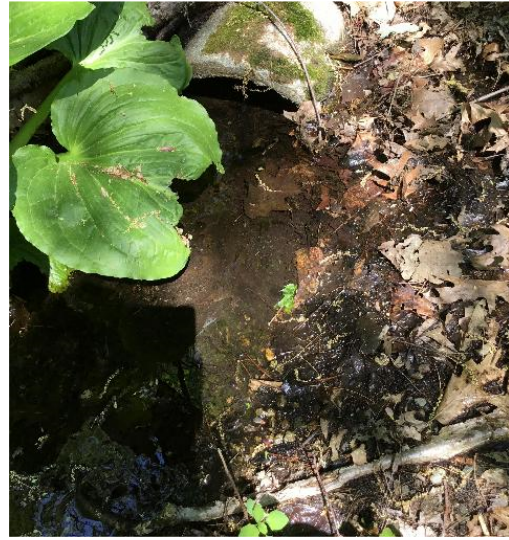
Algae at outfall 34-0000-0011

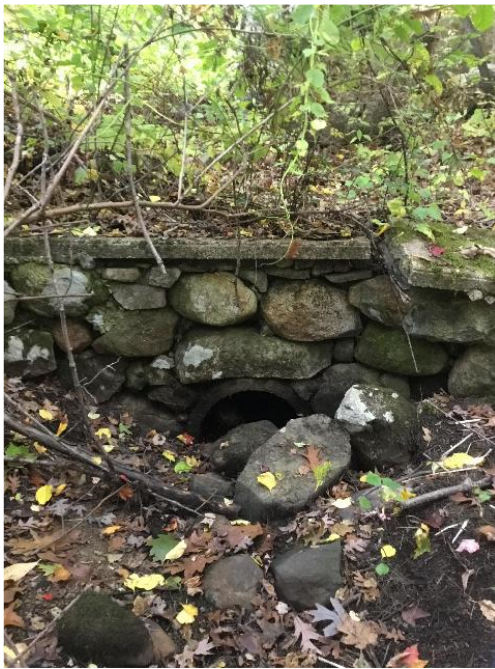
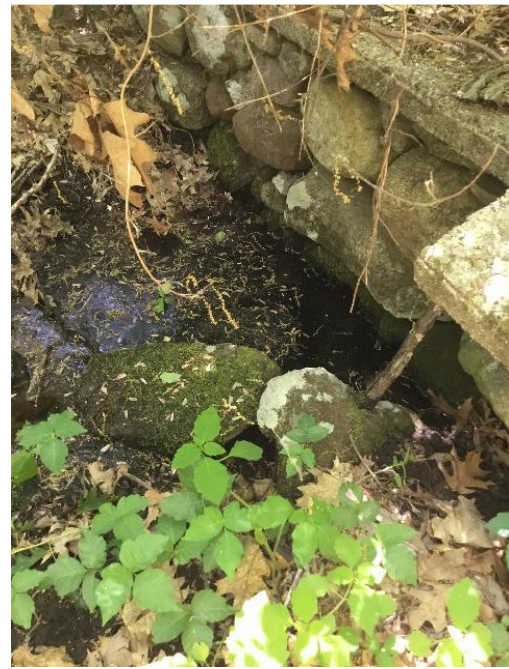
Algae and a pet waste bag found in the outfall pipe at outfall 39-0000-0003

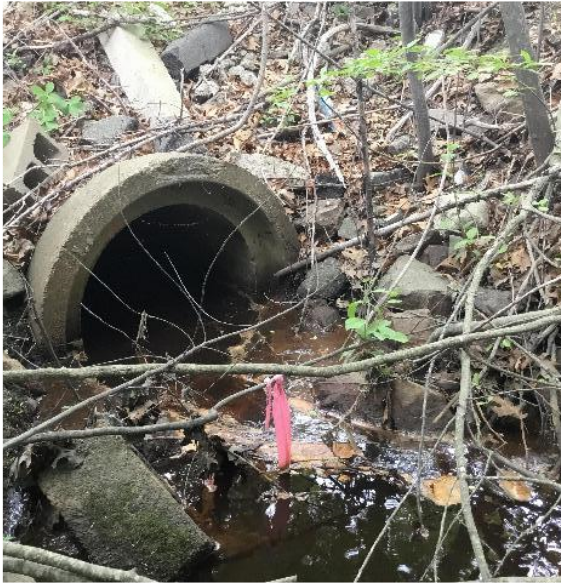
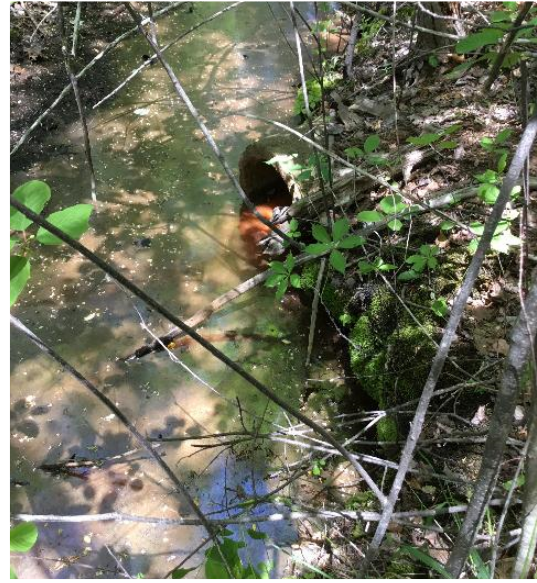
Visible sheen and foam at outfall 46-0000-0002

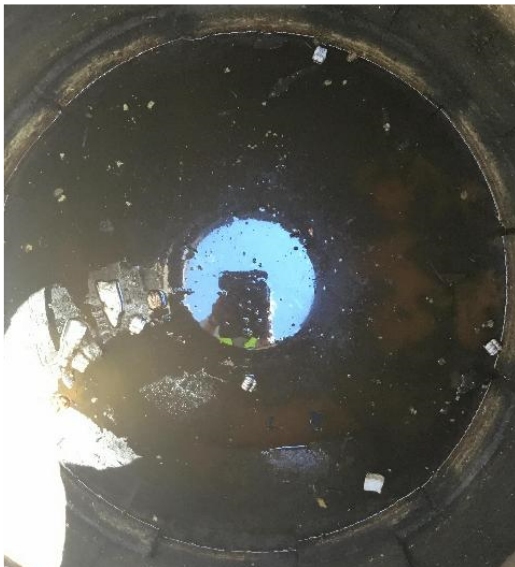
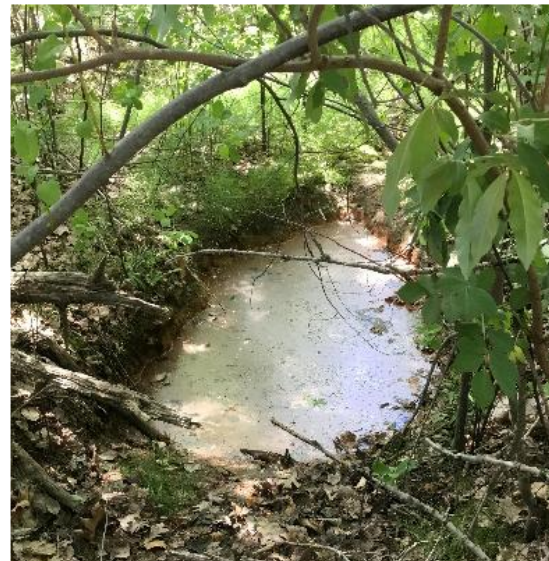
Trash in the upstream structures and a visible sheen at outfall 46-0000-0009

46-0000-0009	DMH-XXX-4731	2021-06-17	2021-06-14	0.65	Floatables, Sanitary waste*, Oily sheen*, Musty odor	Damp														Sampling visit: DMH-XXX-4731 can barely see outfall pipe, floatable (packing peanuts, nips, etc.) can barely see the top of the outfall pipe under dirt/water, don't see any other pipes leading in. Next MH DMH-XXX-3530 is also inundated, lots of orange substance (see outfall image).
53-0000-0012	DMH-XXX-4022	2021-06-21	2021-06-19	0.09	None	Heavy	22.03	6.29	1025.5	0.5	<0.25	0.25	<0.02	20	<0.02	<2	0.39	9.32	<4	Sampling visit: DMH-XXX-4022 one drop every few seconds from 11:00, heavy flow from 9:00, sampled from outlet. Sample ID: 01667210621-06
55-0000-0002		2019-10-15	2019-10-11	0.15	Pet Waste	Damp														Many dog waste bags
55-0000-0005		2021-06-17	2021-06-14	0.65	Ammonia odor	Moderate	16.7	7.65	228	0.1	<0.25	<0.25	<0.02	5						Screening/sampling visit: DMH-XXX-3915 sump is all orange liquid, only see two pipes one at 6:00 where sump water is flowing into, believe this is the outfall, lots of orange substance. 1:00 has lots of orange substance, slowly flowing into sump. Sampled. Sample ID: 01667210617-03 and -03D

46-0000-0009	Buried outfall, recommend digging out and assessing need for additional street sweeping in this catchment

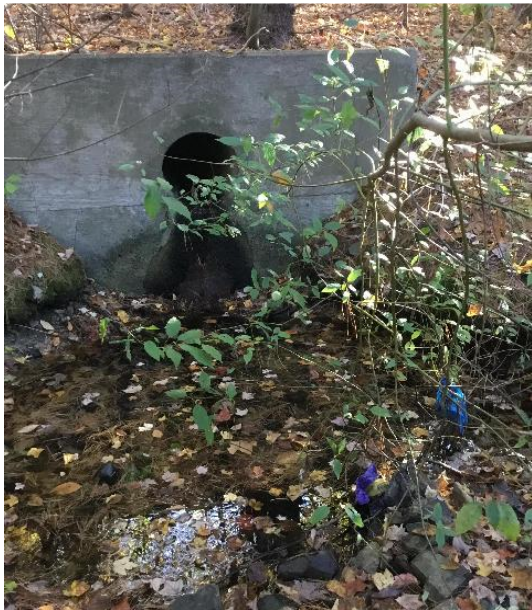
Pet waste bags at outfall 55-0000-0002

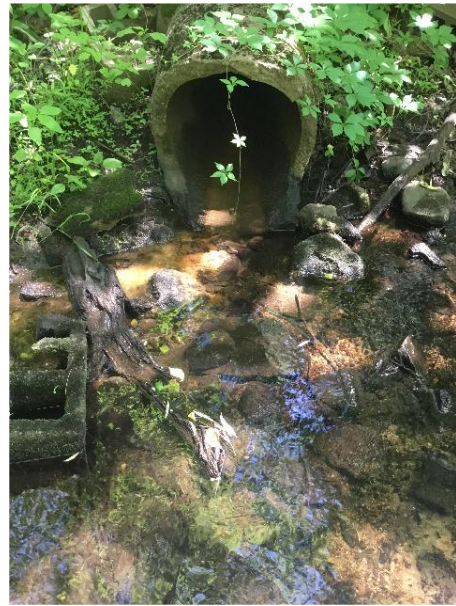
Oily sheen at outfall 55-0000-0006

55-0000-0006		2021-06-17	2021-06-14	0.57	Oily sheen*, Sanitary waste*	Trickle	17.9	6.58	605	0.3	0.50	<0.25	0.03	14						Sampling visit: orange fluffy/chunky substance in pipe and right outside, discharges directly to stream, sampled
55-0000-0007		2021-06-17	2021-06-14	0.65	Algae	Moderate	17.9	6.68	349	0.2	<0.25	<0.25	<0.02	48						Sampling visit: looks like orange sawdust, possible iron, see photo above. Sampled. Sample ID: 01667210617-04

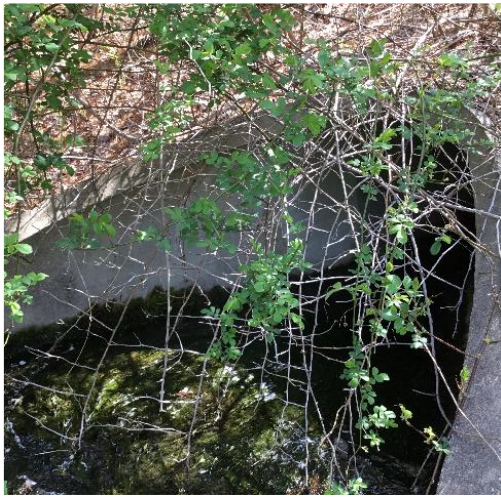
Excessive algal growth at outfall 04-0000-0001

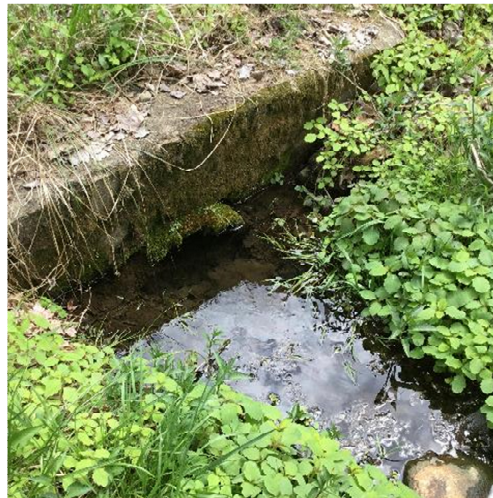
Visible sheen at outfall 05-0000-0001

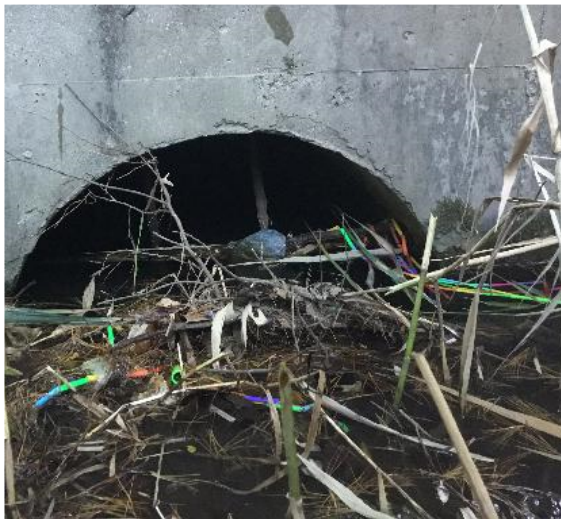
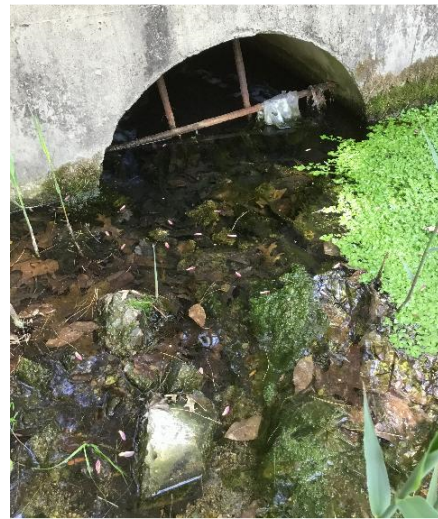
Trash and algae at outfall 07-0000-0001

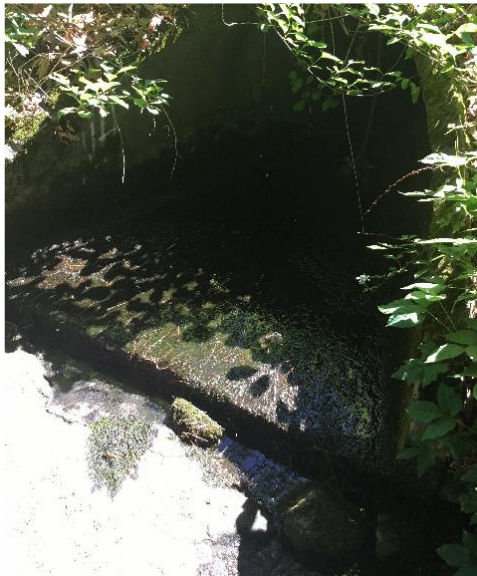
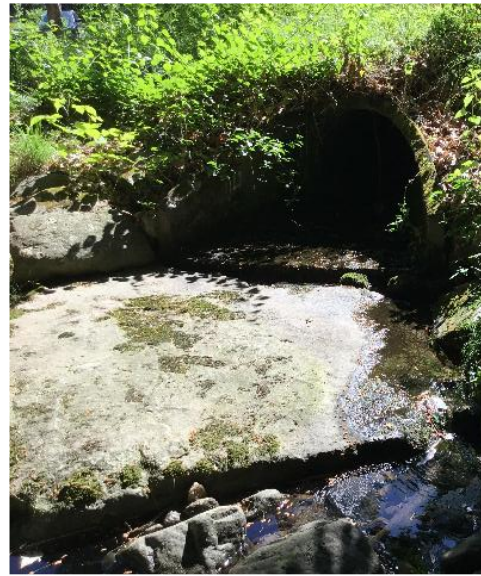
Algae at outfall 10-0000-0003

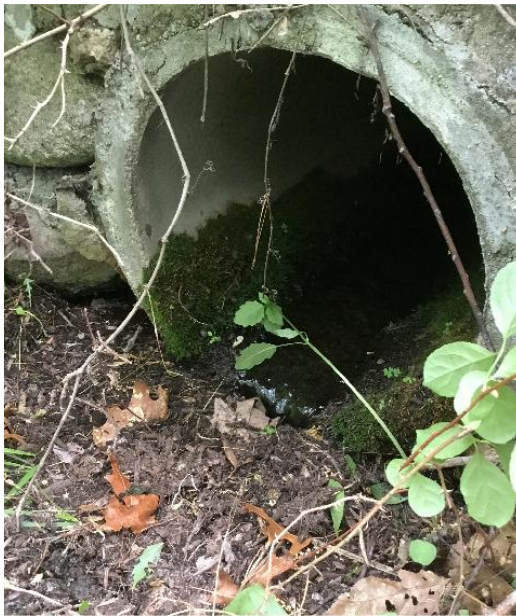
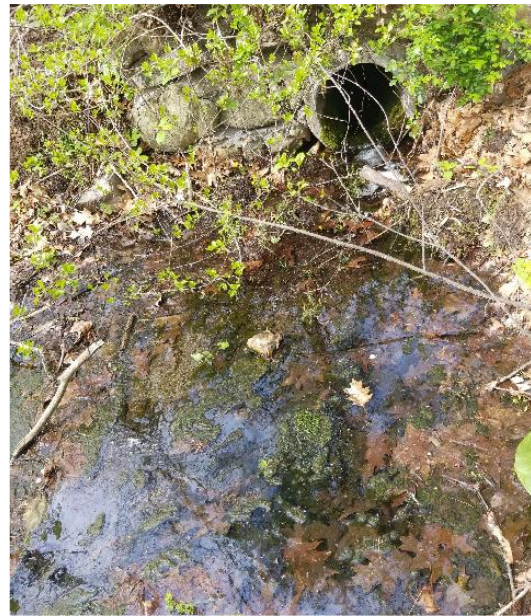
Algae and foam at outfall 12-0000-0008

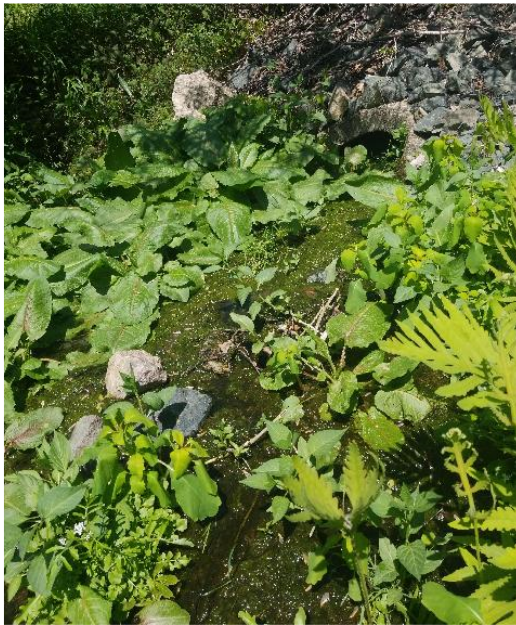
Excessive algal growth at outfall 12-0000-0019

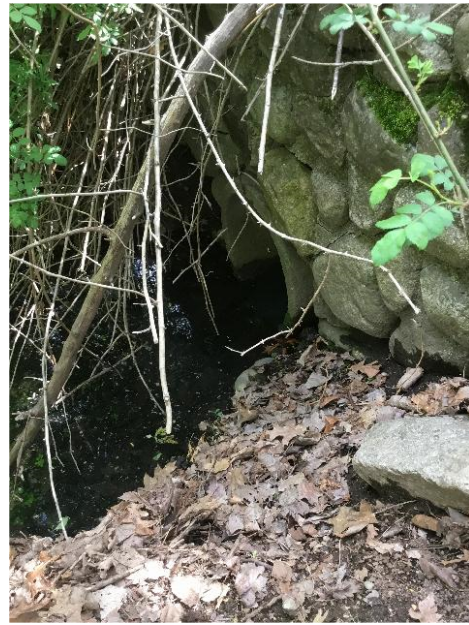
Algae and foam at outfall 13-0000-0001

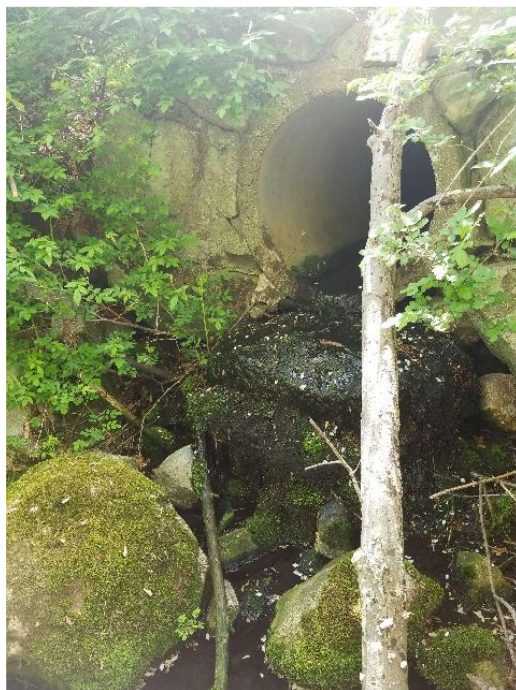
Algae at outfall 17-0000-0014

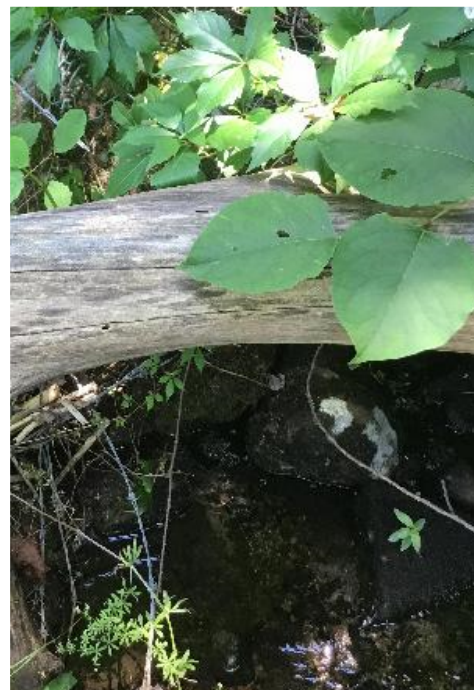
Algae at outfall 19-0000-0003

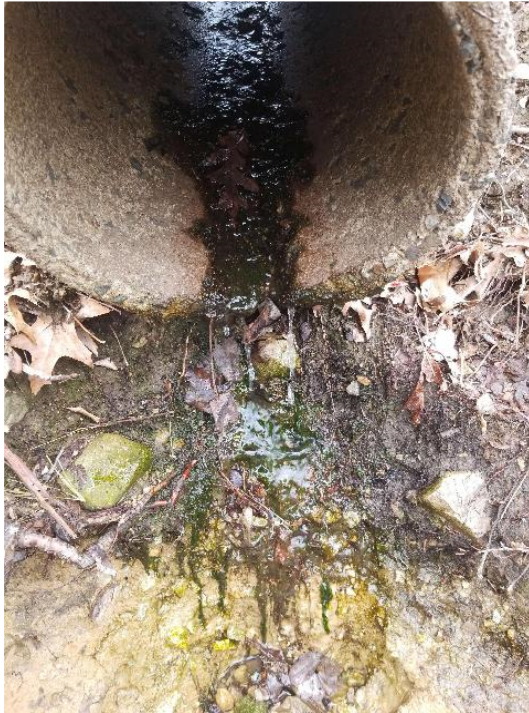
Algae at outfall 19-0000-0005

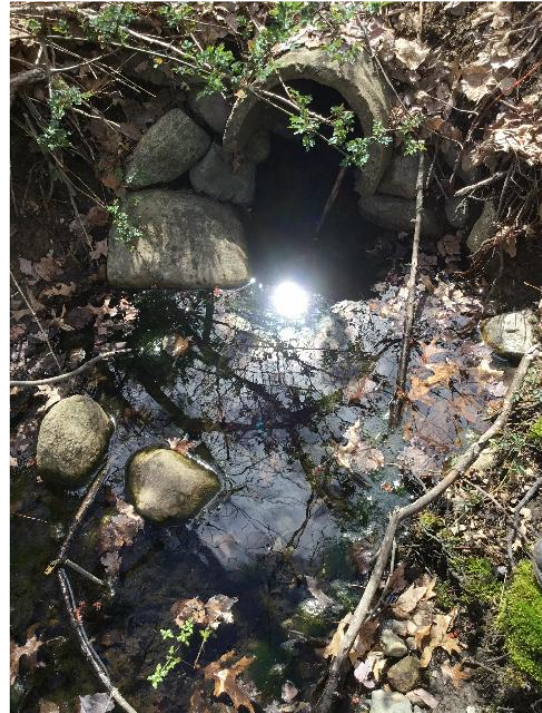
Algae at outfall 20-0000-0016

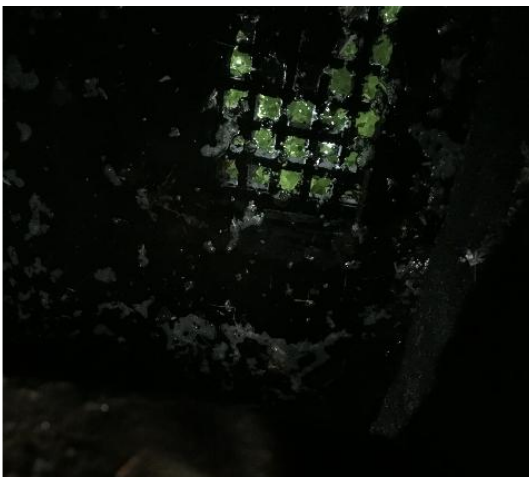
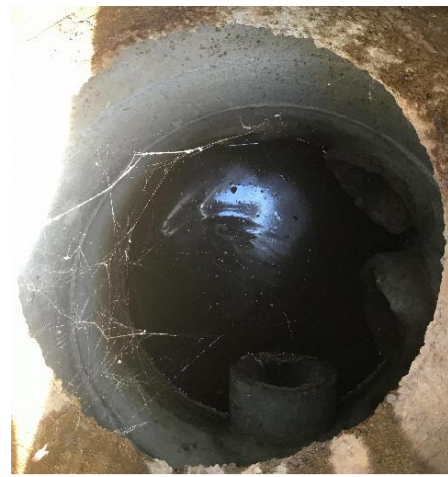
Pet waste at outfall 26-0000-0008

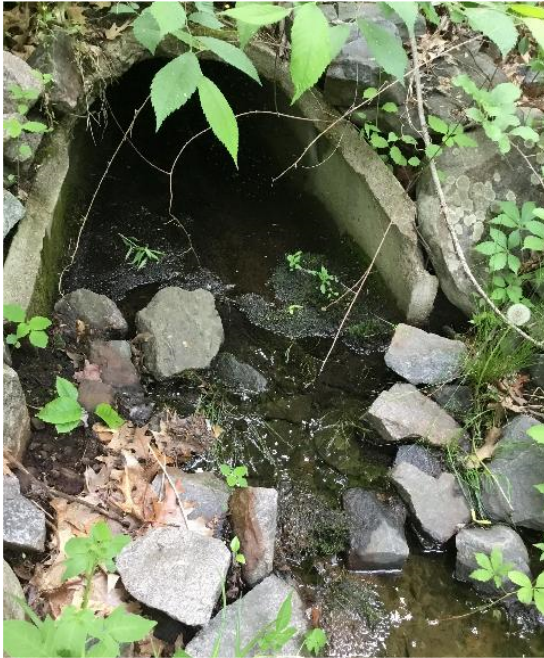
Algae and a visible sheen at outfall 29-0000-0003

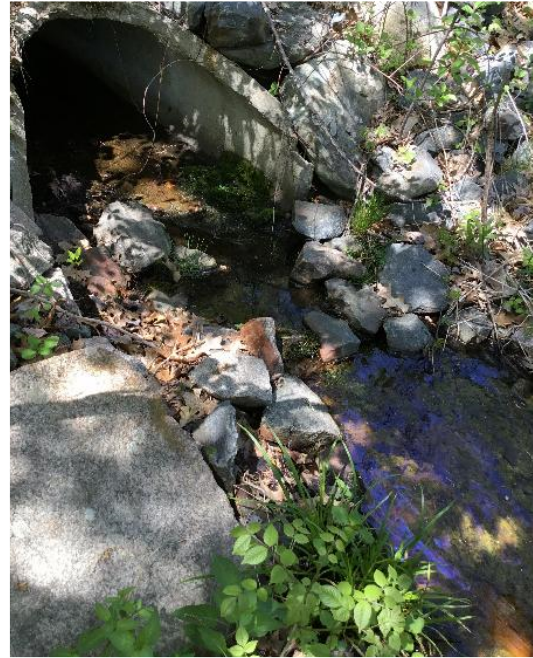
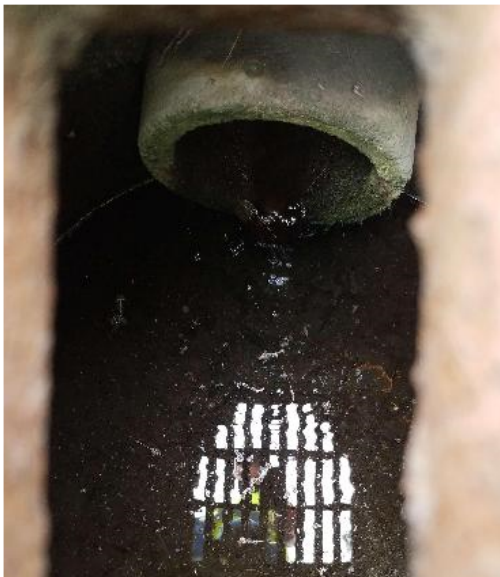
Algae at outfall 32-0000-0001

32-0000-0001		2021-06-07	2021-06-04	0.03	Algae	Trickle	21.9	7.23	574	0.3	<0.25	<0.25	0.51	3						Sampling visit: opaque layer on top of water, dark brown or black algae? Sample ID: 01667210607-07
32-0000-0009	CULVERT INLET	2020-06-16	2020-06-11	0.80	Foam	Damp														
33-0000-0003	CB-165-995	2020-06-16	2020-06-11	0.80	Pet Waste	Dry														Could not locate outfall. Pipe in catch basin was observed to be filled with leaves and sticks.
33-0000-0007		2021-06-21	2021-06-19	0.09	None	Heavy	19.8	6.45	1131.6	0.6	<0.25	0.25	<0.02	2	<0.02	<2	1.1	9.55	<4	Sampling visit: heavy flow, lots of orange substance. Sample ID: 01667210621-02
33-0000-0011		2021-06-21	2021-06-19	0.09	None	Trickle	20.09	6.72	787.2	0.4	0.50	<0.25	0.23	10	<0.02	2	9.72	9.4	<4	Sampling visit: outfall has some standing water but flow (a trickle) is visible, orange substance, sampled. Sample ID: 01667210621-03
33-0000-0017	DMH-XXX-5415	2021-06-11		0.01	None	Heavy	16.7 / 16.15	5.67 / 5.94	528.9 / 546.9	0.3 / 0.3	<0.25 / <0.25	<0.25 / <0.25	0.03 / <0.02	6 / 101	<0.02 / 0.38	<2 / <2	0.25 / 2.11	8.58 / 8.66	<4 / <4	DPW visit: DMH-XXX-5416 1st upstream structure- both pipes full of stagnant water, 2nd US. DMH-XXX-5416 Same inundation but no flow. Orange foam inside. Picture 8:27am. Other one - return later w/o DPW. DMH-XXX-5415 3rd US along busy road has flow, Heavy flow 12:00 some algae - Sample ID: 01667210611-01, Trickle 9:00 orange substance - Sample ID: 01667210611-02, 3:00 wet with orange substance but no flow evident. Photo 8:36. Values given as -0.1 / -0.2

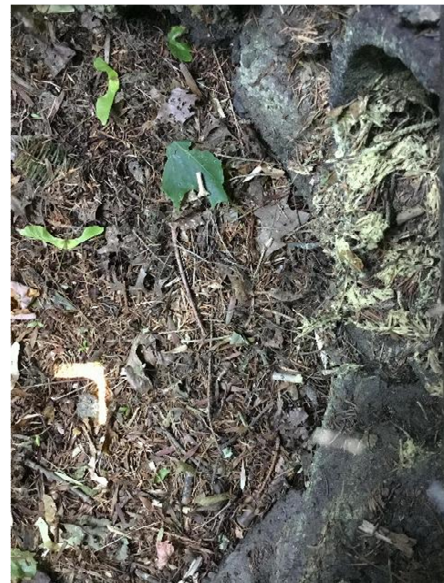
Pet waste at outfall 33-0000-0003

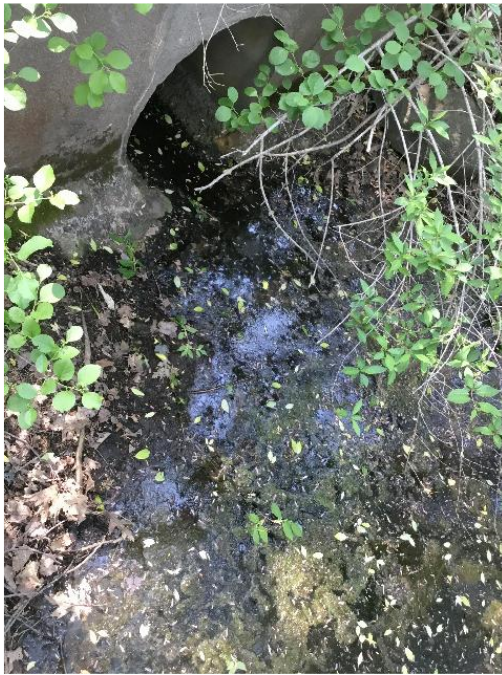
Algae at outfall 34-0000-0017

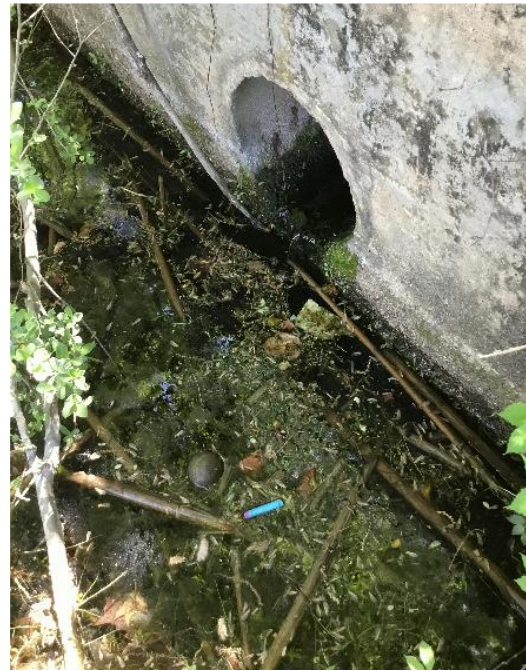
Algae, trash, and foam at outfall 41-0000-0001
