Johnson Middle School
111 Robbins Road
Walpole, MA 02081

Property Condition Assessment

April 1, 2022

Compass Project No: 10110

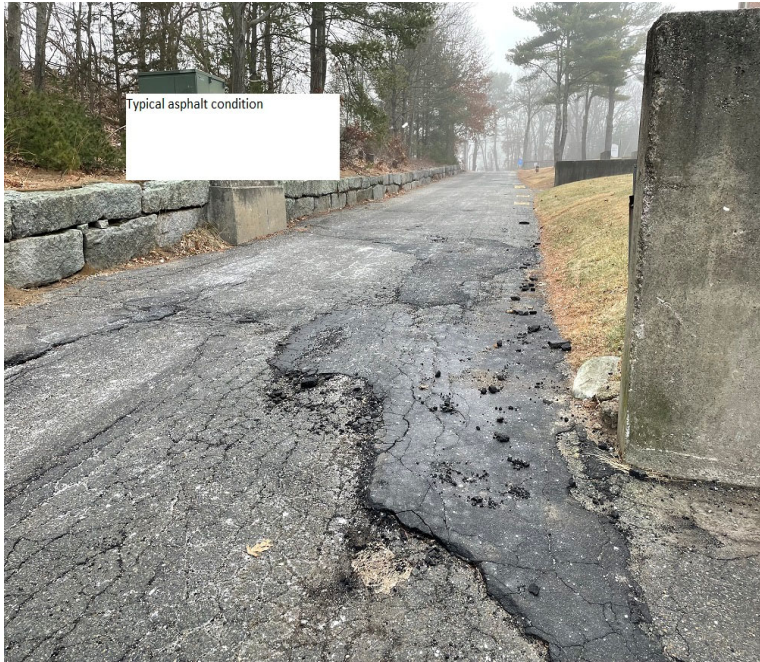
The JMS semi-circular drive is in Fair shape with damaged curbing, significant cracking and uneven surface due to heavy wear.

The East side access road to loading dock area has significant wear and asphalt degradation can be readily observed. The heavy wear in this area will require a monitoring and continuous spot repair. There is no drainage on this drive and surface water runs down the asphalt creating water damage and heaving problems where the drive intersects the loading dock.

The front (bus) drop off circle of the parking lot will need repair and crack sealing. (Table 2 \$30,000)

The east side access drive is nearing the end of its life cycle, and is in need of an asphalt reclamation and repaving. (Table 2 \$50,000)

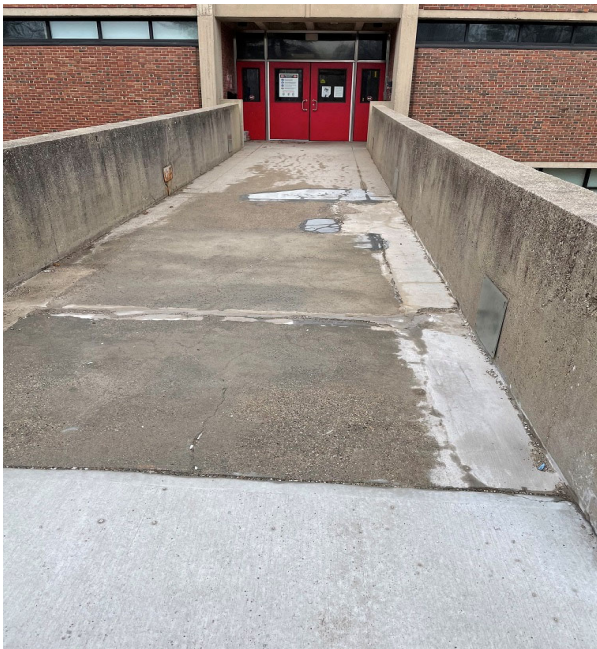
The cast in place entry walkway structure has visible spalling of the slab, around penetrations in the wall and slab, and on the underside of the slab. The Town has done several repairs to repair and stabilize damaged areas. It can be assumed, that salts used in the winter snow/ice conditions on the walkway have penetrated the concrete and caused negative reactions within the concrete and the reinforcement bar. While not critical at this time, planning and budgeting should be considered to perform a more comprehensive repair of the structure to enhance it longevity.

Bridge concrete repairs

This assessment should also address the walkway structure delaminating concrete and the anticipated damage to the rebar. A capital plan should be developed and implemented addressing these observed issues to repair and stabilize these issues to assure longevity of the structure. (\$100,000)

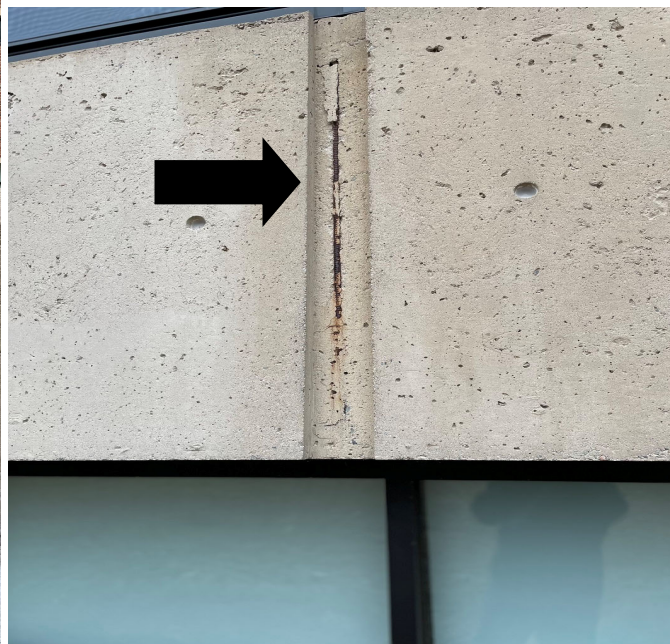
At several locations around the building and on the pedestrian walkway, it could be readily observed that concrete has spalled exposing the re-enforcement bar. Based on the observation, the re-enforcement bar installed during the original concrete pour was installed too close to the exterior. This lack of concrete coverage creates a condition where the rebar is subject to moisture and freeze/thaw conditions which impacts the concrete's cohesive bond. Moisture penetration in the concrete, can build up around the rebar and freeze in winter or rust the rebar. Both conditions create expansion pressure on the thin concrete surface and "pop" the face of the surface, exposing the rebar. The areas with damage appear minor.

However, repairs are needed to be addressed to stabilize concrete face, protect the rebar, and prevent further damage or rusting which will impact the façade.

Typical exposed rebar and spalling concrete

Assessment and repair should be budgeted and addressed a comprehensive repair of various locations of concrete spalling and cover exposed rebar. (\$20,000)

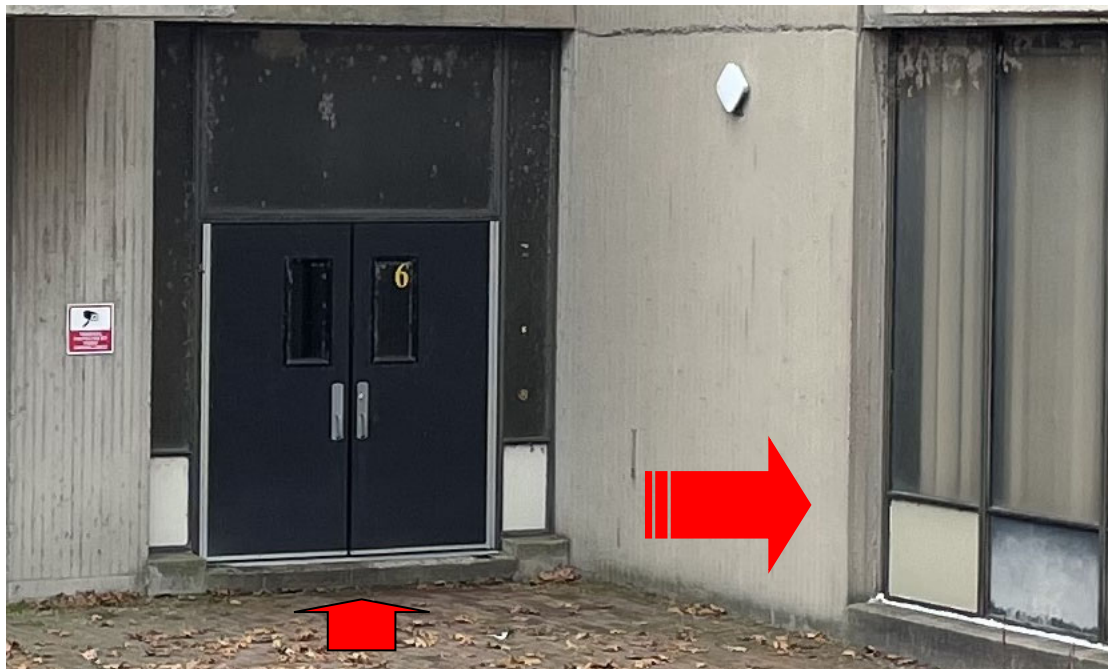
The solid panels in the existing window systems (the lower panels at the floor level) all have faded in color and in some locations, the metal has deteriorated and subject to water infiltration or have been replaced with a wood panel.

Step down to courtyard and example of existing window panels that are replaced or rotting.

- b. The Town should continue its systematic replacement of the window systems to match the work it has done on the north and south faces of the building. (Table 2 \$700,000)
- c. Upgrades to the weatherstripping, and repairs to the rusting doors or frames along this painting is required to stabilize the condition to prevent further damage. (Table 1 \$50,000)

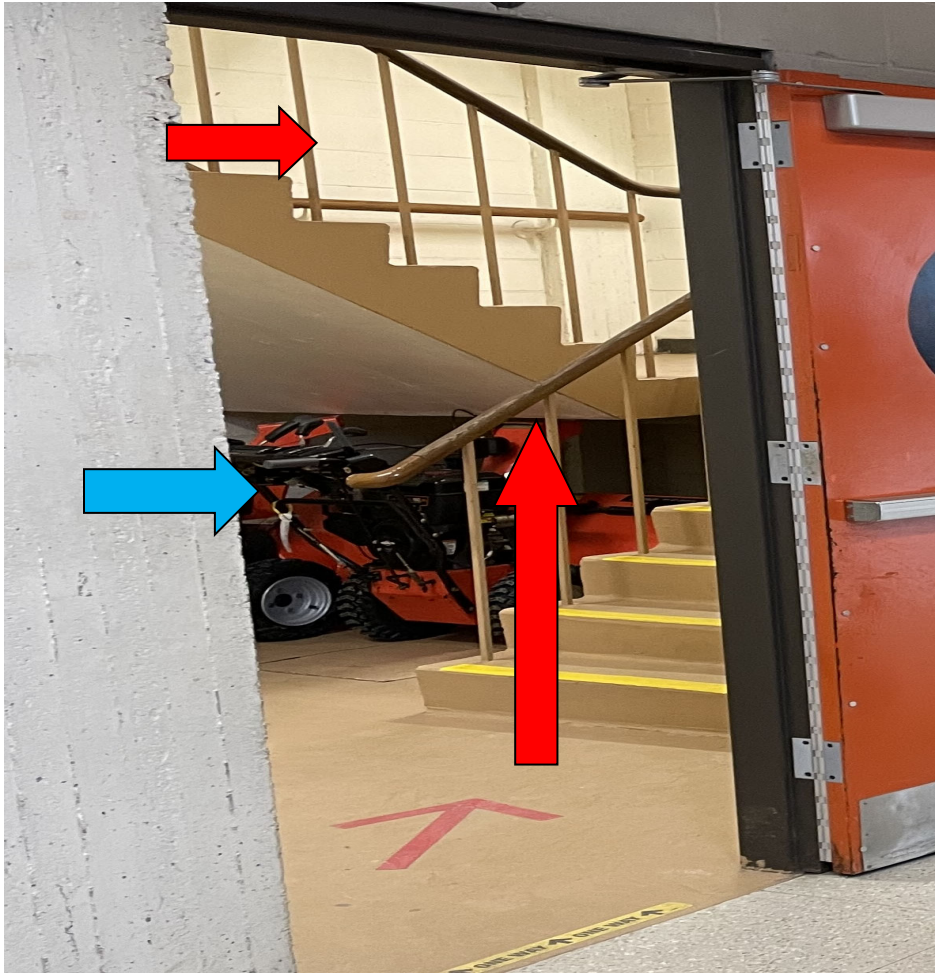
Handrails: On stair towers and courtyard stairs handrails are non compliant. Balusters on stairs are non-compliant. (It should be noted that baluster spacing is not compliant with building code spacing.)

Arrows identify baluster spacing non-compliant with MSBC & Handrails to compliant with MAAB. Blue arrow demonstrates operational need to relocate gas powered equipment to a proper storage area.

Install MAAB compliant handrails in all four stair towers and install address baluster spacing to meet current code for safety of a preschool/ kindergarten population. (Table 1 \$170,000)

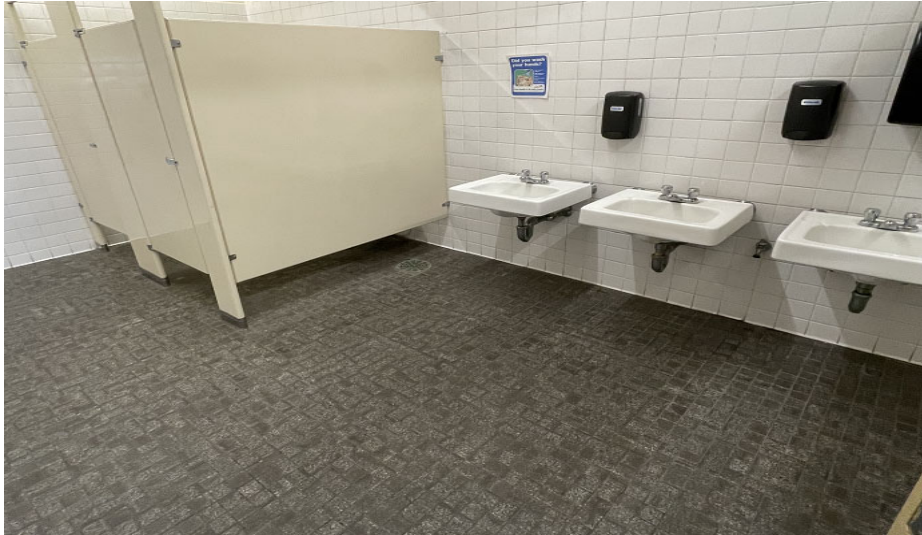
Typical existing bathroom lacking handicap assessable fixtures

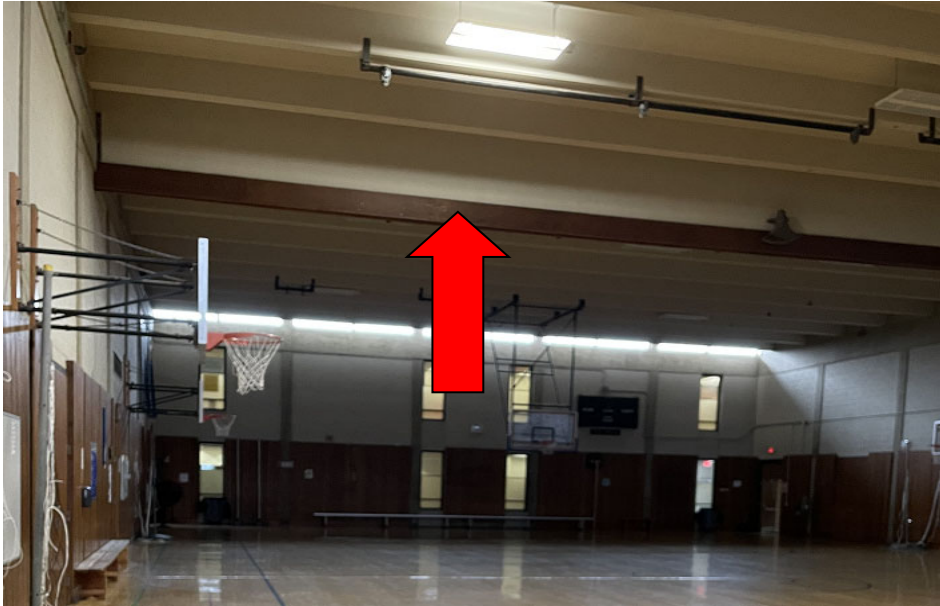
Location of non functional gym wall

Repair/ replace gymnasium folding separation wall. (repair \$10000 Replace \$50,000 net type)

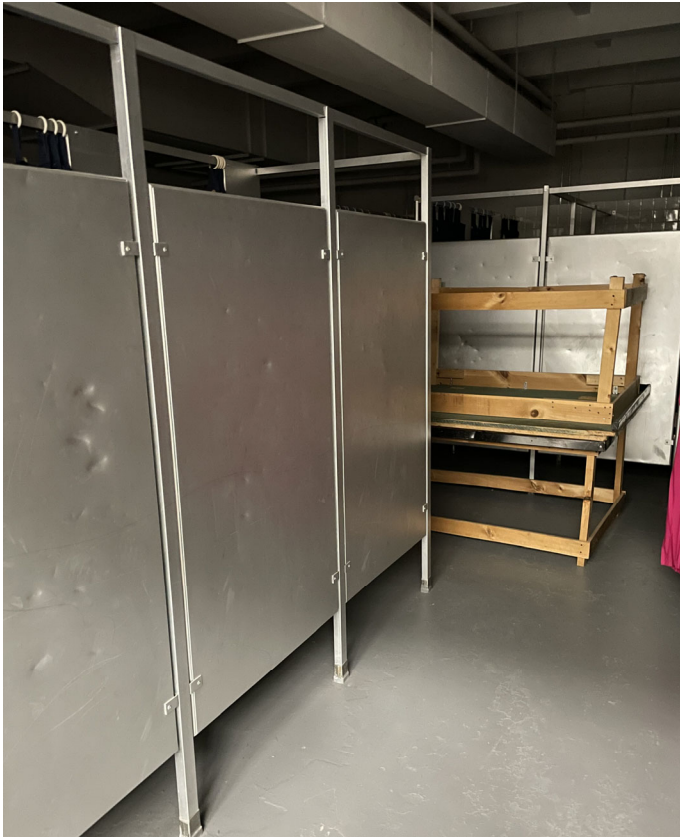
Mothballed locker rooms and shower facilities

Locker Rooms/shower areas: The shower facilities were not being used (currently used as storage for various material) and therefore could not be evaluated. However, as reported in the Architectural Engineers report to Tappe Architects, the existing gang type shower units are serviced by multiple common floor drains that do not meet current codes. The mixing valves could not be determined if they work. It was noted that due to non use, the floor traps in the old shower room have dried and sewer gas is escaping to atmosphere.
