# WALPOLE TOWN HOUSE

Re-Use Committee Report to  
The Board of Selectmen

# 1881 Walpole Town Hall Feasibility Study

June 2019

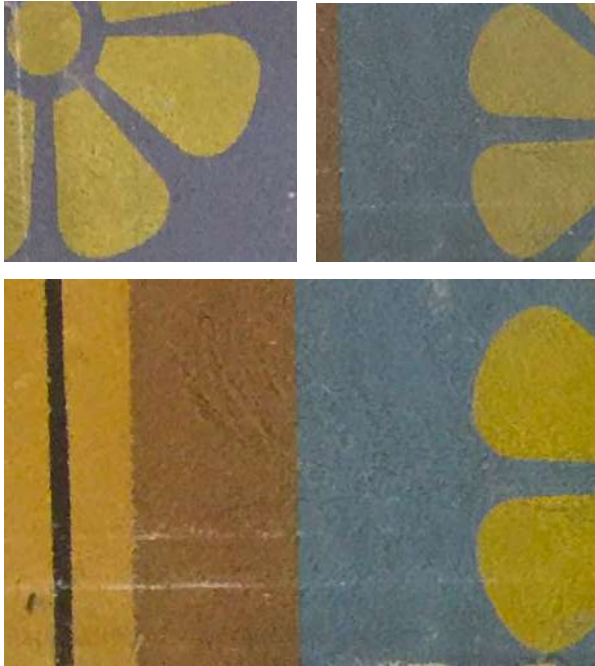
Fig. 1. Remaining Historic Hall Stenciling

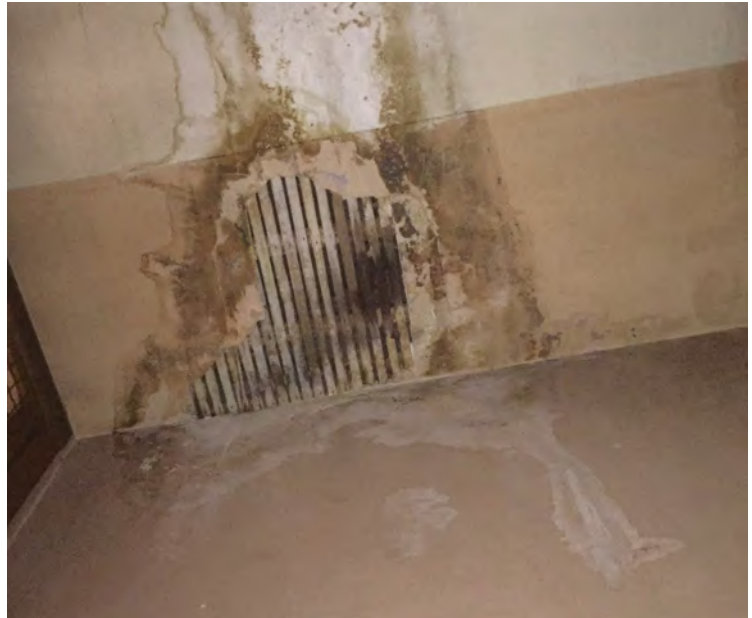
The building's exterior provides protection from the elements and conveys its historic character. The most prevalent cause of deterioration in historic buildings is due to uncontrolled water and its deleterious effects. The main concern is the ongoing water infiltration through the roof and subsequent deterioration of the building interior due to needed roof repairs. This has been a chronic problem for the building as evidence by the amount of staining of the original hair plaster meeting hall ceilings (Fig. 2) and walls (as seen from the balcony)

Fig. 2: Roof leak, failing plaster + damaged finishes

and subsequent failing of the plaster keys and falling plaster. Buckets and plastic tarps have been used to try to contain the water. However, wet balcony floors infer water is damaging the second floor and possibly lower levels below. The condition of the wood rafters and beams beneath the plaster and lath is unknown and will require either further investigation or additional contingency monies set aside for repairs. Continued deferment of repairs will result in permanent loss of character defining hair plaster walls and ceilings, destruction of structural wood roof components, increased repair costs and ultimately use of the building.

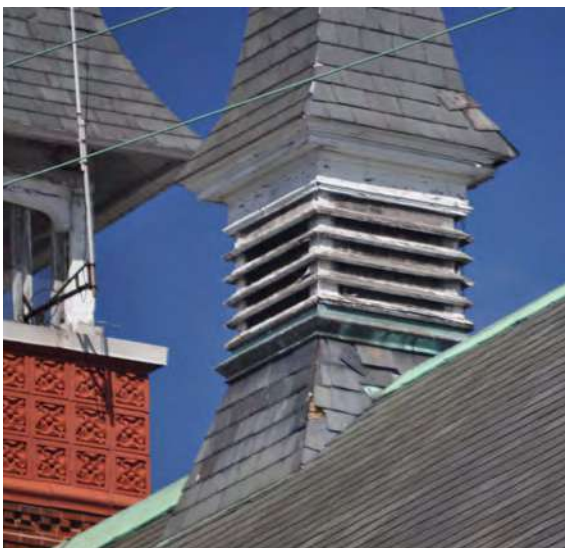
Fig. 3: Broken/failed slates

The copper ridge flashing and slates at the ventilator (Fig.3) have failed and need to be replaced.

The paint on the ventilator wood trim and louvers is cracked and peeling (Fig. 3) and needs to be prepped and painted. Several pieces of trim need to be replaced.

materials. Periodically roof slates break, slate fasteners fail and either slip in place or fall to the ground. Both these were evidenced. Approximately 53 slates need to be replaced as of this report as well as those associated with the copper valley (~315 slates) replacement. Typically, slate roofs should be inspected every 5 years and repairs made as necessary.

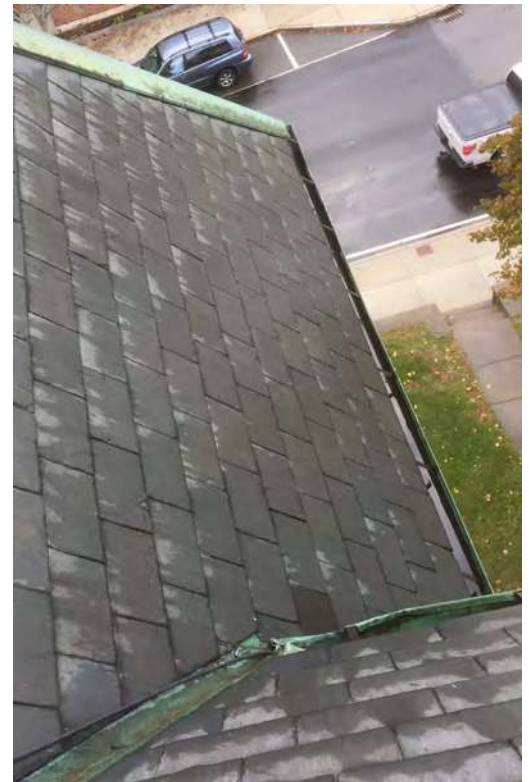
Most of the copper gutters and downspouts are functioning properly and in good condition. The exception is the copper gutter and downspout at the southwest corner of the transverse hip roof (Fig. 4) facing Main Street. This gutter and/or downspout are full of water, overflows during rain and snow melting events and needs to be unclogged. Above this is a section of gutter that is deformed and has a hole from a former aerial cable. Water runs down the face of the brick during rainstorms. This section of gutter needs to be replaced.

Fig. 4: Clogged and damaged gutter and valley flashing

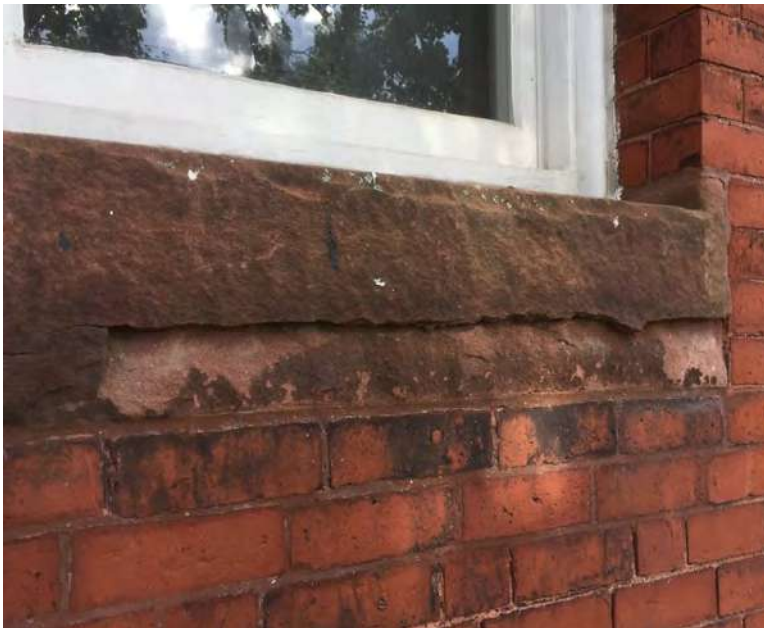
Fig. 5: Spalling brownstone sill

The Nova Scotia brownstone (Fig. 5) used for lintels and sills at window has not fared as well. The brownstone at the window sills, window transoms and lintels has a rockface finish for greater contrast and boldness. The brownstone at the arched stone openings of the portico has a fine hammered finish. The brownstone used was cut along both seam (parallel to bed displaying a single layer) faces and split (perpendicular to the bed displaying the layers) faces. About a tenth of the stones exhibit serious problems such as spalling and/or cracking. Some have deteriorated to a point where they need to be replaced in kind. Others holes and spalls can be

patched, after removing material down to sound stone, using epoxy consolidants matching the existing stone in color and texture. Cracks can be repaired using an epoxy injection.

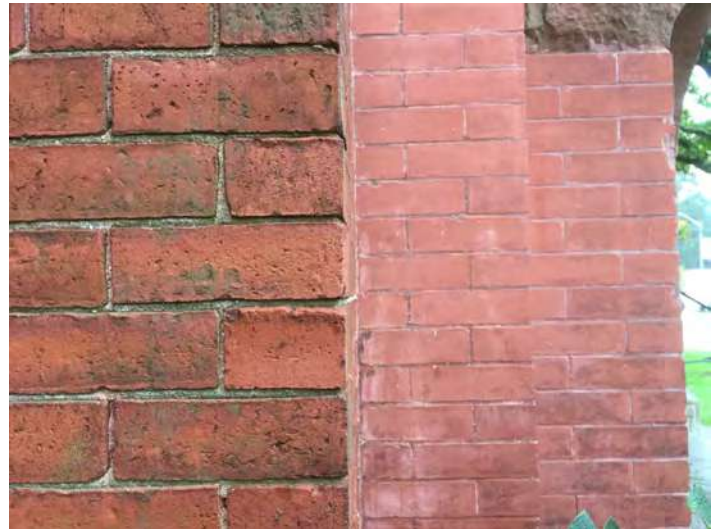
The brick was replaced at the portico (Fig. 6) at some point in time with brick not matching the historic in size and color. The result is new brick not aligning with the original brick coursing and creating a sharp visual contrast to the historic. This work is not appropriate. There are areas of brick on the north and south (sides) and east (back) and west (back) façades where brick infilled openings, new openings were made, brick was repointed and repairs were made. The areas are easily seen since the mortar does not match the historic mortar in color and tooling and some of the brick does not match the historic. Unless a full restoration of the exterior is made, then replacement is not required.

Fig. 6: Inappropriate brick replacement

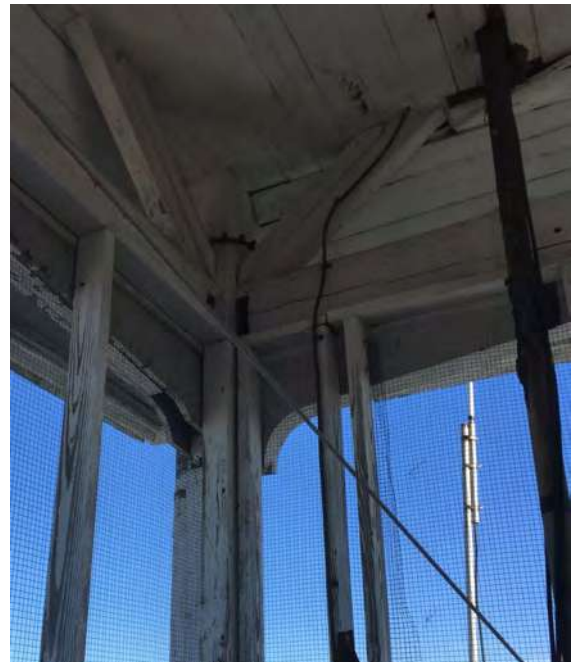
Elements of the belfry wood trim that encase the corner posts that support the roof and form an arched enclosure for the belfry are rotting (Fig. 7) and parts are missing. Past repairs of the trim did not match the existing remaining historic profiles of the trim and are failing. The ceiling boards and access hatch show water damage as well as animal or bird nesting. Very little of the trim is salvageable. All the wood architectural elements of the belfry should be replaced

Fig. 7: Rotting Belfry trim and ceiling

matching the remaining historic trim dimensionally and in shape and profile.

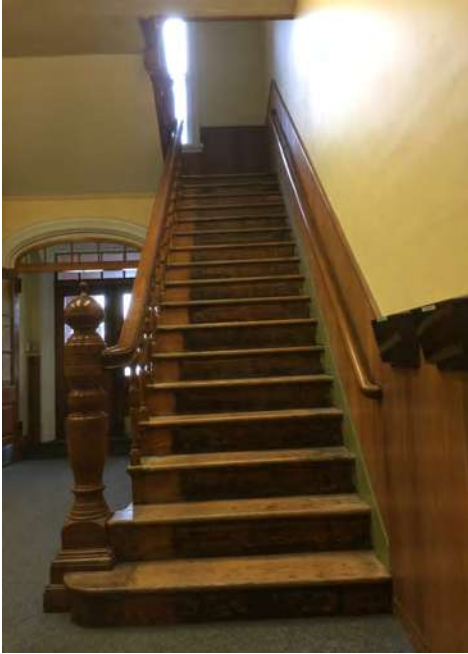
Fig. 8: Double staircase (Right)

The historic double staircase (Fig. 8) is in serviceable condition and should be restored and reused. While retention of the double staircase requires a variance from the Massachusetts Architectural Access Board, my experience with past variance applications for historic stairs have been conditionally approved by the MAAB as long as there is a compliant elevator to the floors served. Simple modifications can be made to the stairs to make it acceptable to the MAAB.

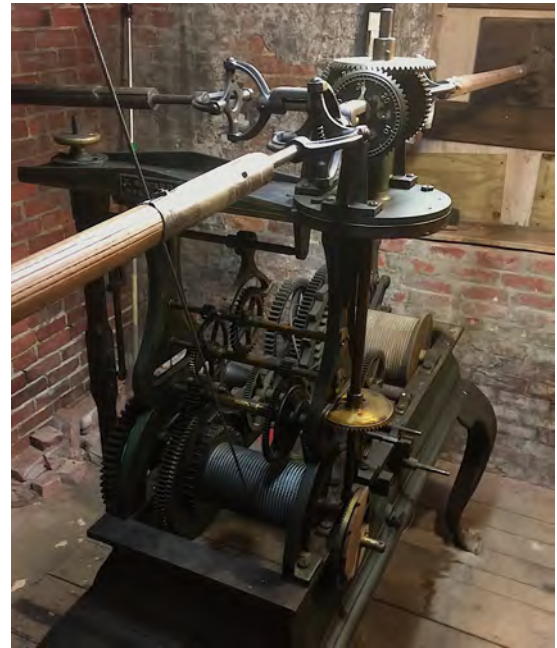
The clock is a striking tower clock (Fig. 9) driving hands on three faces and at one time struck the hours. It was manufactured by the E. Howard & Company of Boston, Massachusetts. The bell disappeared in the mid 20<sup>th</sup> century and has never been found or replaced.

The clock access ladder that extends to the belfry hatch, clock mechanism, clock room wood flooring, framing and entrance door and hardware to the pendulum room below are all original to the building when constructed in 1881. This is evidenced by the saw marks on the wood, nails, the type and date of the manufacturer's hardware and clock purchase records. The paneled bead board used for the clock enclosure and the paneled door hardware is consistent with late 19<sup>th</sup> century usage and was likely installed after the clock was in place to limit access. The entire clock mechanism and rooms are historic and need to be retained, maintained and restored as necessary.

Fig. 9: Howard tower clock mechanism

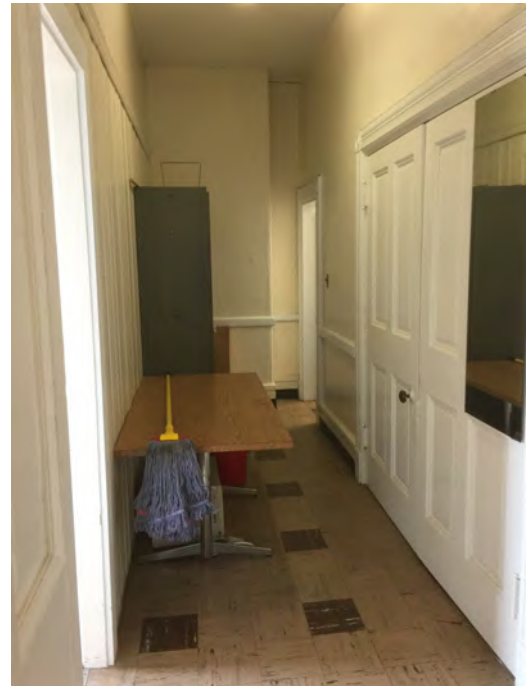
1. The building is over 137 years old and it is assumed that lead paint was used and is present on the exterior and interior painted components of the building.
2. It was noted that 8"x8" floor tiles (Fig. 10) were visible at the several locations at the second floor. These tiles were likely installed between 1920 and 1960 and 8"x8" floor tile installed during this period may contain asbestos. It is likely the tiles contain asbestos. These locations are at the two single user bathrooms and the corridors leading to them from the stair hall.
3. Black adhesive to glue ceiling tiles to the historic plaster ceilings was observed in the two corridors leading to both single user bathrooms on the second floor. This type of adhesive may contain asbestos and/or possibly PCB's (Polychlorinated biphenyl).

Fig. 10: Potential asbestos floor tile

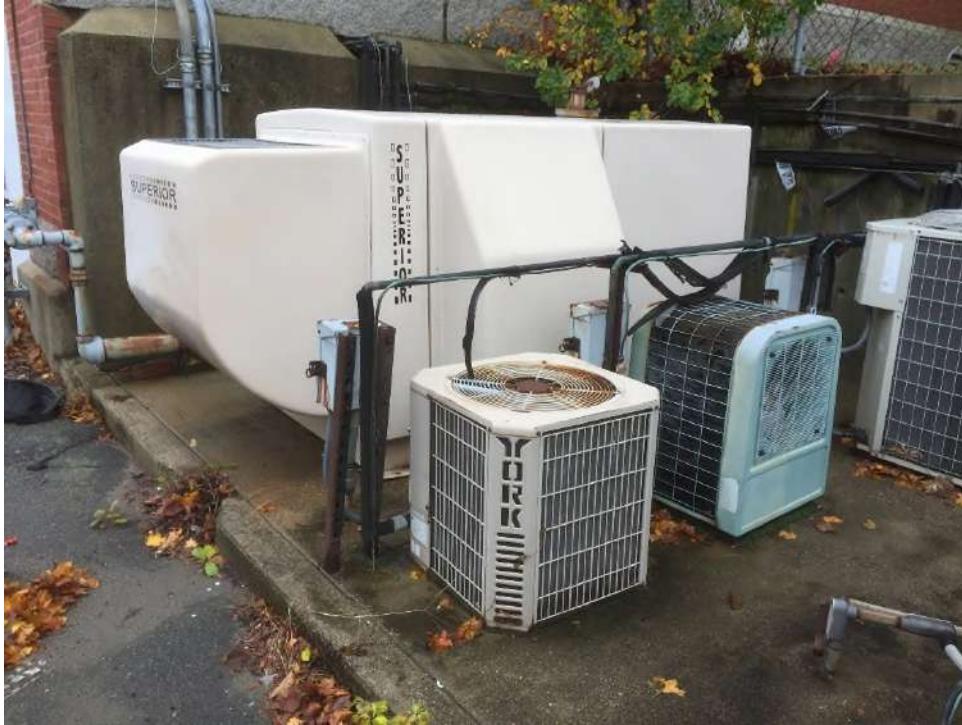
Picture 1: Condensing units next to the gas generator.

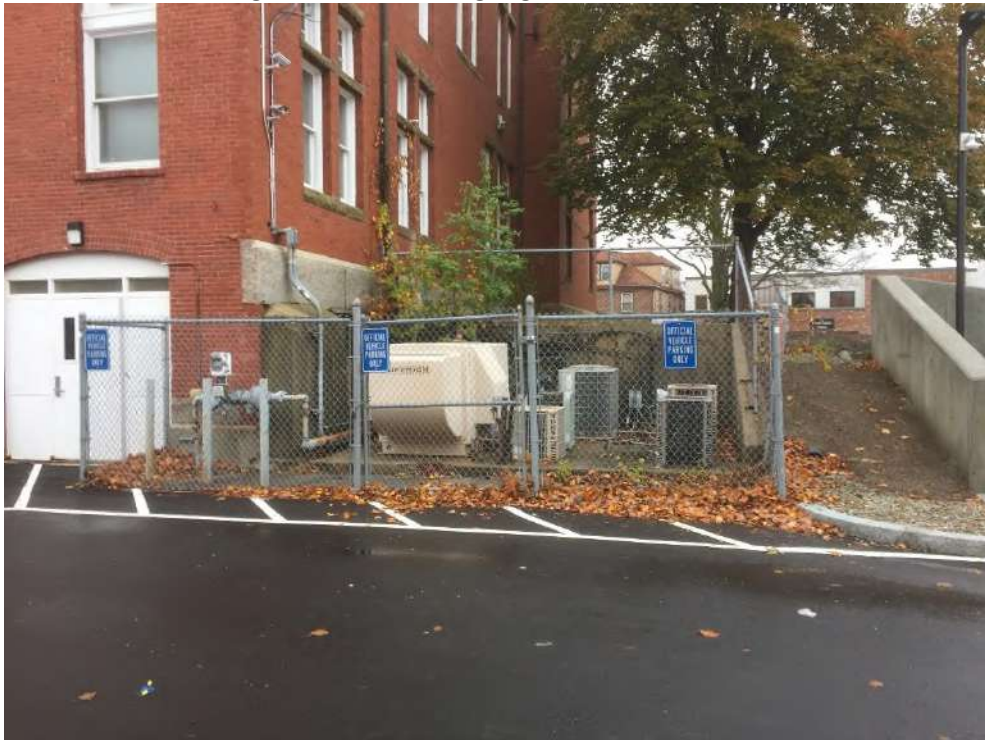
Picture 2: Condensing units next to the gas generator.

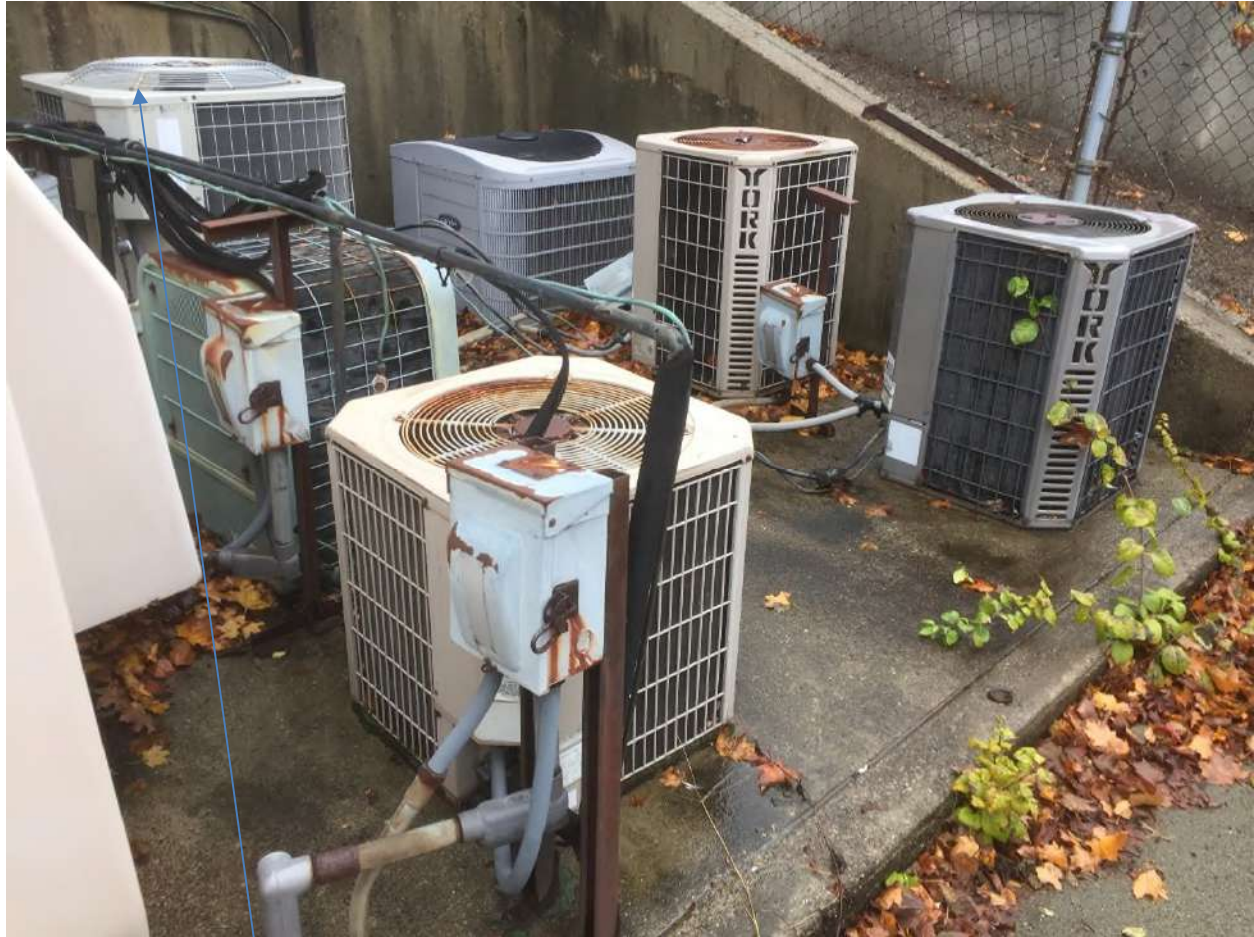
Picture 3: Five (5) 2 to 3-ton, air-cooled, condensing units of various age, and one (1), 4-ton unit (labeled). New 2 to 3-ton units will be about the physical size, or larger, of the 4-ton unit.
