Walpole Old Town Hall
980 Main Street
Walpole, MA 02081

Facility Condition Assessment and Report on Report on Preparing Building for Development

May 19, 2022

Compass Project Management, LLC
A Vertex Company
One Edgewater Drive, Suite 204
Norwood, MA 02062

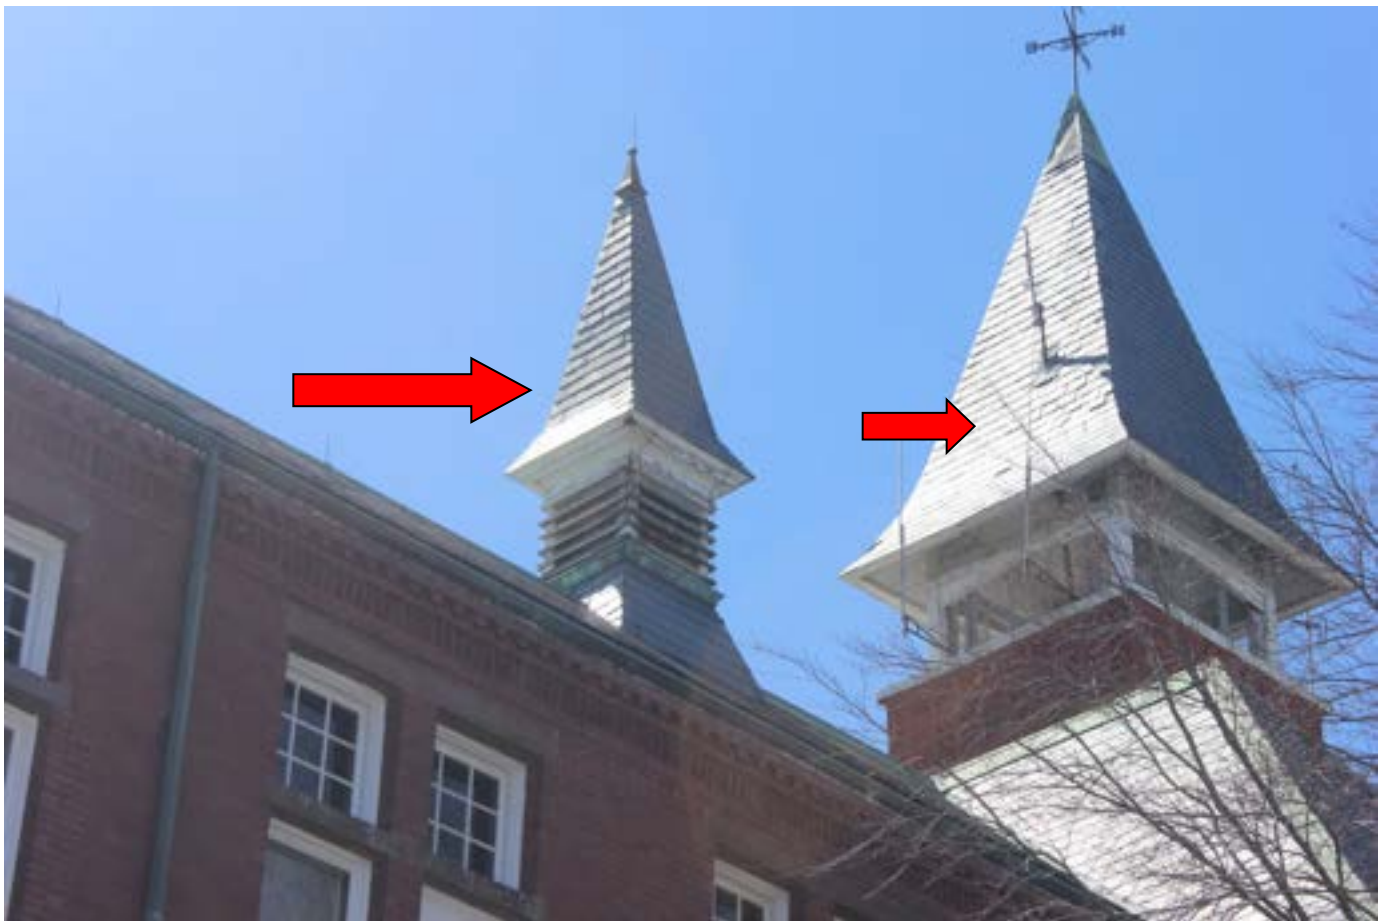
Peeling paint can be observed on most of the wood trim. On the clock tower and cupola, some trim has rot beginning to occur on the corner joints. These joints are opening and allowing weather and birds to access, which will lead to additional rot.

- a. The town should continue its program of roof monitoring and slate repair. The upper clock tower slate roof and lower cupola roof have missing or damaged slate that will need attention. On the east side at the base of the valley there are several damaged or missing slate. This critical area should be addressed to assure water penetration is prevented.
- b. Copper work: On the front (northeast face) along the edge of the masonry clock tower wall, there is a damaged and missing copper gutter section. It is assumed that an ice/snow slide dislodged, ripping a small section of gutter off. This

Broken and missing slate. Cupola trim rotted and open up at joints

- a. Life cycle of paint and sealants needs to be inspected and evaluated on the original windows and trim. It has been reported that the Town of Walpole is planning to address the paint issues this summer.
- b. The Town should continue its systematic replacement of rotted trim at windows and gutters. The work identified should be repaired and replaced immediately to stabilize the front porch gutter and Cupola trim.
- c. Upgrades to the weatherstripping, and repairs to the rusting doors or frames along with painting is required to stabilize the condition to prevent further damage.
- d. Patch/seal all open penetrations in the brick façade.

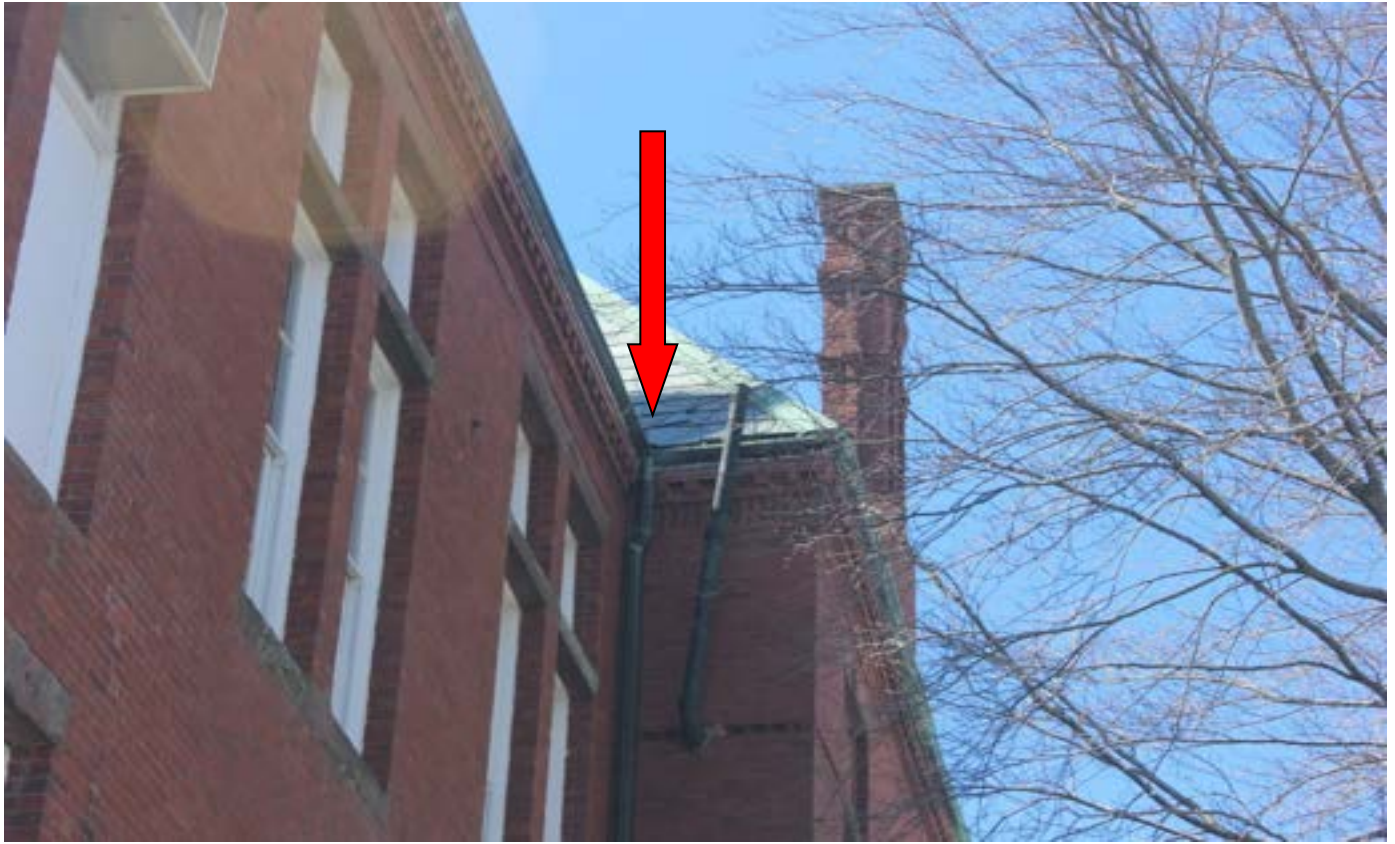
- c. On the main roof east side, it could be observed that a section of the copper hip cap has become “unfastened” at the base of the hip and appears to be lifting.
- d. Gutters along the base of the main roof generally appear in good condition. There are several small areas where the gutter appears to have suffered some distortion due to sliding snow. Gutter should be evaluated and repaired as required to assure proper flow of rainwater and no excessive “ponding” occurs within the gutter.

Broken slate at valley. Copper cap on hip is lifting. Cut back tree affecting the building.

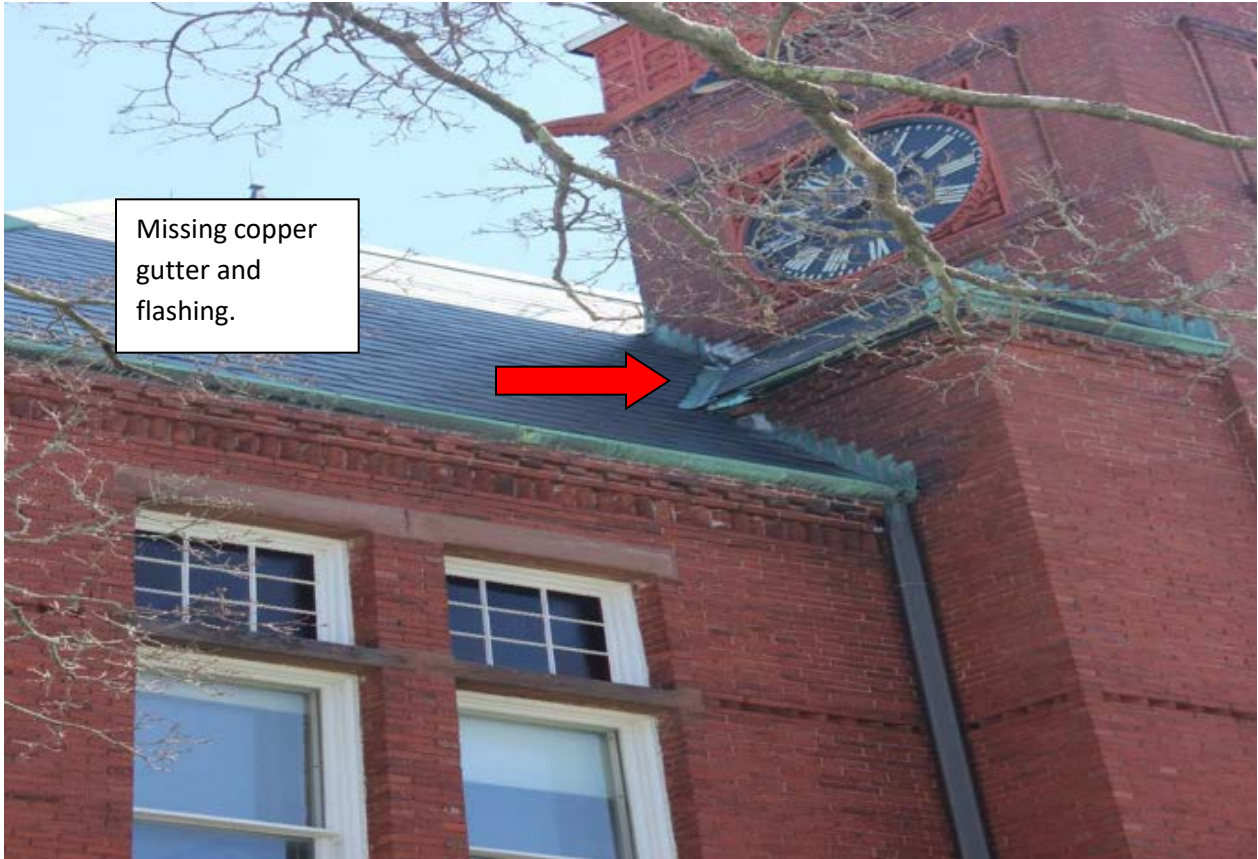
section should be replaced and the damaged flashing at the base of the small valley be repaired to prevent any water penetration.

Missing copper gutter and flashing.

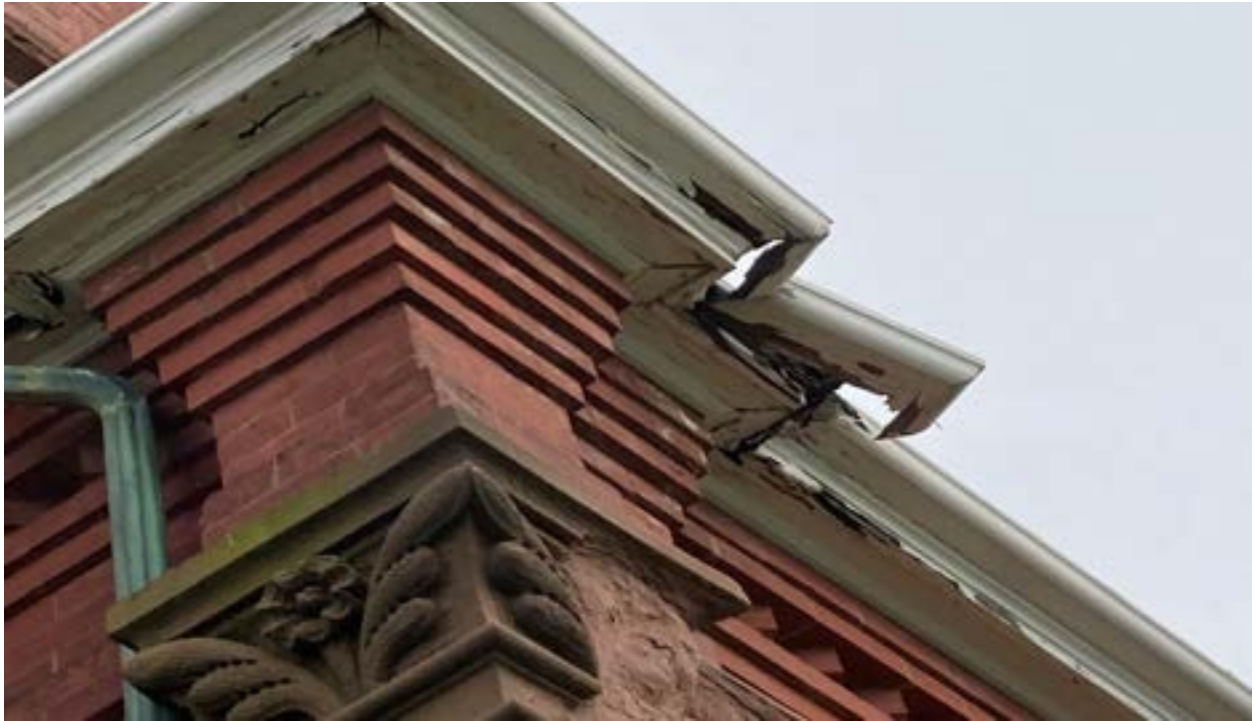
Wood gutters on the front porch have significant rot occurring and need immediate repair.

Front porch wood gutter failure

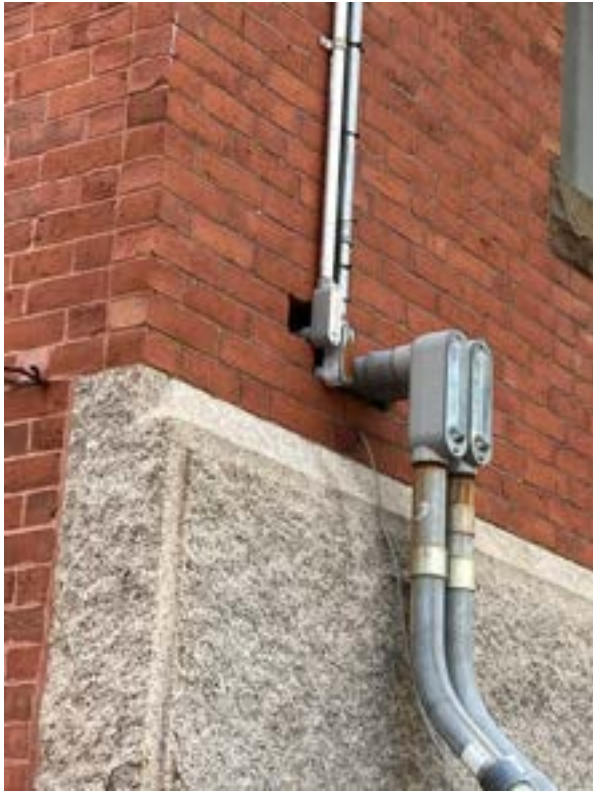
Unsealed wall penetrations

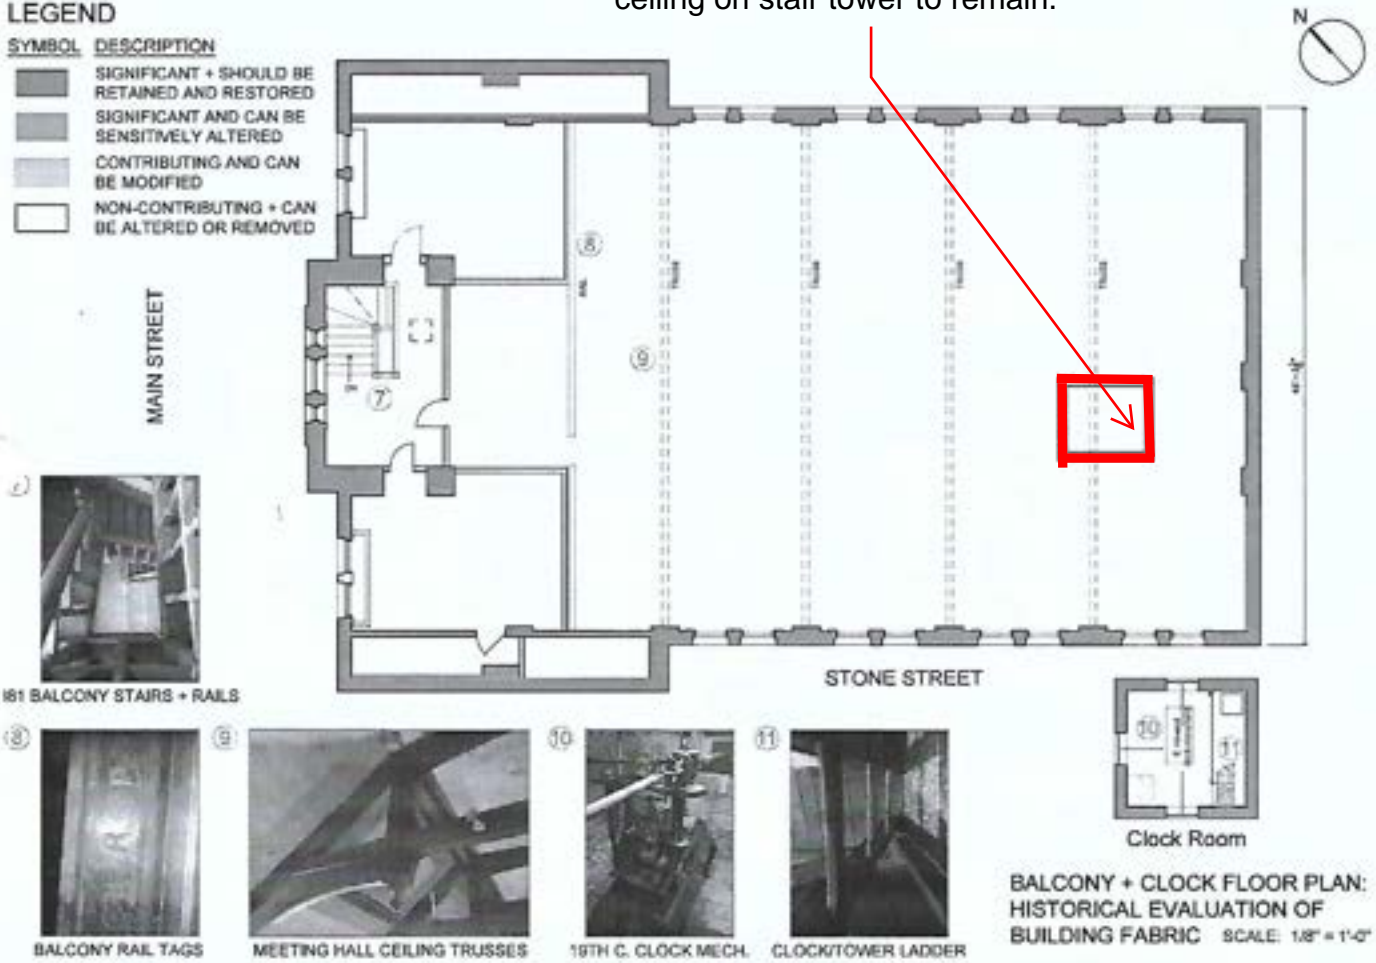
Area of remedial work to maintain ceiling on stair tower to remain.
