# TOWN OF WALPOLE

# RECREATION PROGRAMMING AND FACILITIES STUDY

2 0 2 2

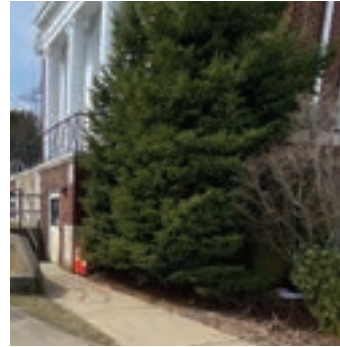
Photo 5: Foundation planting overgrowth

- **Landscape Vegetation:** Plantings are in healthy, good condition. Overgrowth of plantings at the foundation of the building at the Southeast corner may lead to damp conditions and future damage to the masonry structure (Photos 5,6). Planting along the access walks from Stone Street are more recent and in good condition.

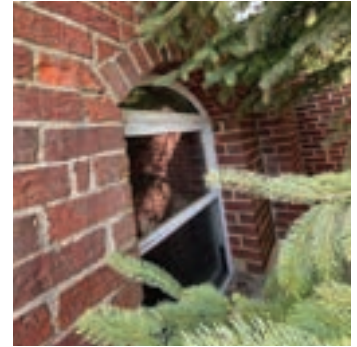
Photo 6: Planting conflict with building materials

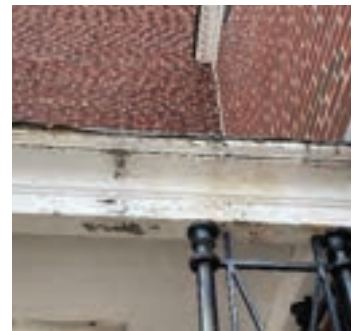
Photo 9: View of fascia in poor condition

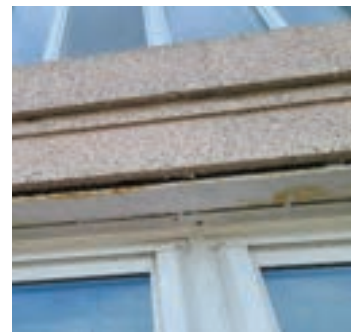
Photo 21: View of the rusted steel lintels over windows

- Some rusting and slight warping of steel lintels was found along the first level of the building (Photo 21). Rust and corrosion were observed on the main service disconnect. Some damage to the brick masonry was observed at the tops of both chimneys. Some surface cracks were observed in the front exterior concrete steps. It was indicated on site that steps had been previously repaired. The cracks are likely due to weathering over time (Photo 22).

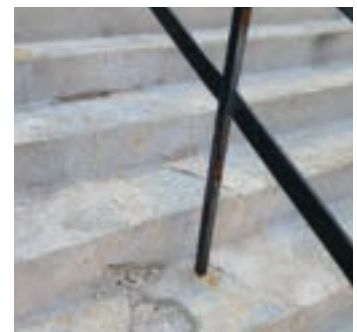
Photo 22: View of concrete steps

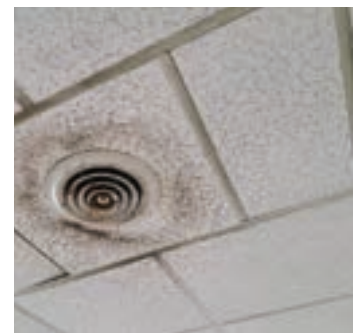
- The second floor auditorium appeared to be in good condition. Some mold was observed around ceiling vents in this area (Photo 23). In storage and mechanical spaces, some window frames appeared to be rusted (Photo 25). The ceiling in the men's and women's bathrooms appeared to be constructed of a concrete slab on supporting concrete beams. Some cracks and spalling of concrete were observed in these areas (Photos 24). Visible cracks in wall finishes were observed throughout the building as well as at corners of window openings in the attic space. The underlying structure behind wall finishes was not visible at the time of this visit.

Photo 23: View of staining/mold at Level 1 recreation room ceiling

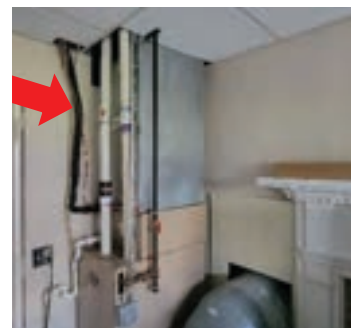
Photo 30: Combustion air split needs repair

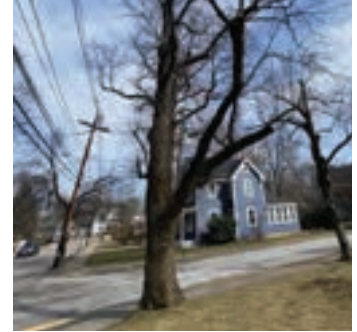
Photo 6: Existing tree in decline

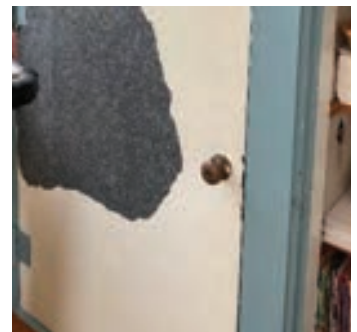
Photo 7: View of painting chipping on metal door

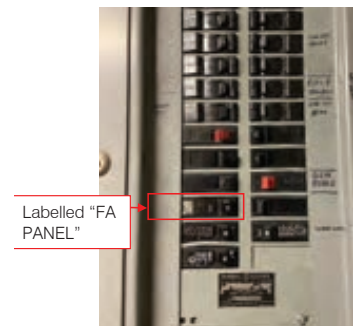
Photo 23: Improper type and label for fire alarm control panel branch circuit breaker

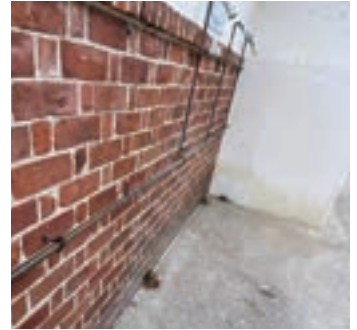
Photo 3: Erosion outside of pool deck

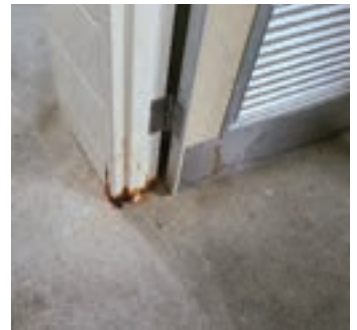
Photo 11: Rusted door frames inside building

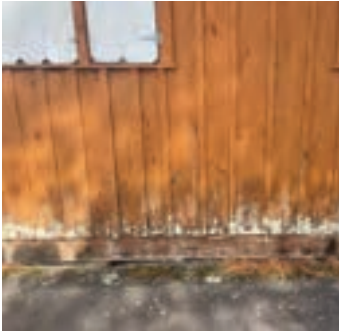
Photo 12: Mold and algae growth on siding

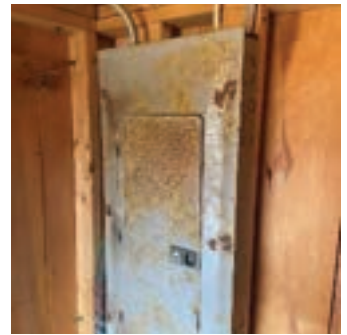
Photo 26: Rust and corrosion at panelboard

- It is recommended that the panelboards throughout Jarvis Farm have permanently affixed, non-handwritten labels indicating the power source. Any major electrical upgrade on-site will require this.

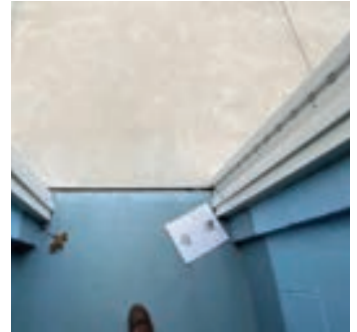
Photo 3: Gap at doorway

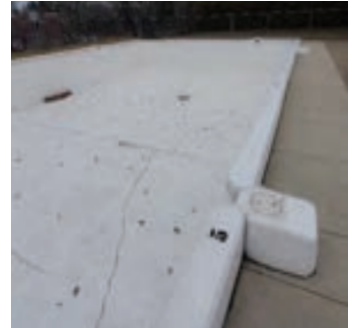
Photo 28: Cracks in pool
