Town of Walpole, Massachusetts

Municipal Facilities Master Planning Study

Final Report

June 21, 2013

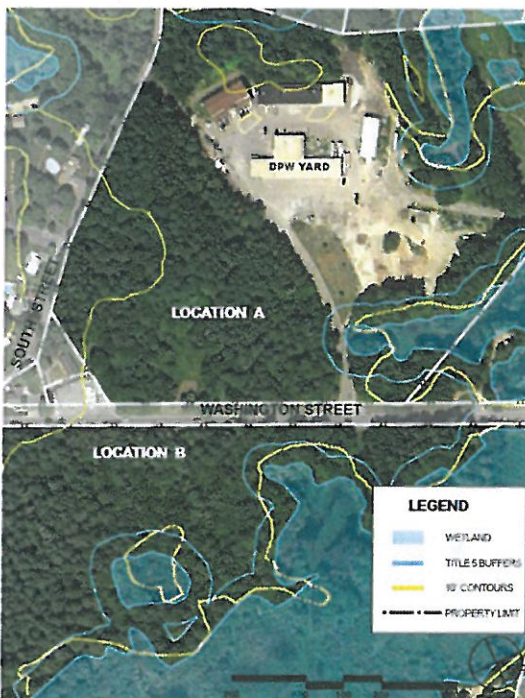
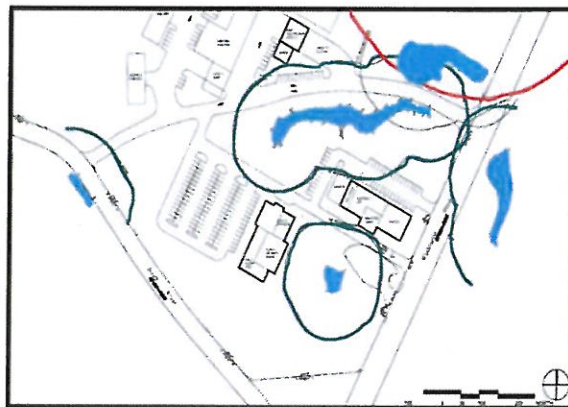
Plan enlargement of Location A with wetlands and the well radius indicated in relation to proposed buildings.

Zone 1 Wellhead Protection Area: Portions of the Washington Street property are located within Zone 1 of the overlay district. No proposed construction within the 400' well radius is recommended in this study.

Wetlands: Wetlands are present within the boundary of the DPW property however no construction is recommended that would encroach upon the 100' setback.

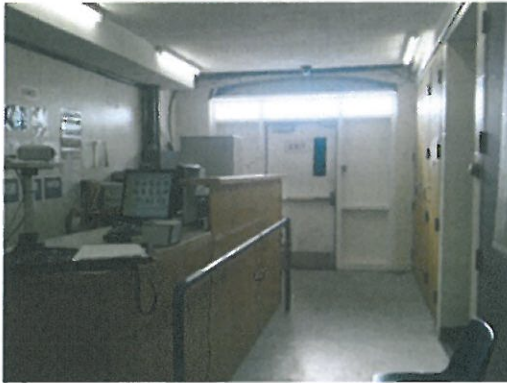
Booking Area

Building Interior: The interior of the facility has experienced substantial changes since its construction including renovations to the basement to accommodate the detention facility and the added ceiling construction to reduce the height of the second floor court room. This ceiling modification allowed the second floor hall space to become office occupancy. All finishes are in good condition including portions of the second floor that are undergoing renovations.

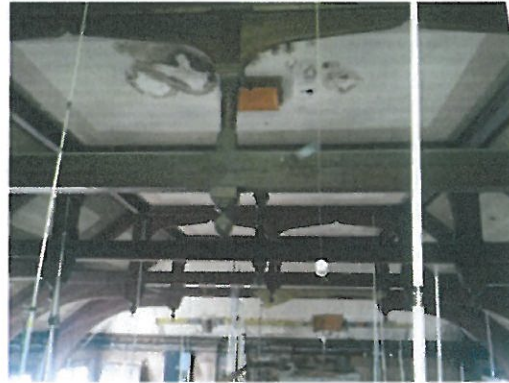
Original Wood Structure

Structure: The building structure consists of load bearing masonry walls with wood framed floors and roof. The structure does not comply with current seismic and reinforcing requirements. This condition is of particular concern at the clock tower. However, seismic upgrades are not required by the International Existing Building Code unless other building improvements are performed. Depending on the amount and value of renovations, this will trigger what structural upgrades are required to be performed.

Currently the central stair leading to the mezzanine is sagging and structurally unsafe. To prevent further damage to the stair and possible injury to the users, the Town has cordoned off this portion of the stair.

Restoration/Addition: Full renovation of the existing building including restoring the original upper level auditorium to its original condition, removing the second floor ceiling, existing elevator, toilet rooms and stair. The original wood structure, balcony and interior detail would be restored. An addition to the building on the southeast corner with new stair, elevator and toilet rooms would also be required.

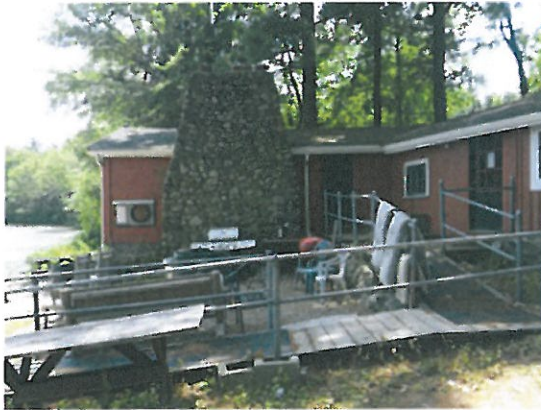
Rear Patio and Ramp

Accessibility: The building, and in particular the exterior, has components that are not accessible including the ramps and handrails that extend from the porch to the pond.
