Phase V Status & Remedial Monitoring Report

RTN 4-3024222

Former Bird Machine Company Site

Walpole, Massachusetts

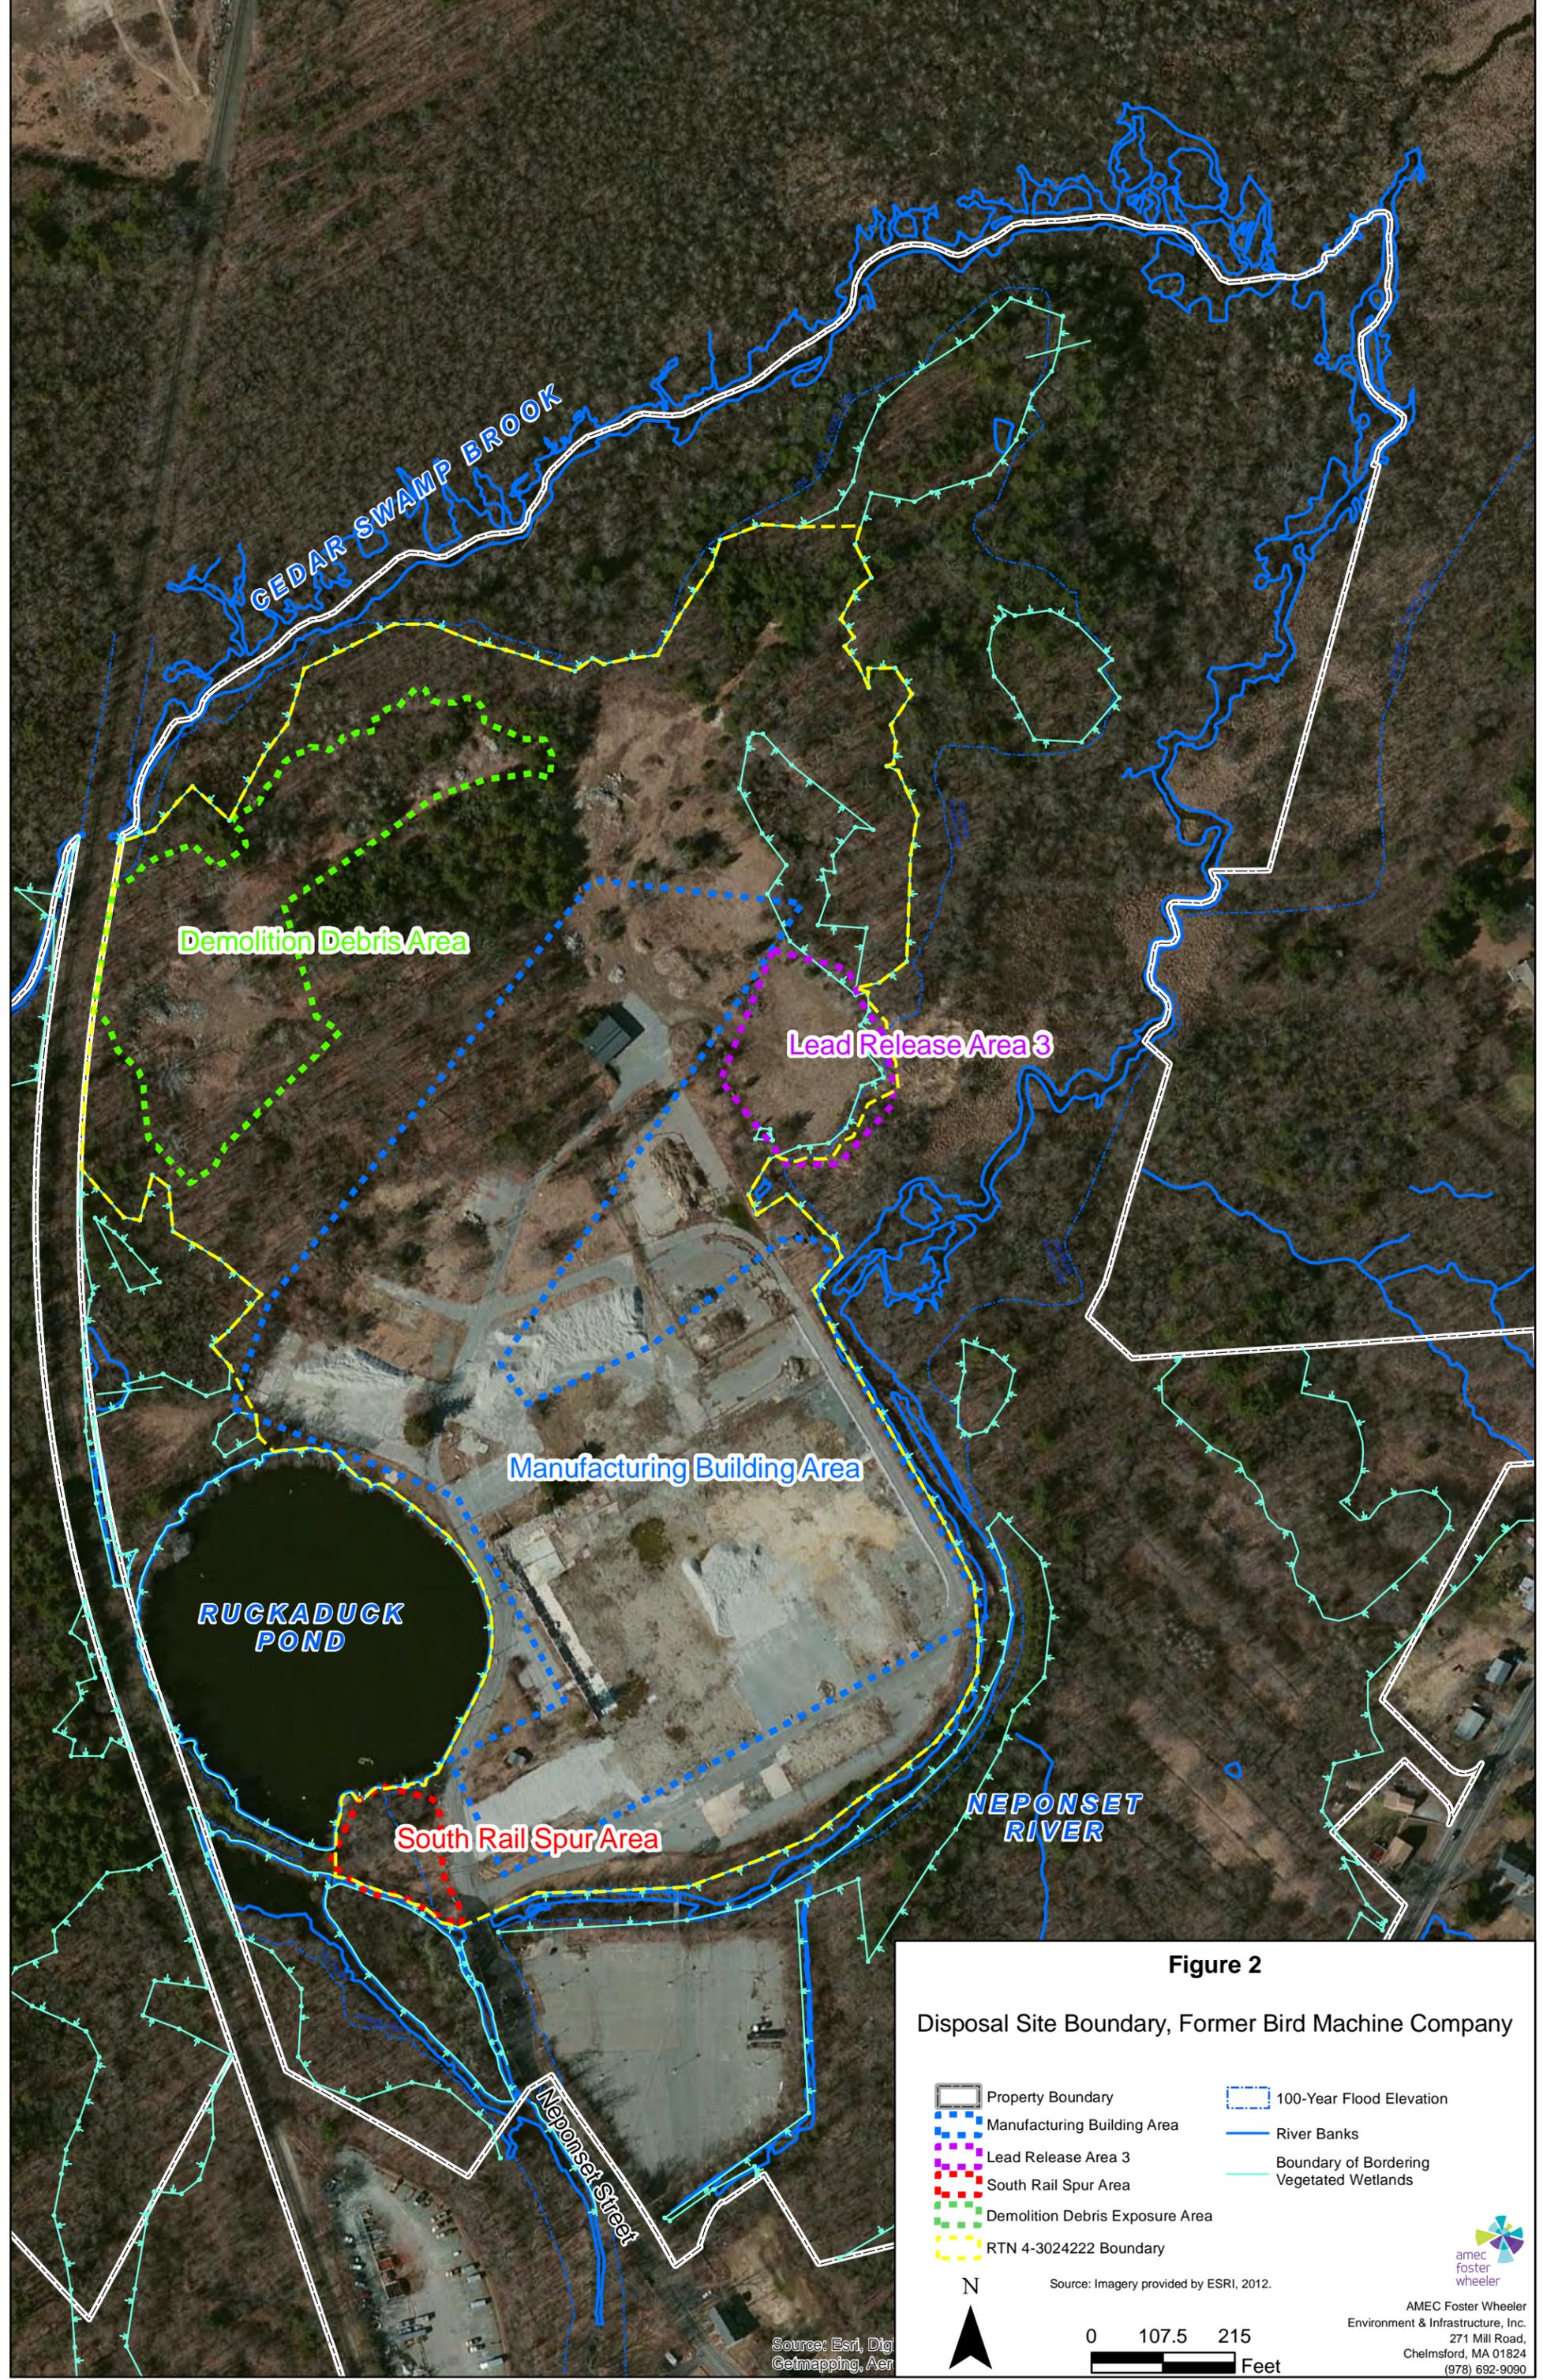
Figure 2

Disposal Site Boundary, Former Bird Machine Company

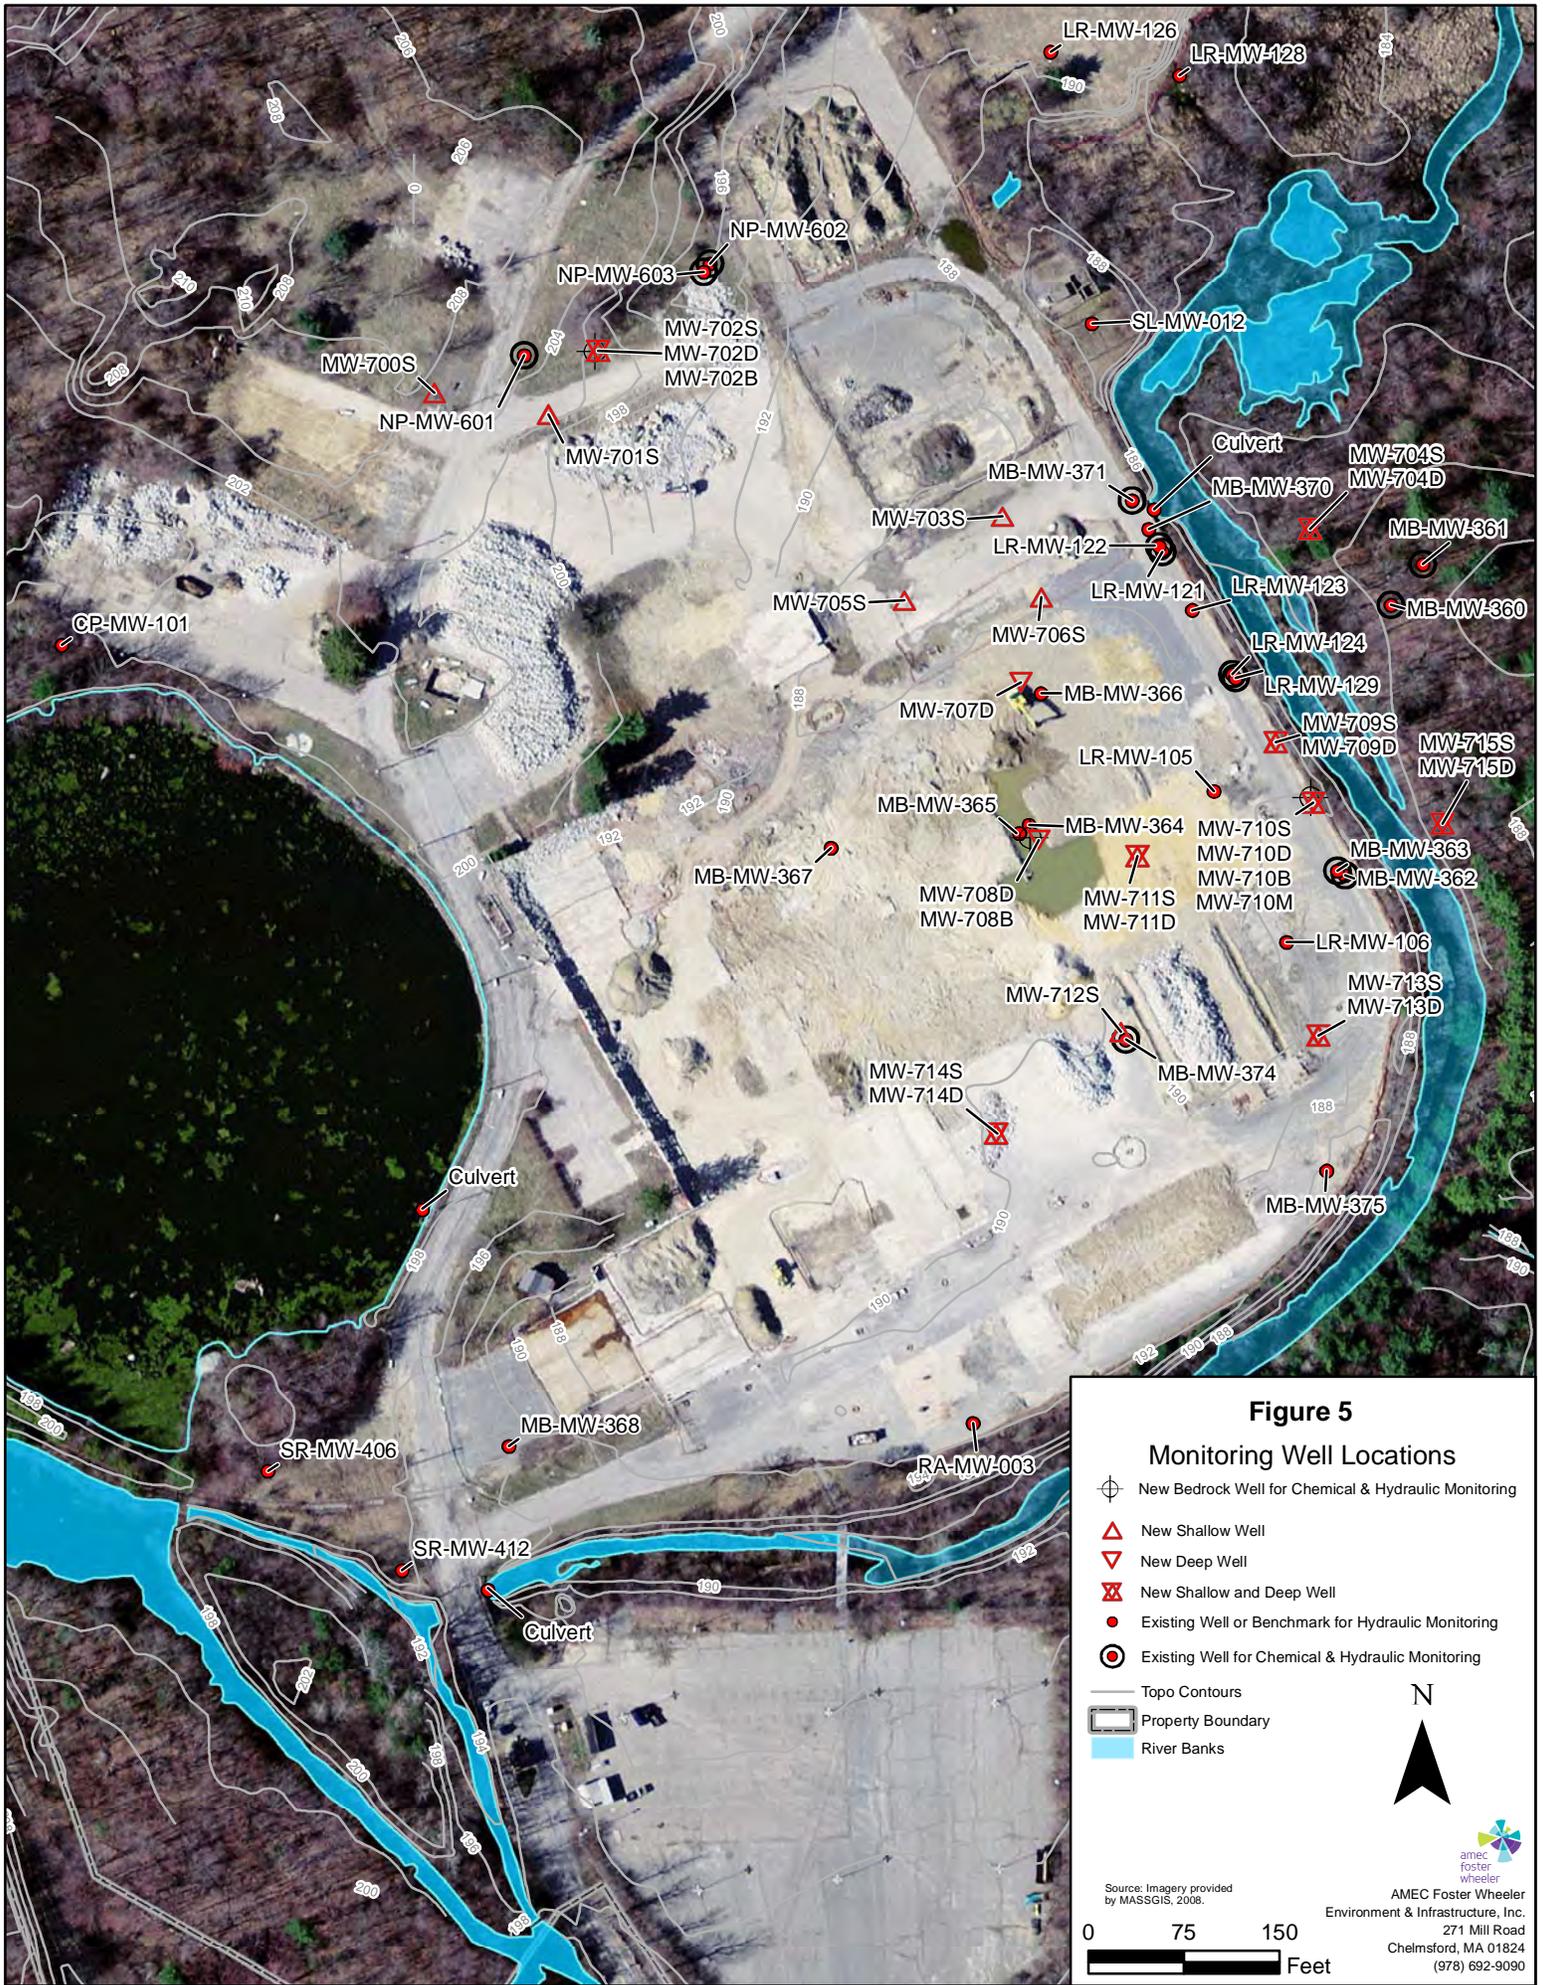
Figure 5

The locations of monitoring wells are indicated in **Figure 5**. Initial process monitoring was conducted in the first year of OMM (August 2012 – August 2013) through quarterly sampling and measurements of water levels in the monitoring wells and river. Analytical parameters for the current reporting period are summarized in **Table 2**. Monitoring well road boxes and protective covers will be inspected and maintained as needed during sampling events. Monitoring wells will be redeveloped if needed based on observations during purging and sampling.

Monitoring Well Locations
