Figure 6b
Deep Groundwater
Elevation Contours
February 25, 2013

GEOLOGIC CROSS SECTION A-A'
 BIRD MACHINE
 WALPOLE, MASSACHUSETTS

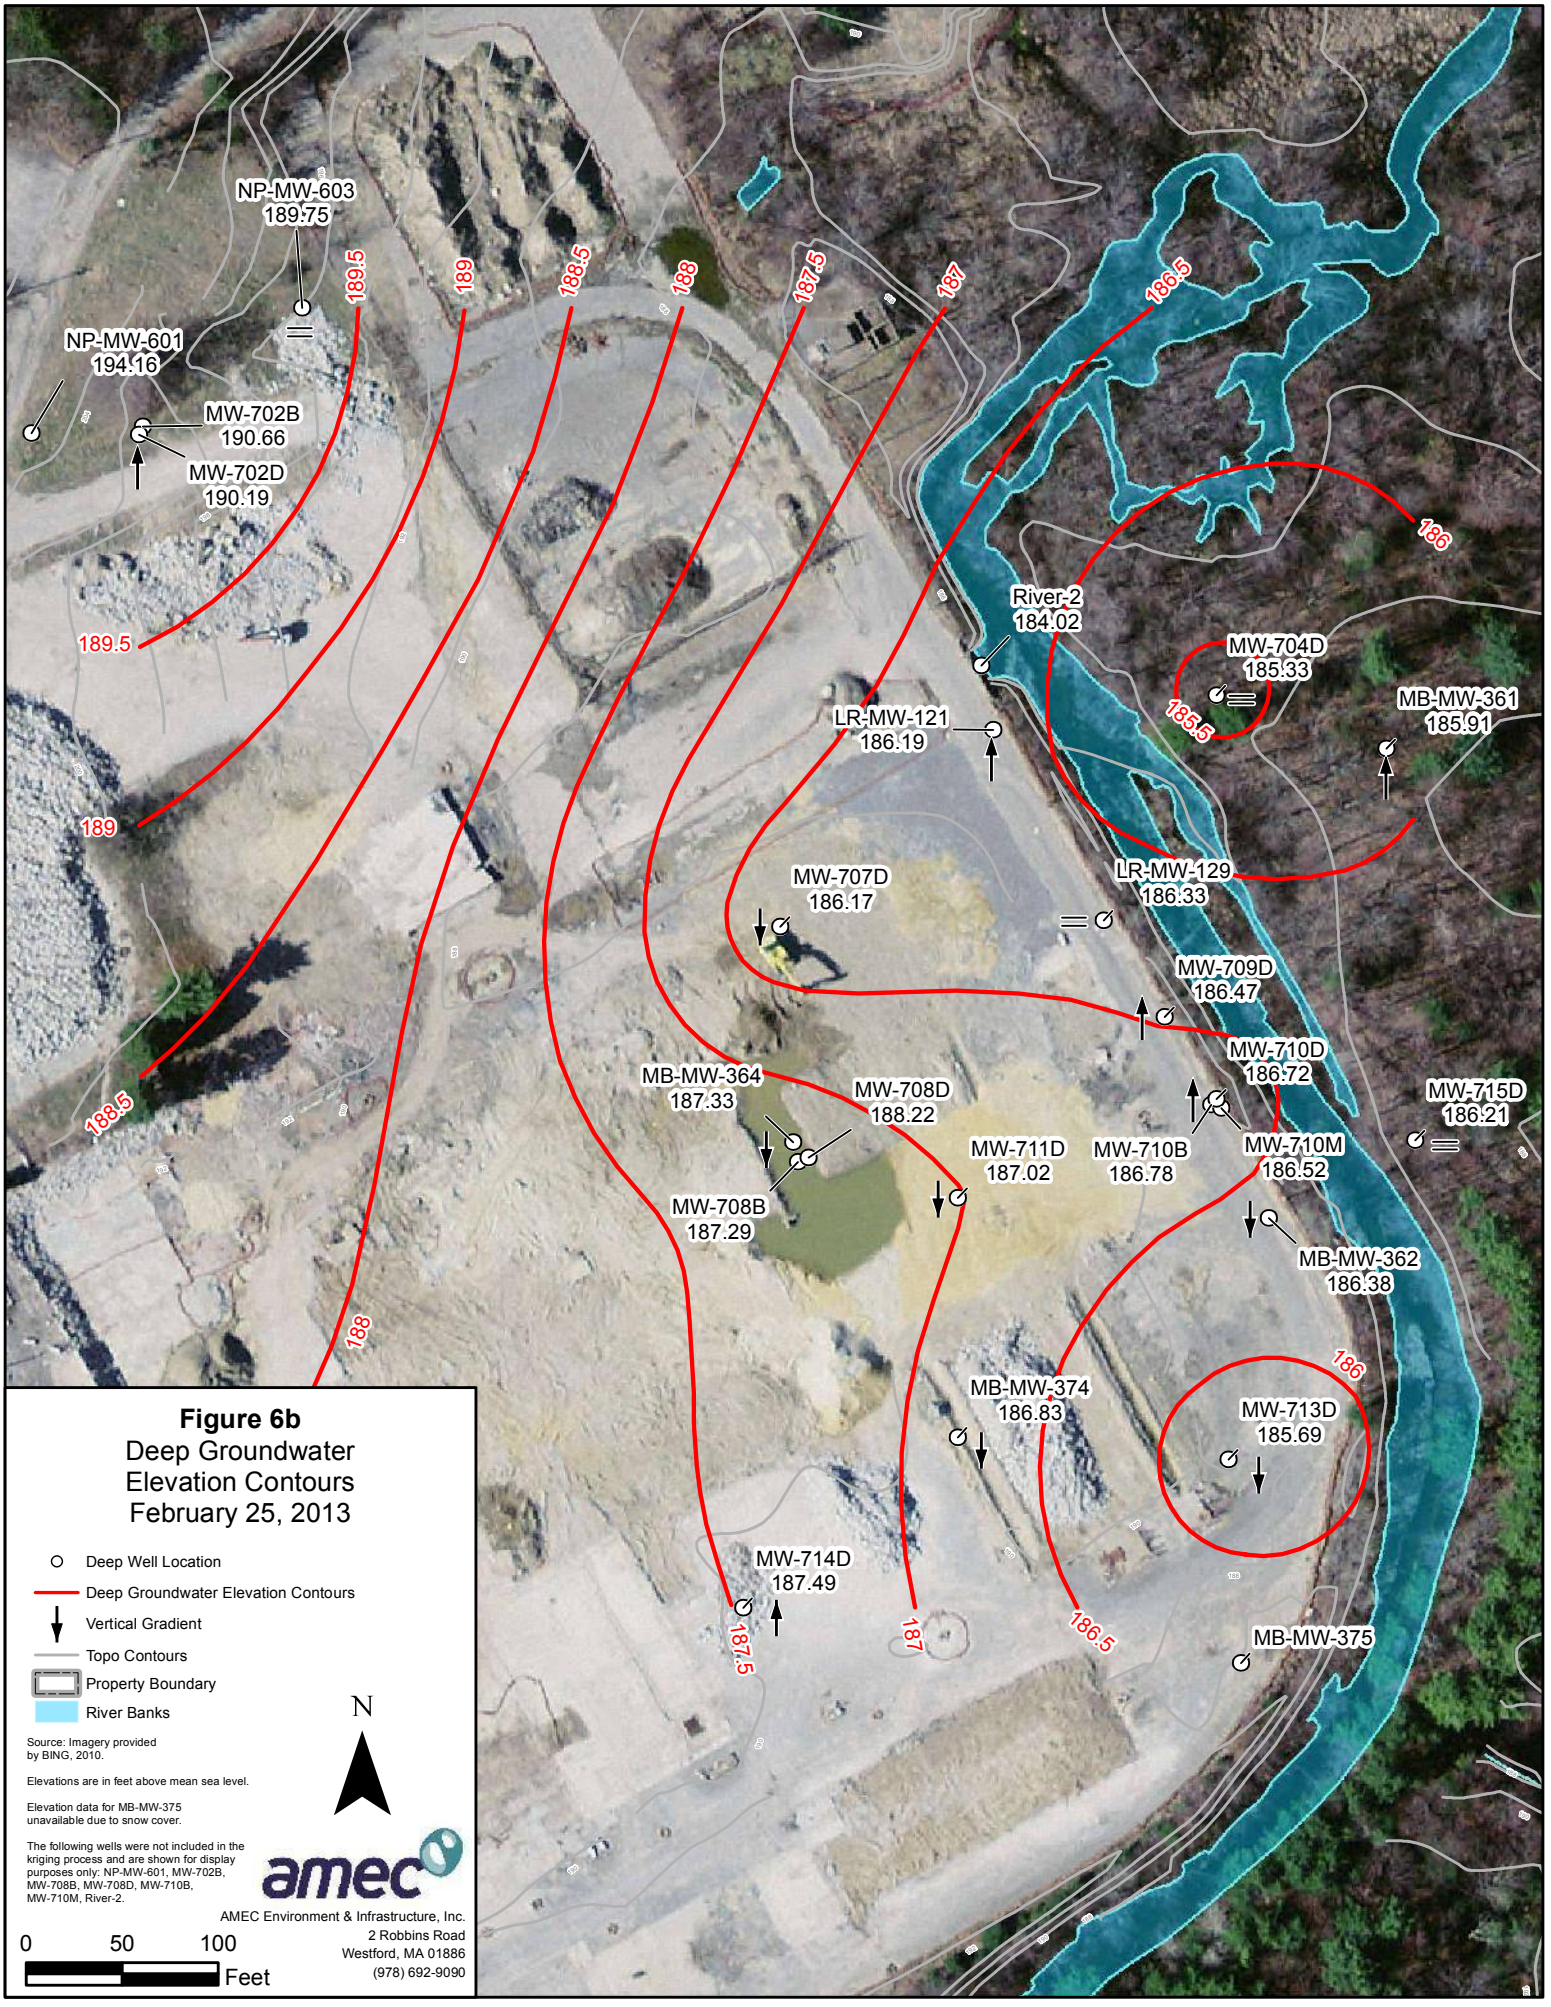
Elevation data for MB-MW-375 unavailable due to snow cover.

The following wells were not included in the kriging process and are shown for display purposes only: NP-MW-601, MW-702B, MW-708B, MW-708D, MW-710B, MW-710M, River-2.

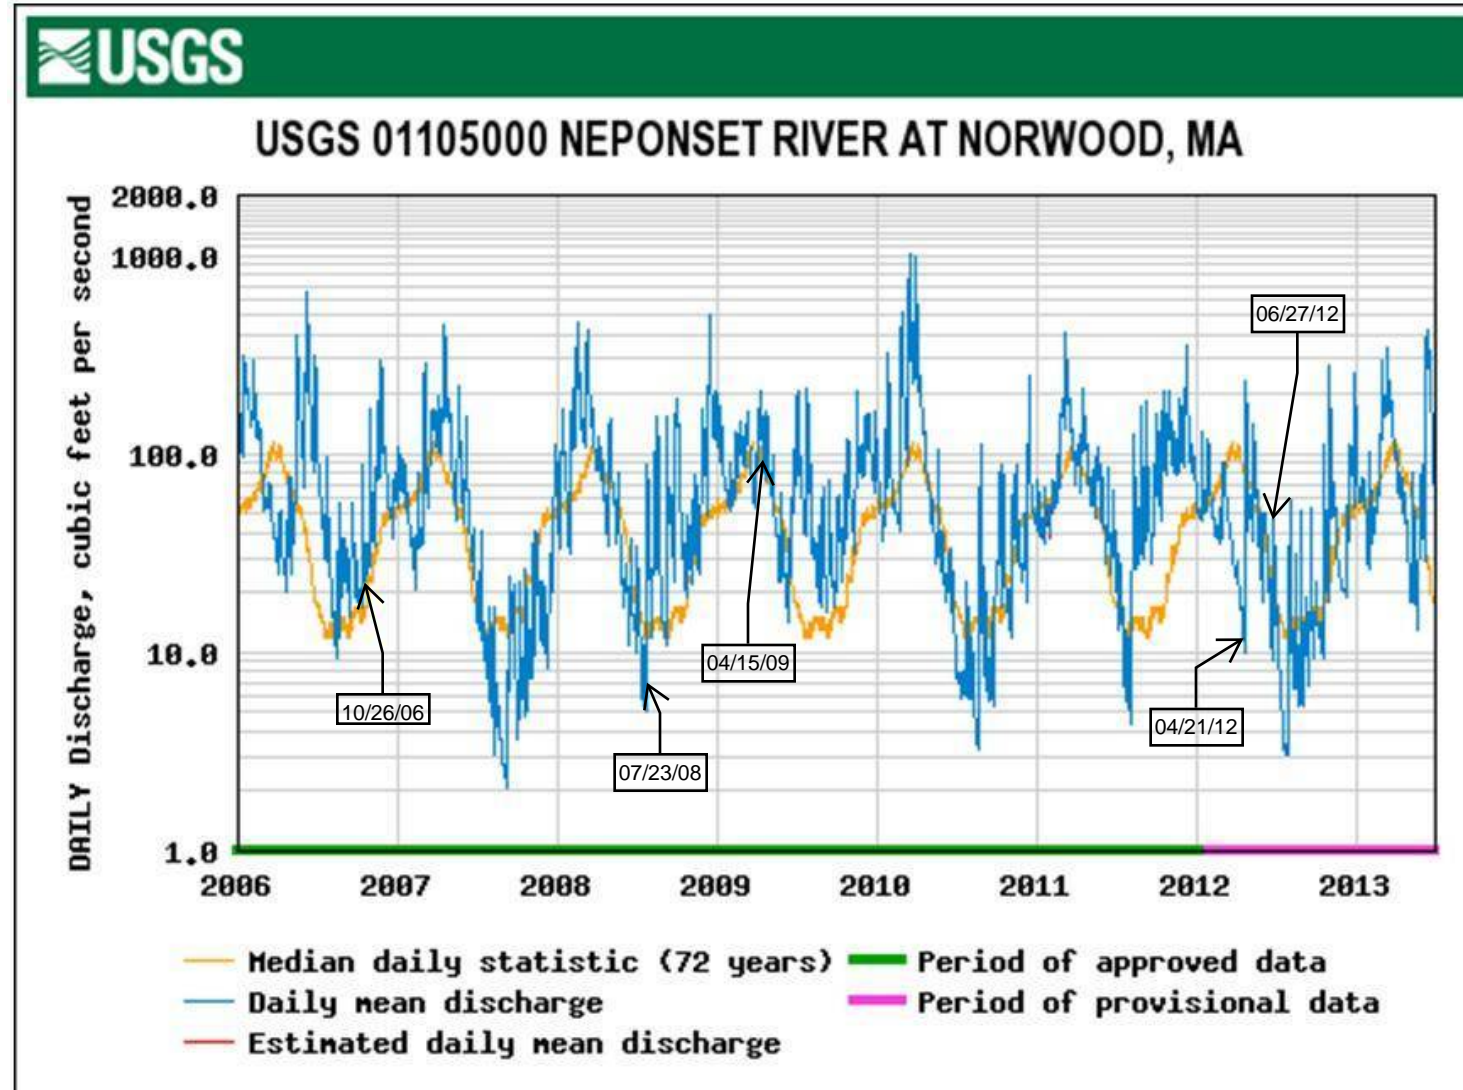
Figure 8. USGS Hydrographs for the Neponset River

2006 to 2013 Daily Discharge

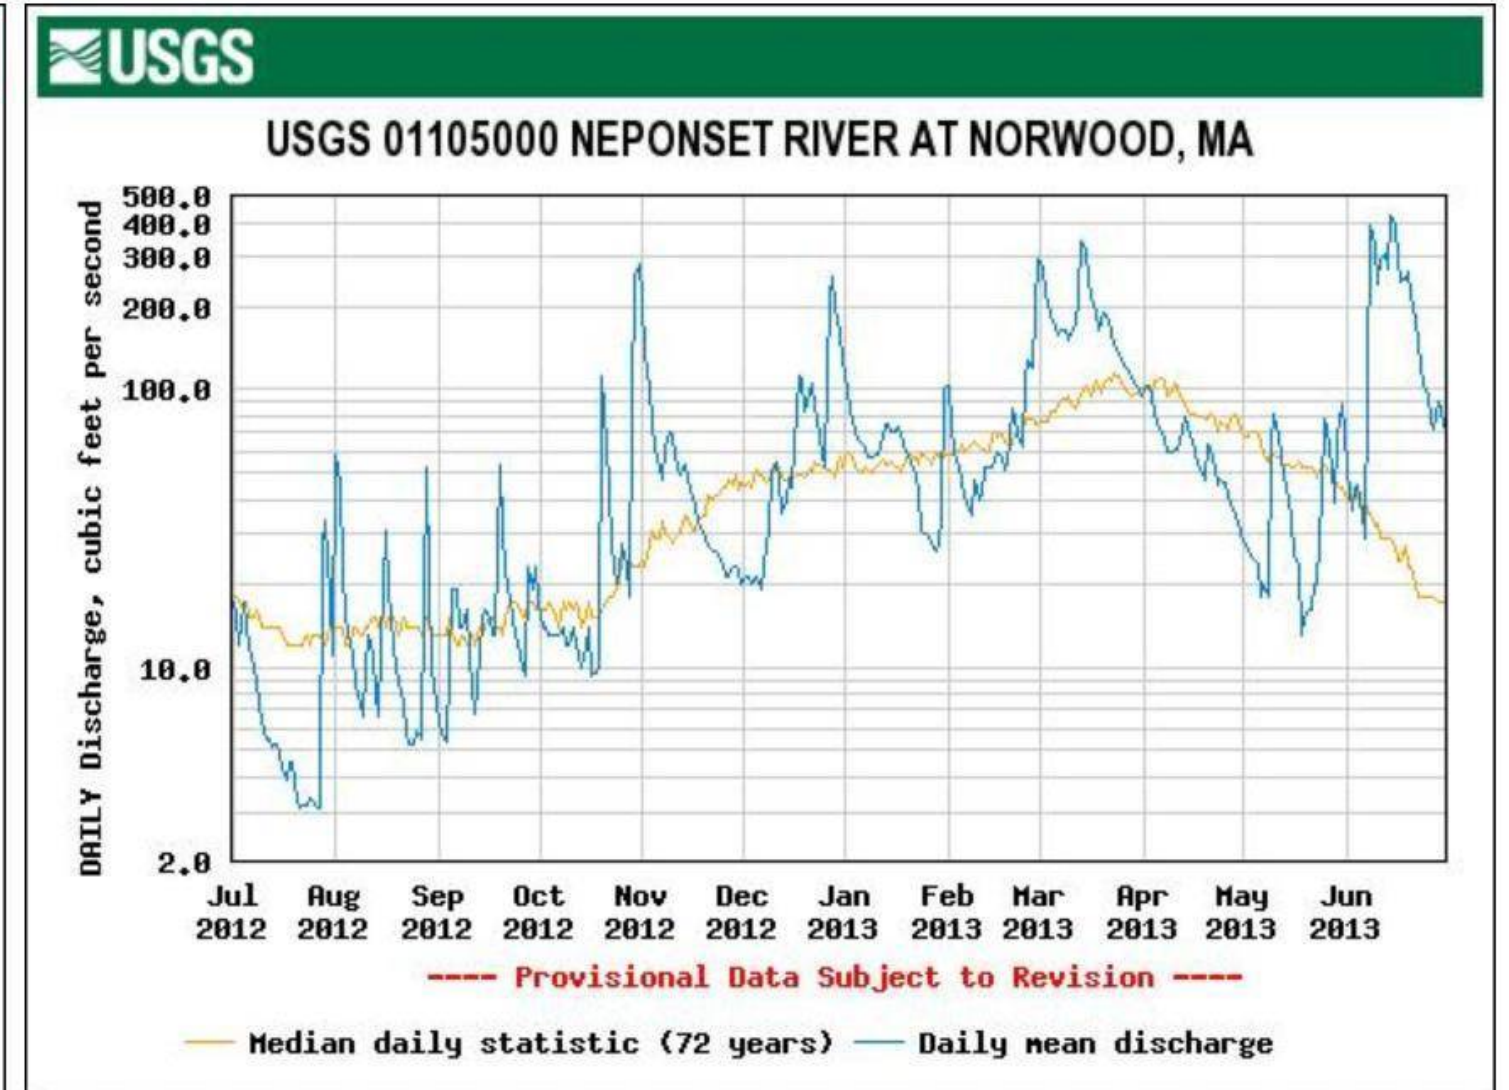
July 2012 through June 2013 Daily Discharge

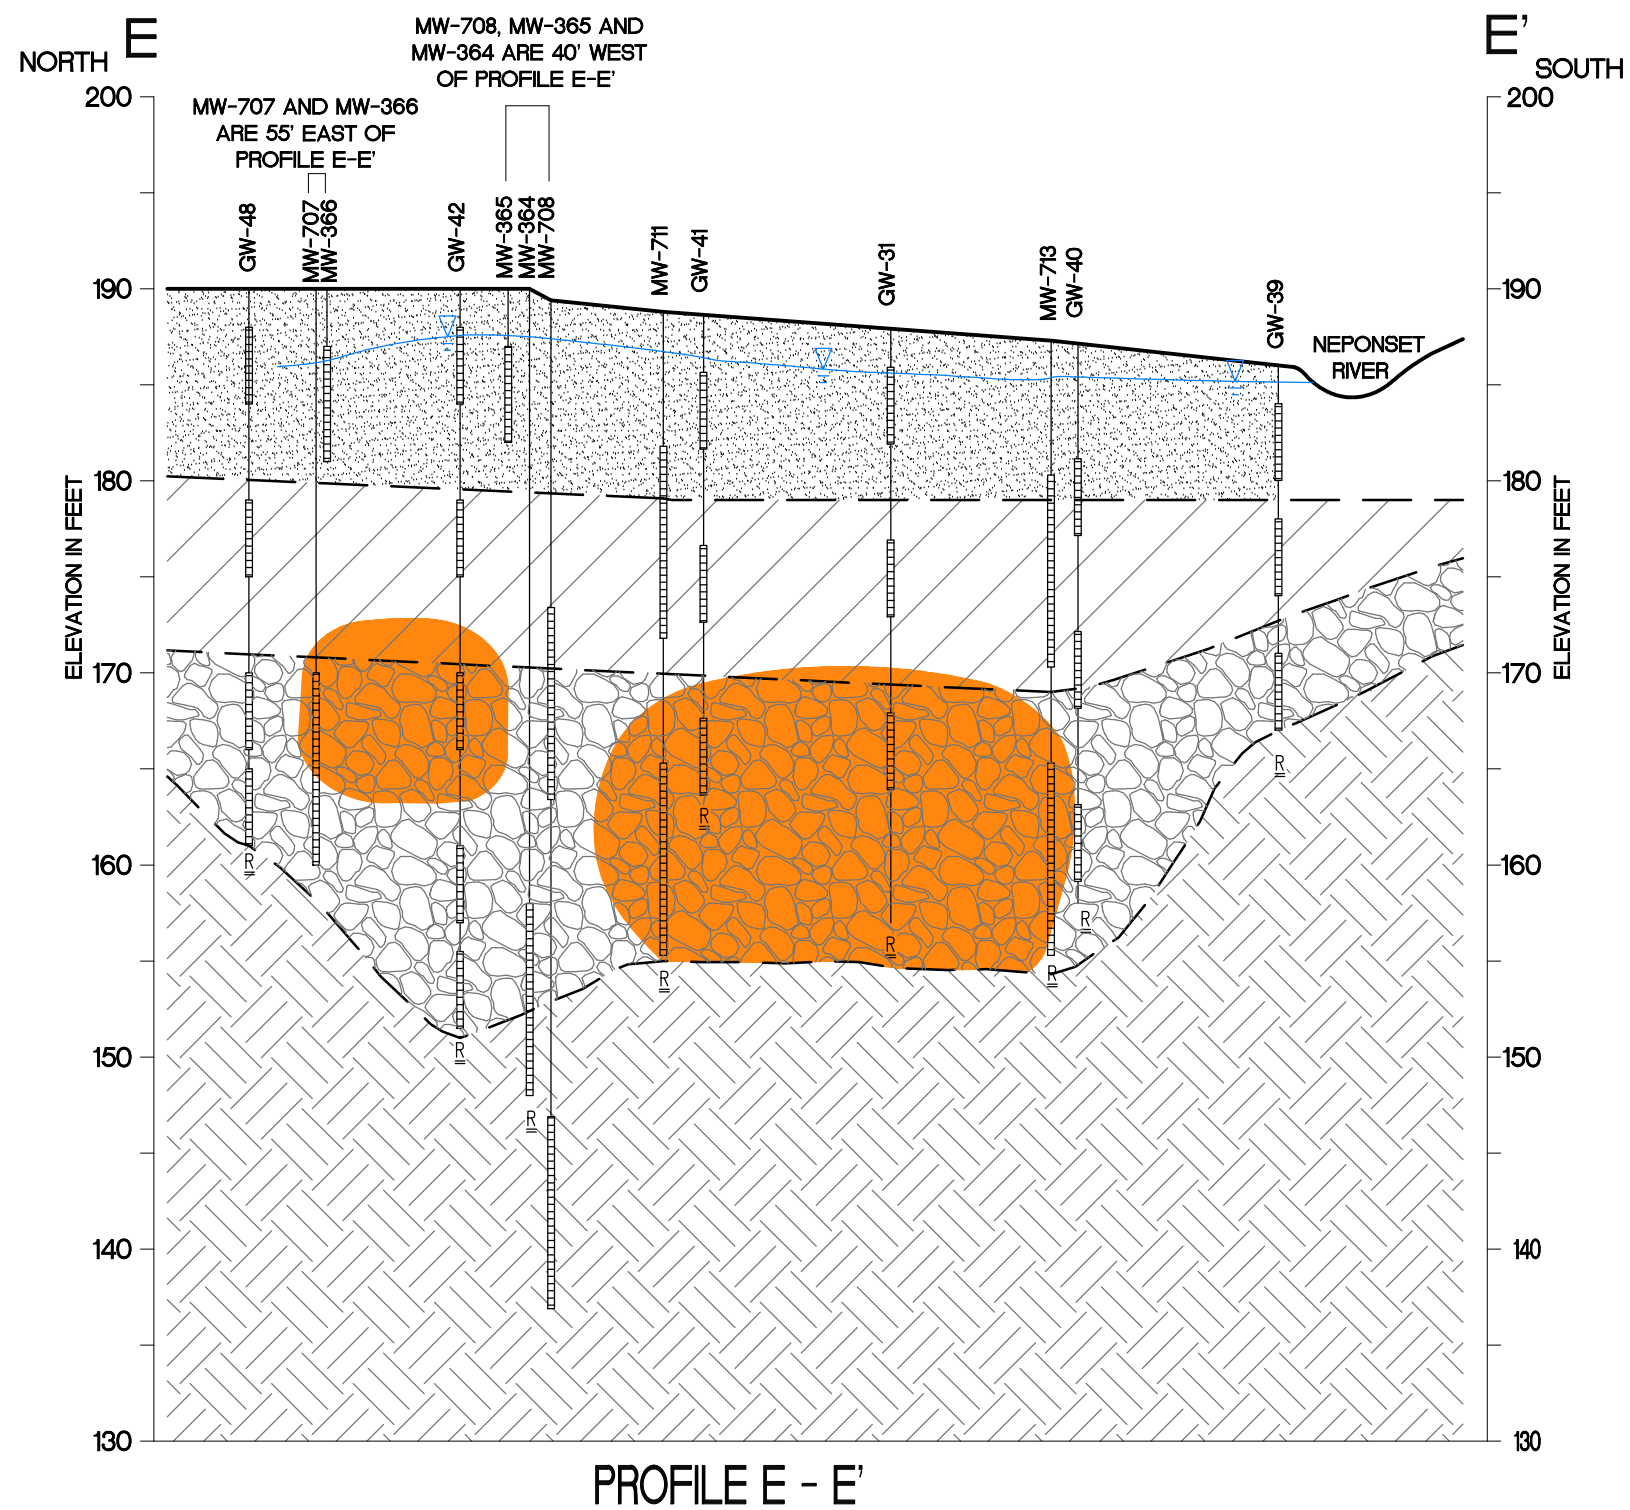
FIGURE 13

GEOLOGIC CROSS SECTION E-E'
BIRD MACHINE
WALPOLE, MASSACHUSETTS

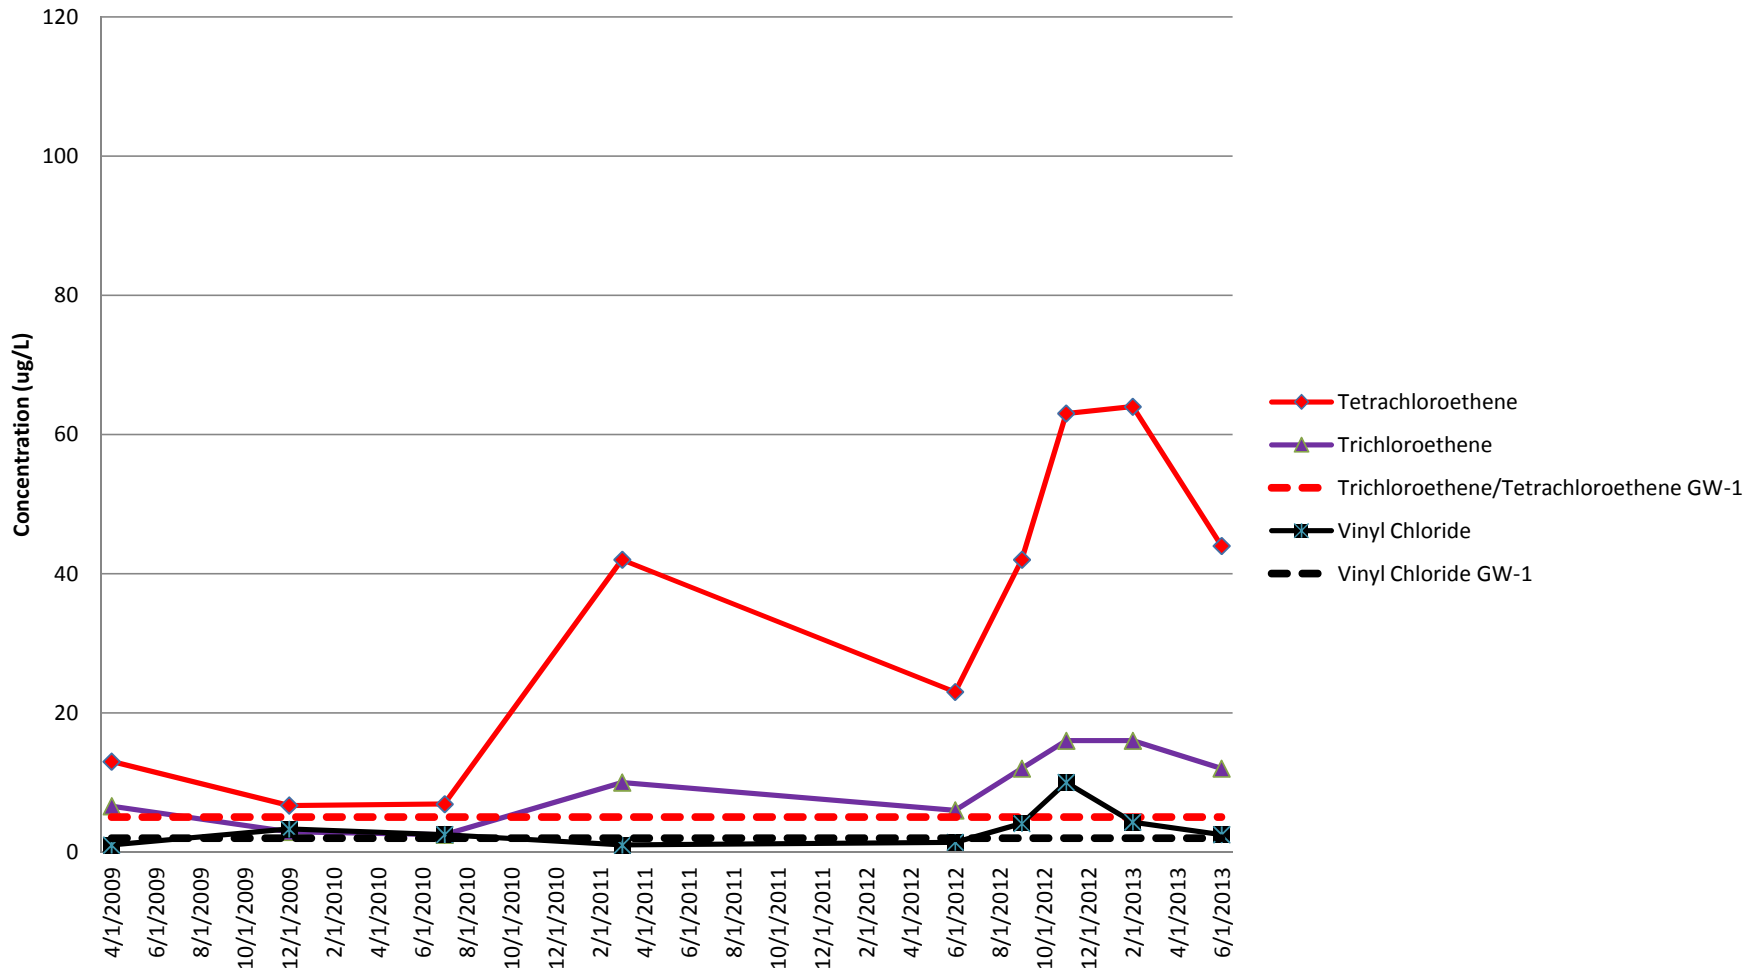
Figure 20
MB-MW-374 cVOC Concentrations vs. Time
