## FIELD NOTES SUMMARY

**Customer:** Town of Walpole (Clarks Pond)

**Site Location:** Walpole, MA

**Date:** 6/30/22, 9:40 AM

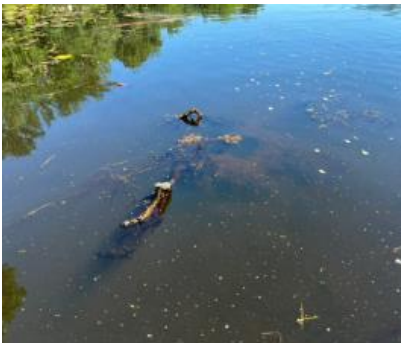
Upon arrival, a survey was conducted using visual observation. As a result of the last treatment, the milfoil observed within the water column has been stripped, with no healthy milfoil found. The remaining stocks of milfoil within the water column have epiphytic algae attached to them, which serves as an indication that the plant is dying. In addition to the milfoil being impacted, the water lilies as well as the curly leaf pondweed (invasive) were impacted from the previous treatment (Photos 2&3). Along the shoreline, there were scattered patches of filamentous algae on the surface, and towards the eastern cove, dense mats were observed, with mixed in curly leaf (Photo 4). The curly leaf, and milfoil will soon drop from the water column. In the southern cove, there were scattered patches of water chestnut, which were observed at a hand pull-able level. Around the pond, there was also sparse densities of duckweed, as well as floating islands. The floating islands are a result of the die off of waterlilies over the years. As the lily rhizomes die, they can dislodge from under the surface of the water and float up, taking organic matter with them (Photo 1). On the northern shoreline, there was scattered densities of phragmites, an invasive species.

As planned, and based on the survey, a treatment was conducted for the control of filamentous algae.

The liquid algaecide was applied using a treatment boat equipped with a calibrated sub-surface injection system, paired with the foliar method, which is best for dense filamentous algae mats. This application methodology allows for even coverage within the treatment areas. Prior to treatment, neon signs indicating any water affiliated restrictions (no restrictions affiliated with this treatment) were posted, and the Walpole Conservation Commission was notified.
