FIELD NOTES SUMMARY

Customer: Town of Walpole

Pond Name: Clarks Pond

Date: 6/7/23

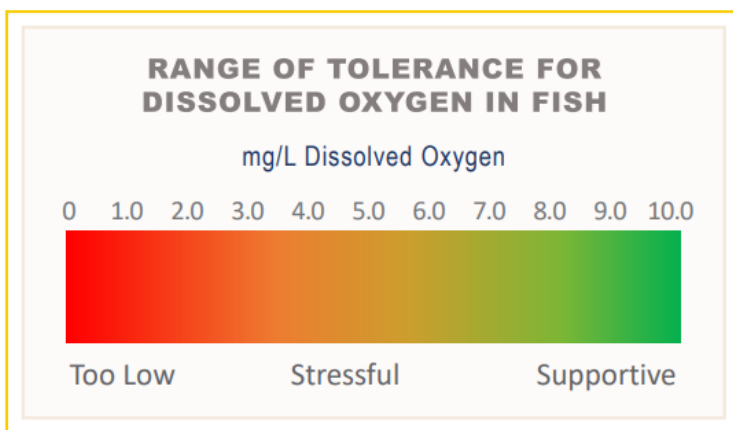
While on-site, dissolved oxygen (DO) and temperature readings were collected using a calibrated YSI meter with optical sensor. Dissolved oxygen is the amount of oxygen in water that is available to aquatic organisms. DO is necessary to support fish spawning, growth, and activity. Tolerance varies by species, but the figure below provides a general range of fish tolerance (Source: epa.gov). Dissolved oxygen can be affected by

many outside factors, such as: temperature, time of day, and pollution. Dissolved oxygen levels are typically lowest early in the morning. Healthy water should generally have concentrations of about 6.5-8+ mg/L.

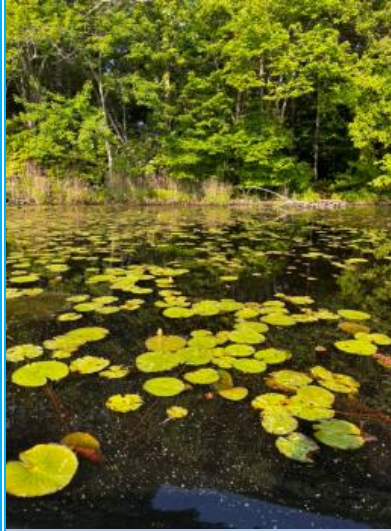
Photo 1

Notes from the Biologist
Among the waterlilies, and in scattered patches within the pond, there were mats of benthic filamentous algae. In addition to this, there were trace densities of both variable milfoil and water chestnut observed, which is a significant improvement compared to last season. There was also a layer of pollen on the surface of the water. Based on the conditions documented during the survey, a treatment was conducted for the control of algae as the milfoil was treated during the previous visit and any remaining milfoil appeared unhealthy/dying. Water chestnut will be addressed during the July and August visits.

A treatment was conducted for the control of algae. The liquid contact algaecide was applied using a treatment boat equipped with a calibrated sub-surface injection system. This application methodology allows for even coverage within the treatment areas. The treatment was completed without issue.
