FIELD NOTES SUMMARY

CUSTOMER: TOWN OF WALPOLE (CLARKS POND)

SITE LOCATION: WALPOLE, MASSACHUSETTS

DATE: 9/13/21, 9:30 AM

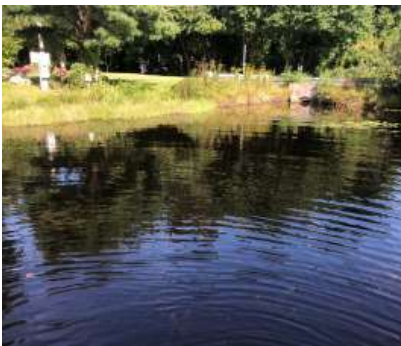
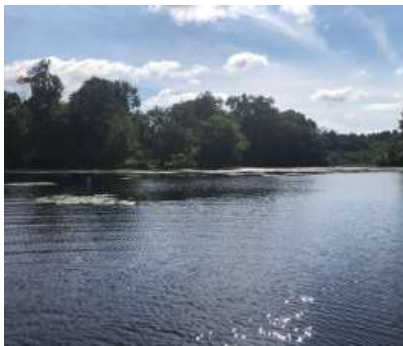
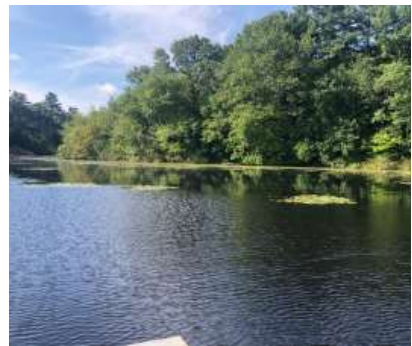
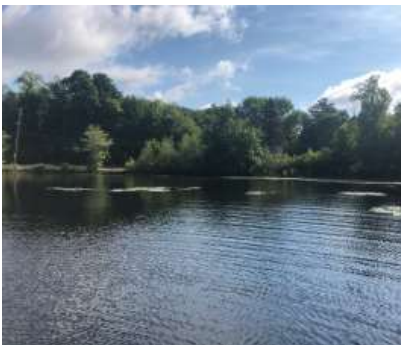
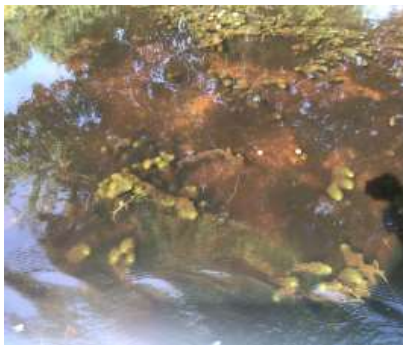
PHOTOS

Upon arrival to the pond, a survey was conducted using visual observation and a standard throw-rake. Waterlilies line the majority of the shoreline, with several scattered patches throughout the middle of the pond. Phragmites was documented by the outlet adjacent to the parking lot (Photo 6). Also documented was watershield, duckweed, and watermeal (all native). Additionally documented was scattered milfoil patches ranging from sparse to moderate densities. All the milfoil looked "banged up" from the previous treatments, but some green milfoil was observed. No milfoil was flowering or reaching the surface (Photo 5). The variable milfoil in Clark's Pond has seemingly developed a bit of a resistance to contact herbicide diquat, as it has been treated for several years in a row with the same product. Given this, it required multiple applications during the season and is still persistent. Several years ago, a new milfoil control option called Procellacor became available and is both EPA/MA approved. Procellacor is the ultimate milfoil control tool as it is a systemic product that works quickly like a contact herbicide. It also has extremely low use rates. The largest benefit of Procellacor is that it provides multiple years of milfoil control (likely 3+ years of nuisance level control). We recommend this product be incorporated in 2022. We could look at the frequency of visits and cut those down to incorporate the additional product cost of Procellacor.

Based on the conditions described above, a treatment targeting milfoil was incorporated. Diquat was applied to the moderate density areas using a jon boat equipped with a calibrated sub-surface injection system. Phragmites were targeted using a calibrated backpack sprayer. The goal of the waterlily treatment was by no means to eliminate lilies, but to scale them back towards the shoreline to a more desirable level that won't limit oxygen exchange or plant

diversity. The target lilies were treated using a foliar application.
