# Integrated Water Infrastructure Vulnerability Assessment and Climate Resiliency Plan TOWN OF WALPOLE, MASSACHUSETTS

OCTOBER 2020

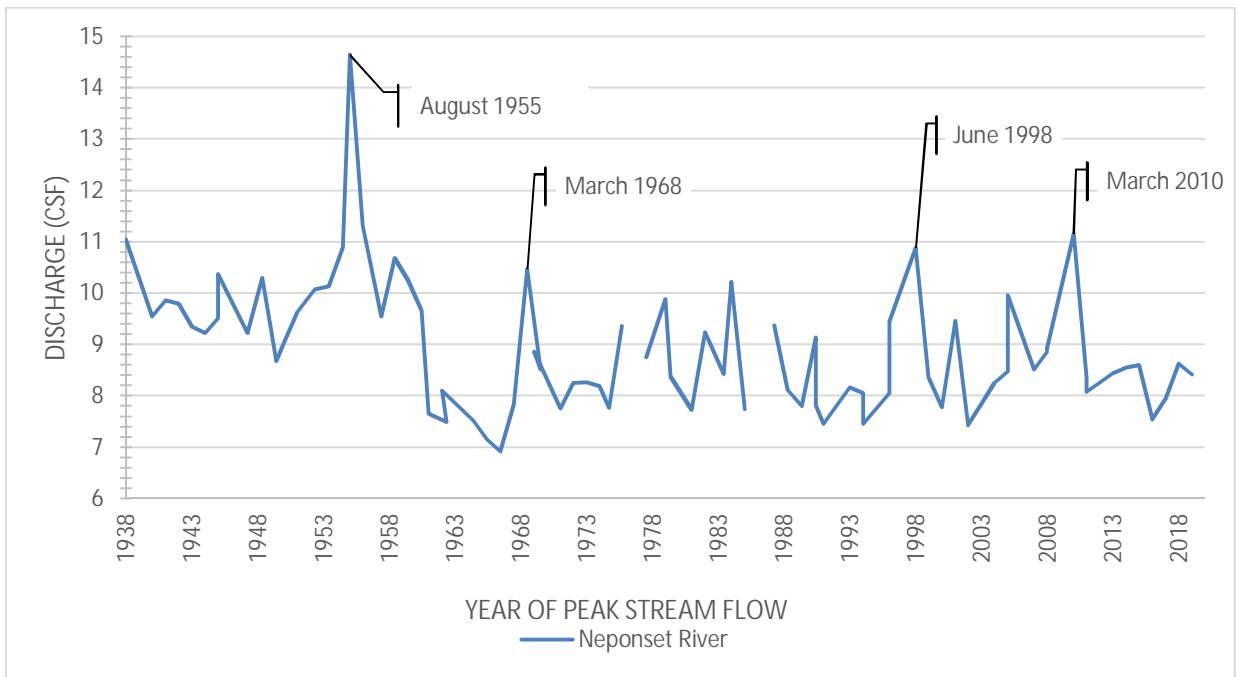
Figure 3-1. Plot of annual peak streamflow at a USGS stream gage number 01105000 near Walpole, along the Neponset River.

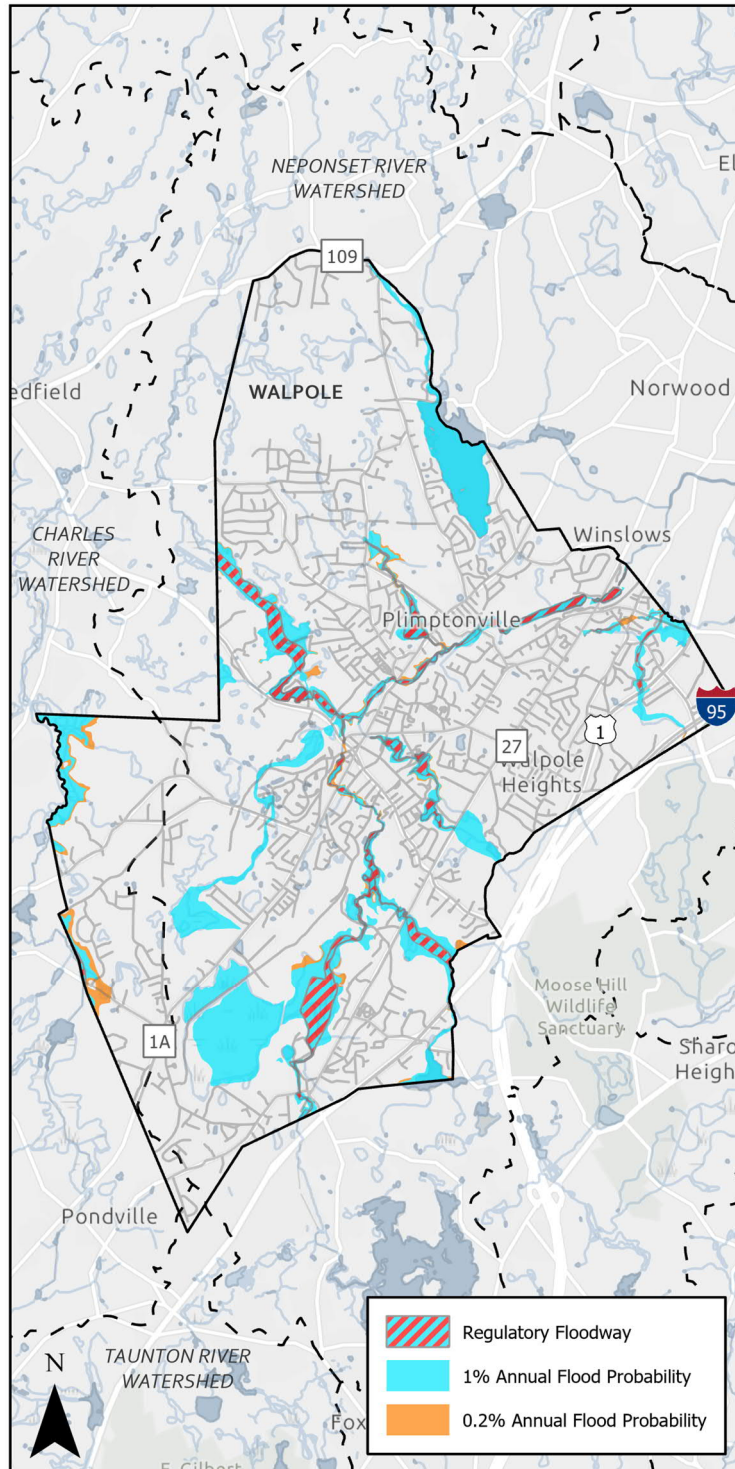
Figure 3-2. Special Flood Hazard Areas in Walpole.

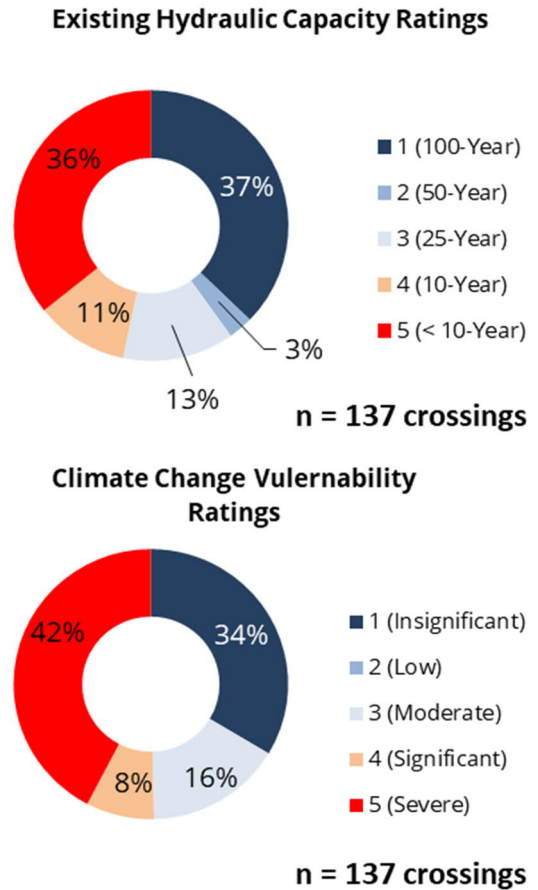
Figure 4-2. Percentage of assessed crossings by existing and future hydraulic capacity ratings.

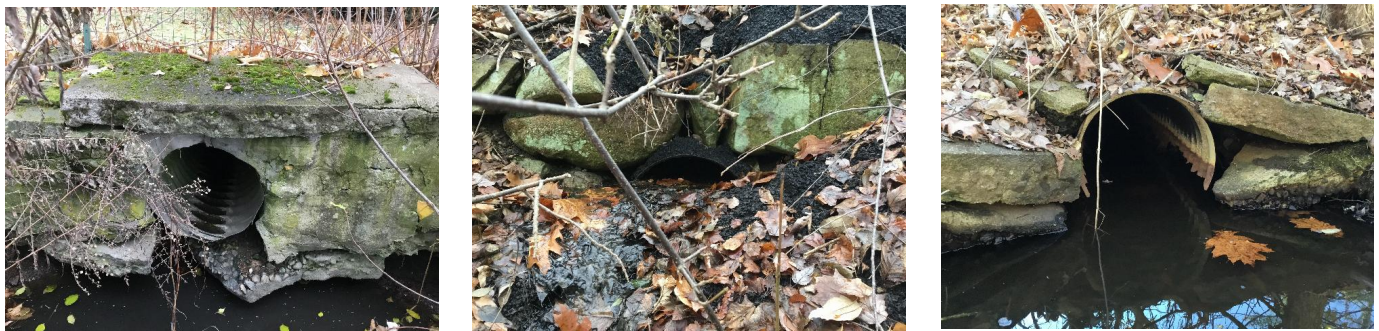
**Figure 3. Examples of crossing structures in poor or critical structural condition observed at various locations during field assessments. Left: Degraded headwall; Center: Critical level of blockage; Right: Deteriorated pipe invert.**

- **Poor Structural Condition:** Many of the structures were observed to be in poor condition and in need of significant repairs or replacement. Fifty seven (34%) of the assessed structures had at least one structural variable rated as poor while 30 (18%) of the assessed structures had at least one structural variable rated as critical. Headwall/wingwall condition, level of blockage, and invert condition were the variables most frequently rated as poor or critical. *Figure 3* provides examples of some of the structural issues observed in the field.

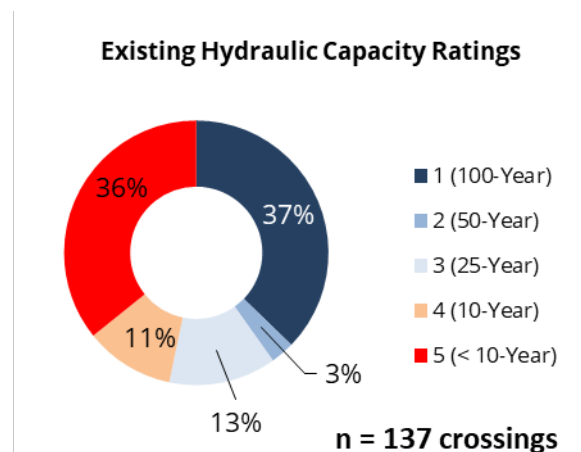
**Figure 4. Distribution of hydraulic capacity ratings across all assessed crossings, under existing conditions.**

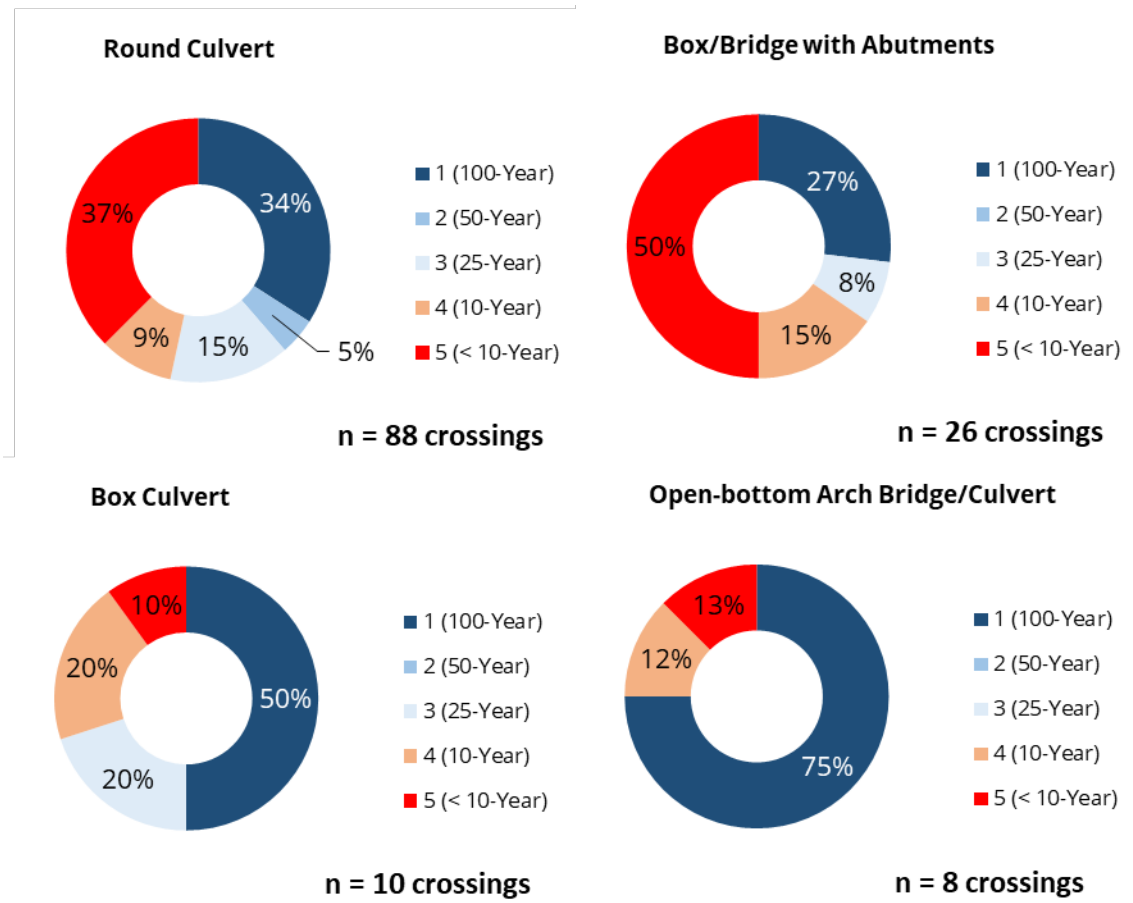
**Figure 5. Hydraulic Capacity Scores of Walpole crossings by structure type.**

**Figure 5** shows the hydraulic capacity scores for the most common types of structures that were evaluated in Walpole. Many round culverts, which were the most frequently seen structure type in the field, are severely undersized and are unable to pass the 10-year flow (37%). However, almost an equal percentage of round culverts are adequately sized to convey the 100-year peak streamflow (34%). Many of these adequately-sized round culverts are receiving flow from watersheds with smaller areas and/or lower peak flows. Thirteen (50%) of the assessed boxes/bridges with abutments were severely undersized and are unable to pass the 10-year peak streamflow. Conversely, 50% of the assessed box culverts and 75% of the assessed open-bottom arch bridges/culverts were adequately sized to convey the 100-year peak streamflow. Many of the open-bottom arch bridges assessed in the field were large structures capable of accommodating larger flows. However, the small number of box culverts and open-bottom arch bridges/culverts assessed in the field (10 box culverts and 8 open-bottom arches) limits the ability to draw conclusions about the hydraulic capacity of these structure types as a group from this assessment.

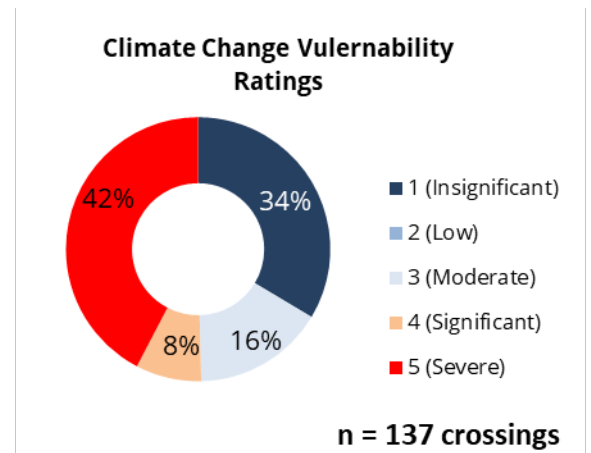
**Figure 7. Distribution of climate change vulnerability ratings across all assessed crossings, under expected future precipitation conditions under climate change.**

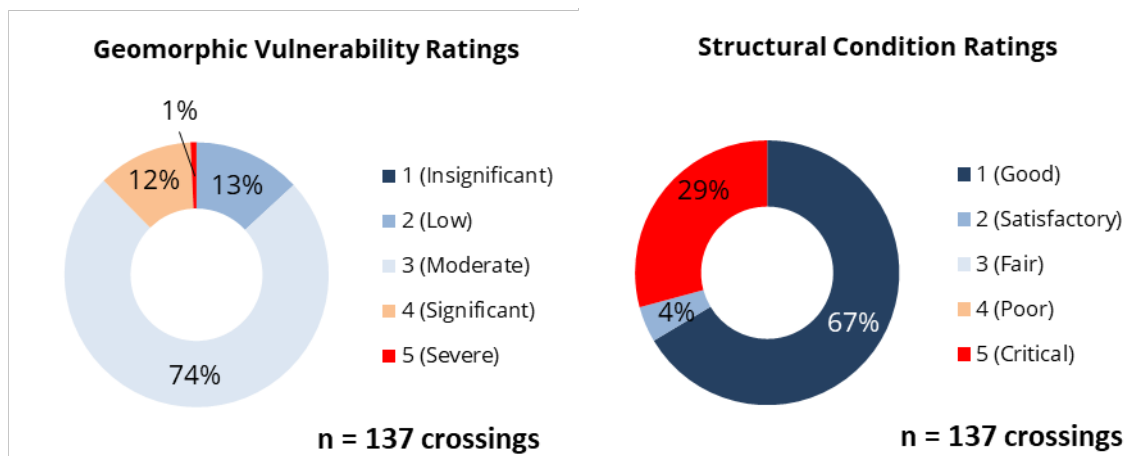
**Figure 8. Distribution of geomorphic vulnerability (left) and structural condition (right) ratings across all assessed crossings.**

Forty (29%) assessed crossings were rated as critical relative to structural condition, and ninety-seven (71%) were rated as either good or satisfactory (*Figure 8*). Two crossings received the highest possible Structural Risk Score of 25, indicating critical structural condition and high flood impacts. These crossings are located on Smith Avenue over an unnamed tributary to Cobb's Pond and Warwick Road over an unnamed tributary to the Neponset River. Both of these crossings were among the top-scoring crossings overall (*Table 1*). Other crossings with high Structural Risk Scores are spread evenly throughout Town (*Figure 9*). The scoring and prioritization of the crossings that received the highest Structural Risk Scores is provided in *Table 5 of Appendix C*.

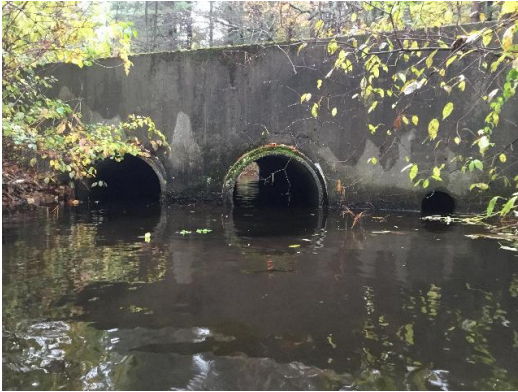
**Figure 14. View of existing crossing outlet on Gould Street (xy42165167124759) taken during field assessment on October 29, 2019.**

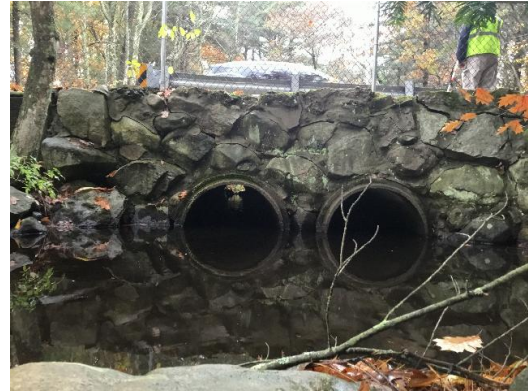
**Figure 15. View of existing crossing outlet on Smith Avenue (xy42165037124747) taken during field assessment on October 29, 2019.**

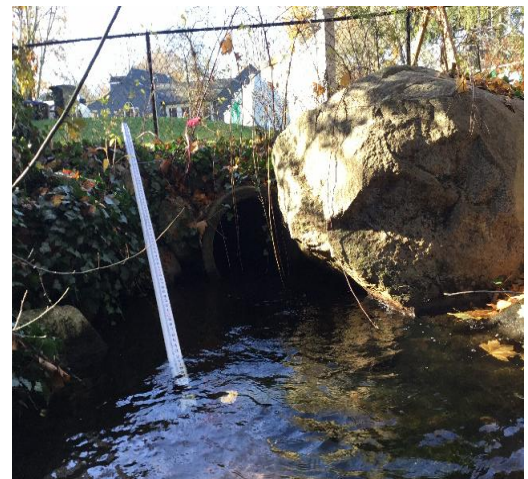
**Figure 20. View of existing outlet on Spring Valley Drive crossing (xy42137957125730) taken during field assessment on November 6, 2019.**

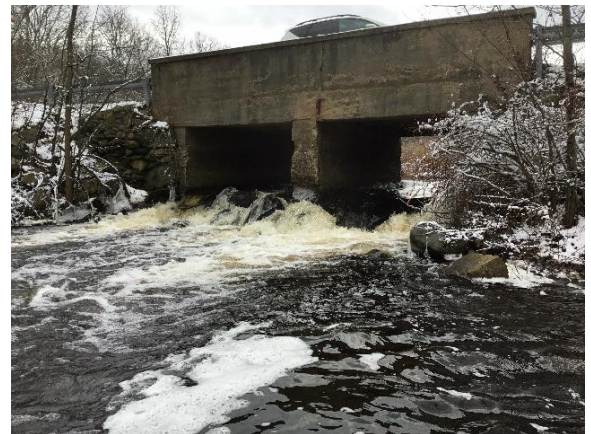
**Figure 23. View of existing box culvert outlet taken during field assessment on December 13, 2019.**

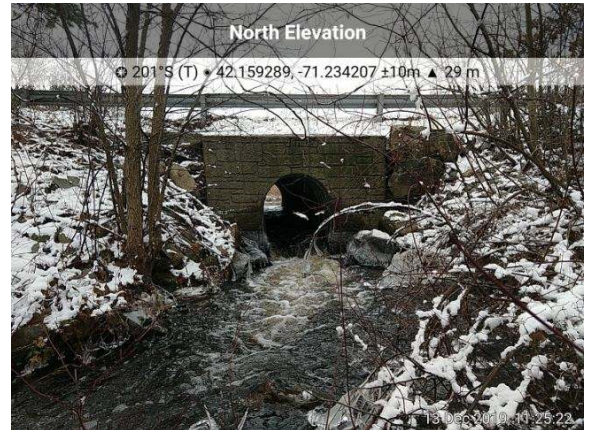
**Figure 24. View of existing arch culvert outlet taken during field assessment on December 13, 2019.**

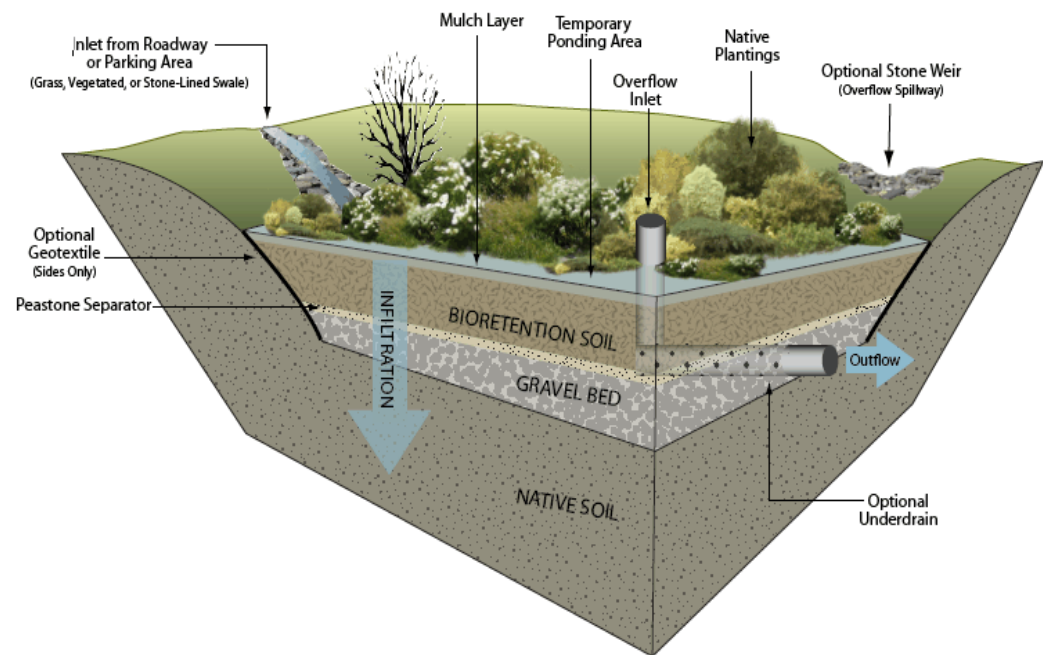
Image 2: Typical bioretention basin cross-section. \*\*

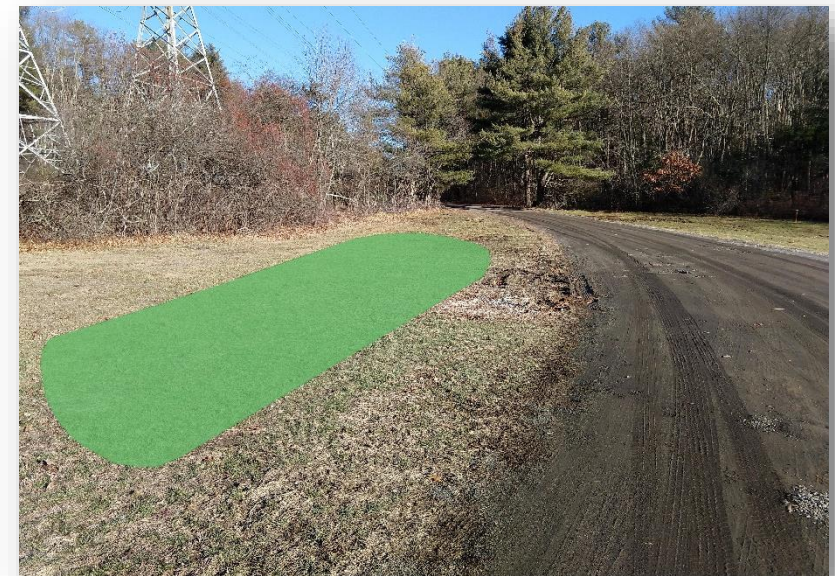
Image 2: Proposed infiltration basin area (JF\_IB\_1) is shown in open area to the left of gravel road.

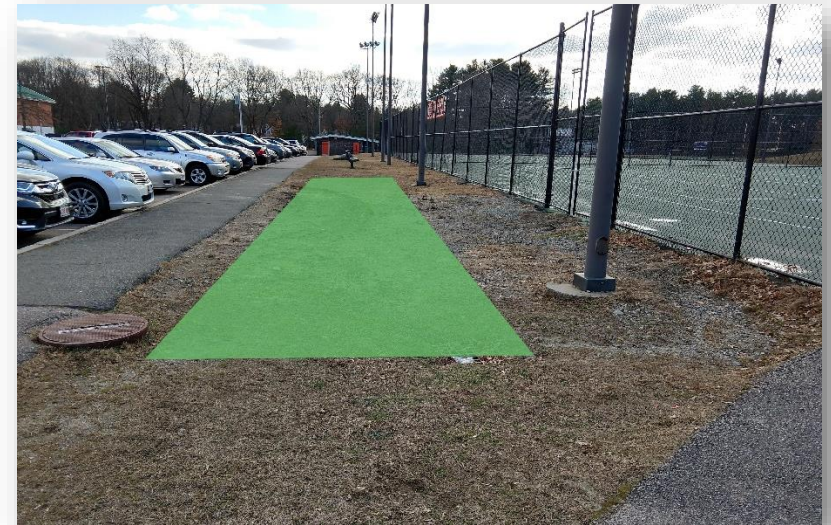
Image 1: Area of proposed infiltration swale (WHS\_IB\_1) along the length of the tennis courts.

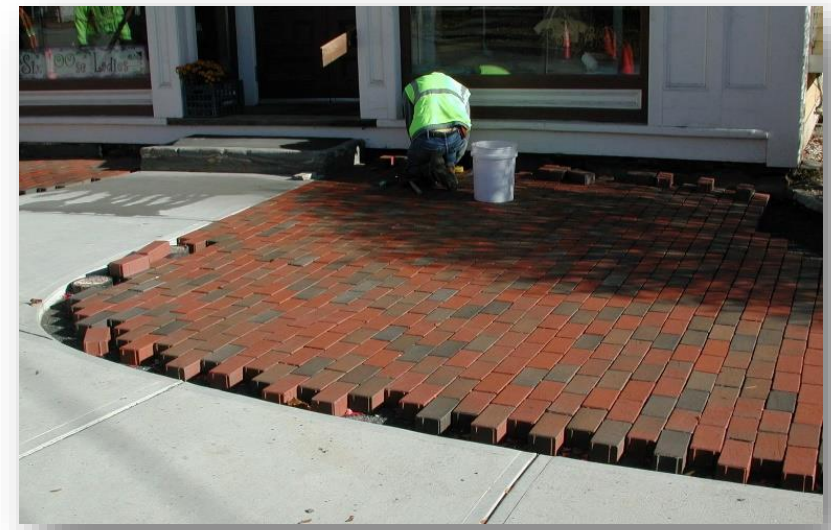
Image 2: Installation of interlocking porous pavers.

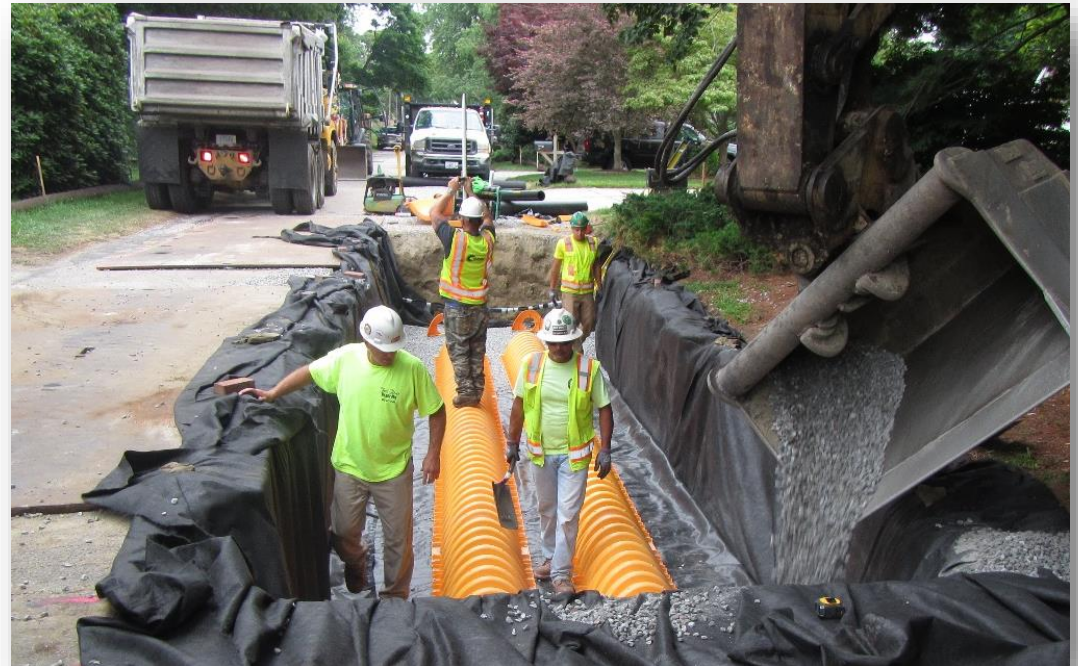
Image 1: Installation of subsurface infiltration chambers under one lane of a municipal right-of-way in Rhode Island.

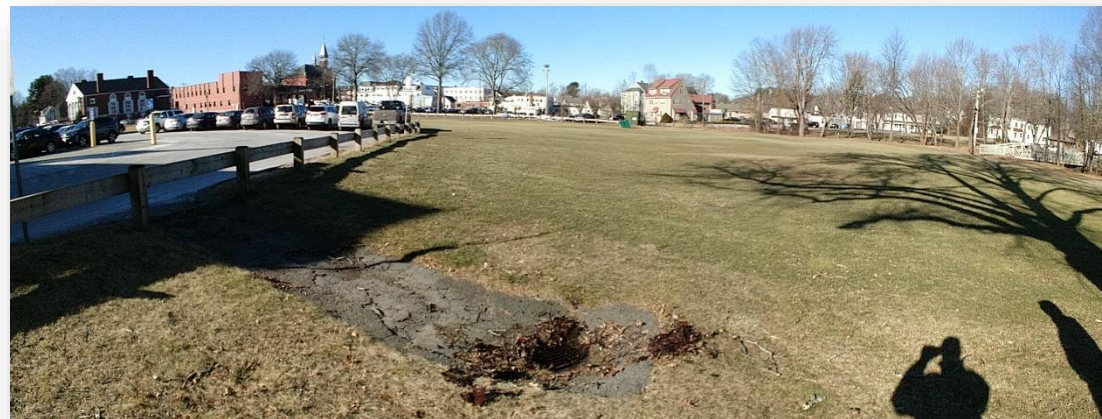
Image 1: Proposed location of bioretention basin north of Town Hall parking lot.

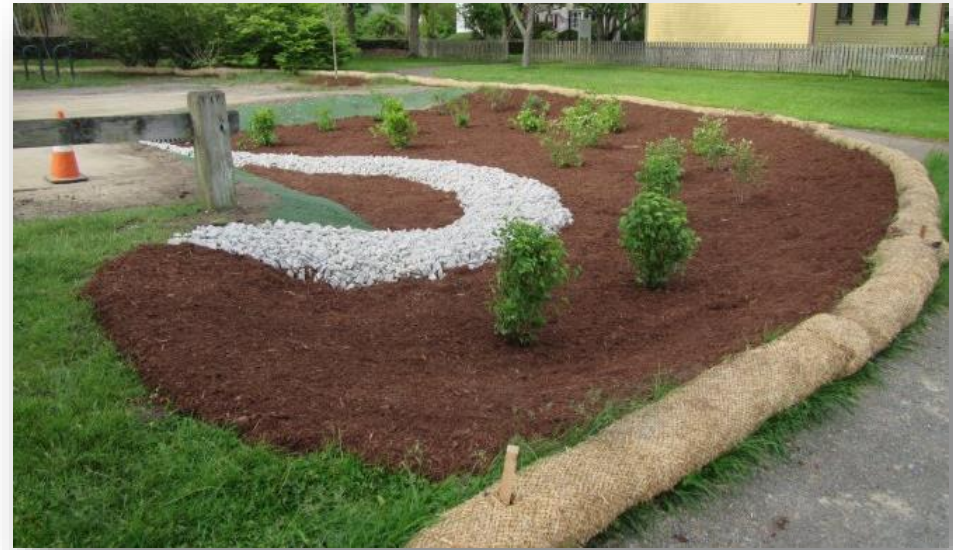
Image 1: Example of a low maintenance infiltration basin.

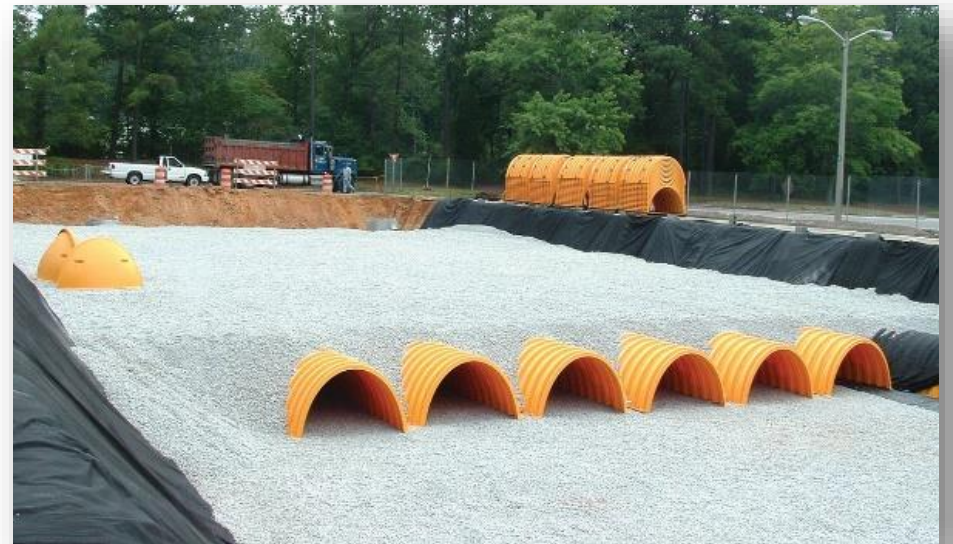
Image 2: Arched chamber subsurface infiltration system, during installation under a parking lot.

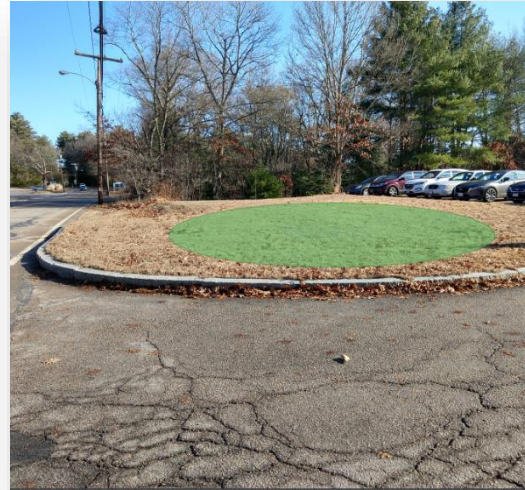
Image 1: Proposed location of infiltration basin (JMS\_IB\_1) near faculty parking lot.

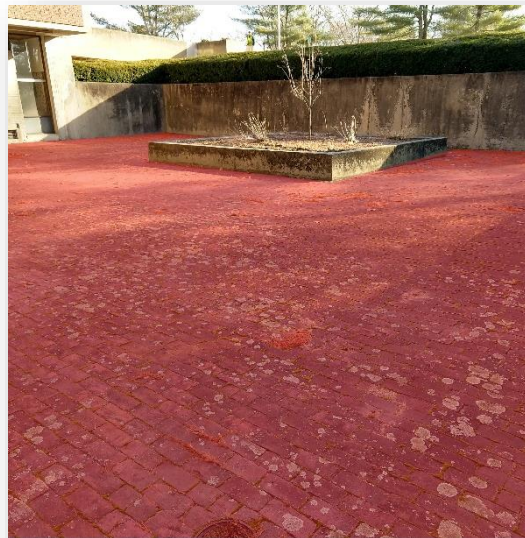
Image 2: One of the school's courtyards. (the red area represents area to be replaced with permeable pavers)

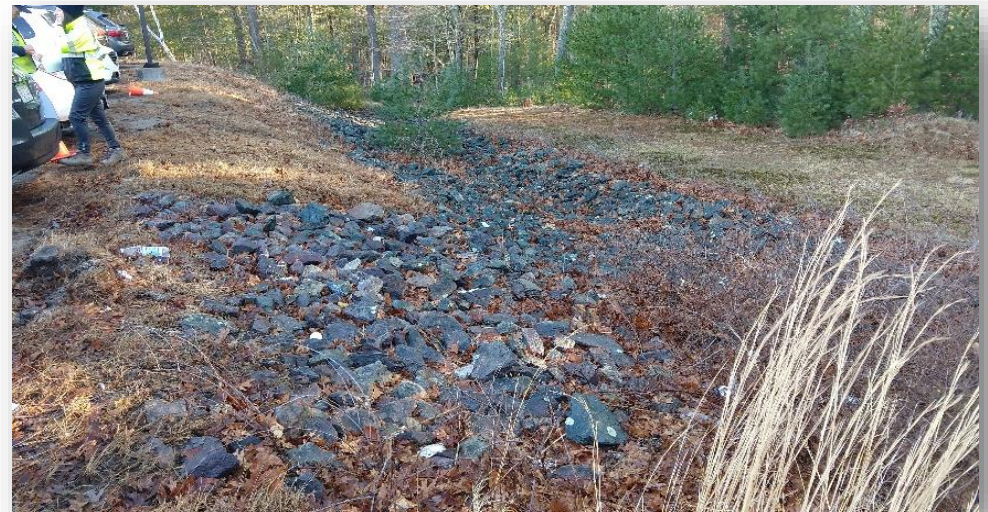
Image 2: Proposed location of infiltration swale and basin (ESS\_IB\_3).

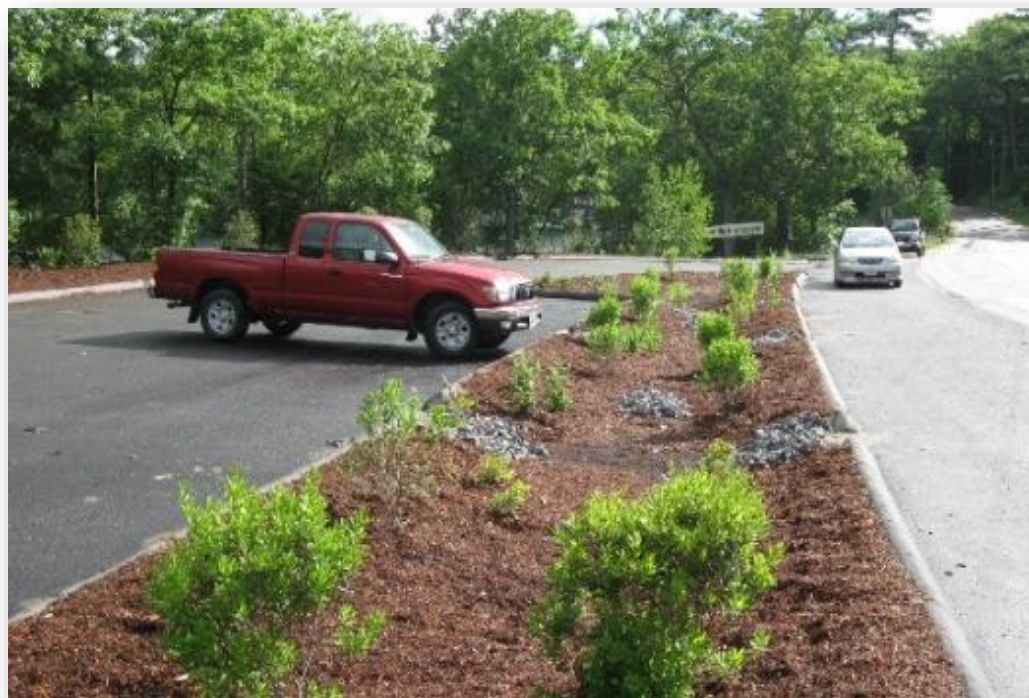
Image 2: Example of a parking lot with a bioretention basin.
