FIELD NOTES SUMMARY

Customer: Town of Walpole

Pond Name: Turner Pond

Date: 6/7/23

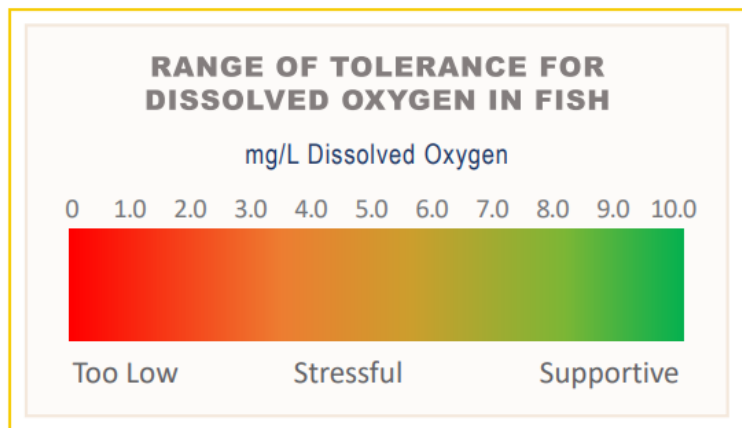
While on-site, dissolved oxygen (DO) and temperature readings were collected using a calibrated YSI meter with optical sensor. Dissolved oxygen is the amount of oxygen in water that is available to aquatic organisms. DO is necessary to support fish spawning, growth, and activity. Tolerance varies by species, but the figure below provides a general range of fish tolerance (Source: epa.gov).

Dissolved oxygen can be affected by many outside factors, such as: temperature, time of day, and pollution. Dissolved oxygen levels are typically lowest early in the morning. Healthy water should generally have concentrations of about 6.5-8+ mg/L.
