## Re: Walpole Ponds (Clarks Pond, Turner Pond, and Memorial Pond) – 2023 Year End Report

It is our pleasure to present a 2023 Year-End Summary Report to The Town of Walpole regarding the Aquatic Management Programs at Clarks Pond, Turner Pond, and Memorial Pond.

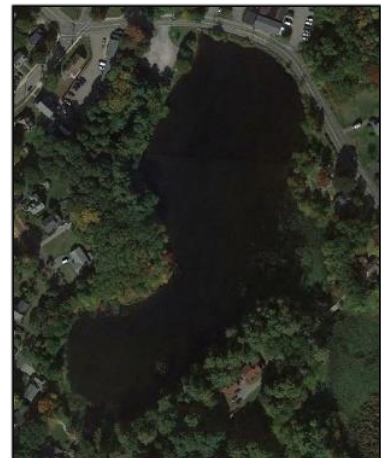
Figure 1: Clarks Pond - Walpole, MA

Clarks Pond (pictured in Figure 1) is approximately 6.6 surface acres and is located in Walpole, MA, specifically in Clarks Pond Conservation Area. The Pond is primarily bordered by sparse woodlands to the west and east, with a handful of properties scattered on the southern cove and northeastern shoreline. Stone Street runs along the northern portion of the Pond. Spring Brook feeds Clarks Pond from the eastern shoreline, with the outlet located on the northern point of the Pond. This outlet from Clarks Pond continues back into Spring Brook. Clarks Pond is a popular recreational waterbody for fishing from the shoreline.

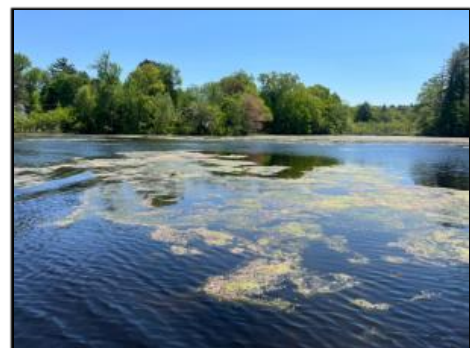
*Figure 3: Filamentous algae mats and pondweeds surfacing*

Upon arrival, a survey was conducted using visual observation paired with a standard throw-rake and handheld GPS/ArcGIS Field Maps, as applicable. The first noticeable observation was that there was a slight reduction in variable milfoil from the 2022 ProcellaCOR treatment. Variable milfoil was documented throughout the Pond, in sparse to dense densities. The most

dense area of milfoil was found in the middle of the Pond. Filamentous algae and epiphytic algae was noted throughout the Pond as well. Filamentous algae was documented both of the bottom of the Pond and on the surface, forming mats of algae on the surface of the Pond. Epiphytic algae was noted on roughly a third of the variable milfoil. Waterlilies were observed growing throughout the water column and surfacing in a handful of areas. Pollen was mixed throughout the surfacing pondweeds and algae. Watermeal (*Wolffia*) and duckweed (*Lemna minor*) were also documented in sparse densities, primarily around the shoreline. Japanese knotweed (*Reynoutria japonica*) was found around the shoreline of the

Based on the survey, a treatment was conducted for the control of Variable milfoil and algae. The liquid herbicide/algaecide was applied using a treatment boat equipped with a calibrated sub-surface injection system. This application methodology allows for even coverage within the treatment areas. Bright pink posters stating the restrictions associated with the treatment were posted around the Pond prior to treatment.

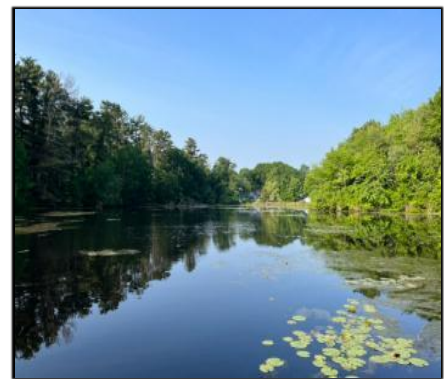
Figure 5: Conducting a survey at Clarks Pond

A survey was conducted in order to evaluate the effectiveness of the previous treatment. Among the waterlilies, and in scattered patches within the Pond, there were mats of benthic filamentous algae (algae pictured in Figure 5 to the right). In addition, there were trace densities of both variable milfoil and water chestnut observed, which was a significant improvement compared to last season. There was also a layer of pollen on the surface of the water, specifically most dense along the wind-blown shorelines. Based on the conditions documented during the survey, a treatment was conducted for the control of algae as the variable milfoil was treated during the previous visit and any remaining milfoil appeared unhealthy/dying. Water chestnut would be addressed during the July and August visits.

As planned, and based on the survey, a treatment was conducted for the control of algae. The liquid contact algaecide was applied using a treatment boat equipped with a calibrated sub-surface injection

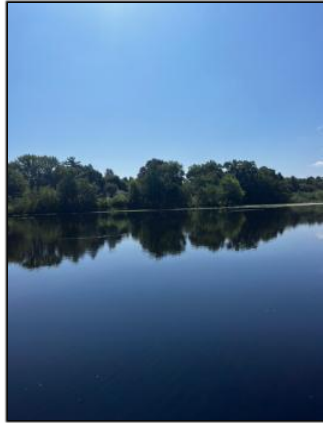
*Figure 6: Clarks Pond post-treatment*

The Pond's conditions had significantly improved since the previous treatments (improved conditions documented in Figure 6). Along the shoreline and throughout the Pond, there was minimal vegetation observed. The most dominant species were waterlilies, which were found throughout the Pond, especially in the southern and eastern shoreline areas. In addition to waterlilies, there were scattered patches of filamentous algae and duckweed along the shoreline. Overall, the Pond looked great, and no phragmites were noted in the areas where it was previously treated. Based

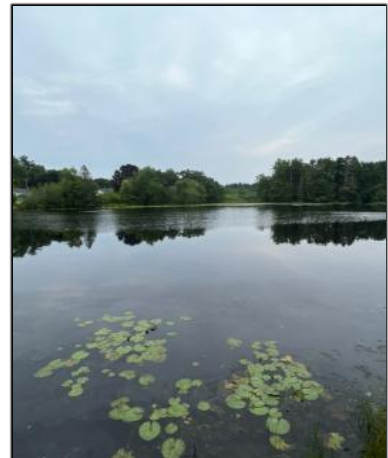
*Figure 7: Waterlilies noted within the Pond*

Upon completing our survey, it was determined that no treatment was necessary during today's visit. The target invasive species and algae have been controlled through the 2023 program. While some Filamentous Algae was present, it was extremely scattered at only trace densities and did not warrant treatment. Waterlilies, which are native, were scattered around the shoreline of the Pond (Figure 7). These provide valuable habitat and cover and did not reach a density/cover which would warrant management. Weather conditions were light rain, calm, with an air temperature of approximately 70 degrees F.

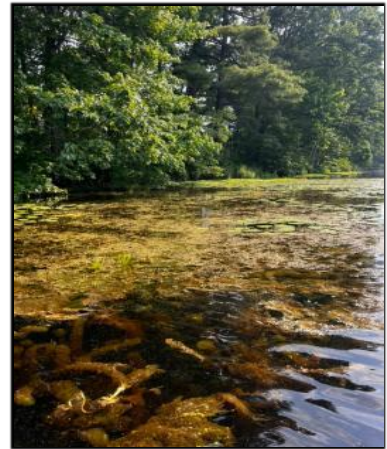
Figure 9: Filamentous algae, variable milfoil, and fanwort surfacing at Turner Pond

A survey was initially conducted in order to document baseline conditions and confirm treatment areas. Along the entire shoreline, variable milfoil was observed in dense densities and flowering at the surface (illustrated in Figure 9). Fanwort was much more scattered but documented in dense densities. Snailseed pondweed (*Potamogeton bicupulatus*) and thin-leaf pondweed, both native species, were noted in trace densities. Waterlilies were documented in varying densities. American featherfoil was scattered around the shoreline in increased densities from 2022 – which the increase in distribution can be attributed to last year’s drought. A layer of pollen was observed on the surface of the water, and certain populations of the vegetation were covered in epiphytic algae, an indication that the plant was dead or decaying. pH was sampled using calibrated meters. The pH was 7.8 which is within a standard range for freshwaters.

A treatment was conducted for the control of target nuisance/invasive plant growth, specifically targeting both fanwort and variable milfoil. The liquid contact herbicide was applied using a treatment boat equipped with a calibrated sub-surface injection system. This application methodology allows for even coverage within the treatment areas. The treatment was completed without issue. We anticipated plant die-off within just a few days to a few weeks. Bright pink posters stating the restrictions associated with the treatment were posted around the Pond prior to the treatment.

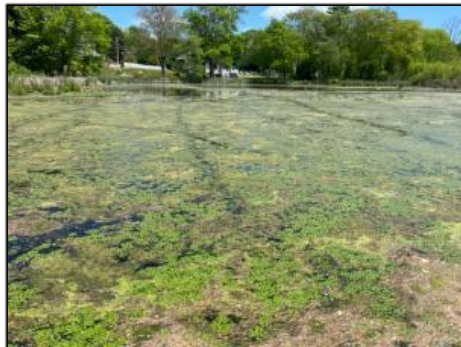
Figure 11: Dense pondweeds and algae surfacing throughout portions of Memorial Pond

Upon arrival, a survey was conducted using visual observation paired with a standard throw-rake and handheld GPS/ArcGIS Field Maps, as applicable. Three invasive species were documented during the survey, including water chestnut, variable milfoil, and curly-leaf pondweed. Variable milfoil and water chestnut were the most dominant invasive species as they were noted in varying densities ranging from sparse to dense

throughout the Pond (Figure 11). Curly-leaf pondweed was found mixed throughout the water chestnut and variable milfoil. Other species noted included Elodea (*Elodea canadensis*), thin-leaf pondweed, waterlilies, duckweed, and watermeal. There was scattered filamentous algae both on the surface and bottom of the Pond (see Figure 11 for Pond conditions). Epiphytic algae was noted in a small portion of the vegetation. Pollen was found mixed throughout the surfacing pondweeds and algae. Fanwort was not yet documented but would also be a target in Memorial Pond through the anticipated Sonar treatment program once permits are put in place. The Water chestnut has spread steadily since our previous survey of Memorial Pond.

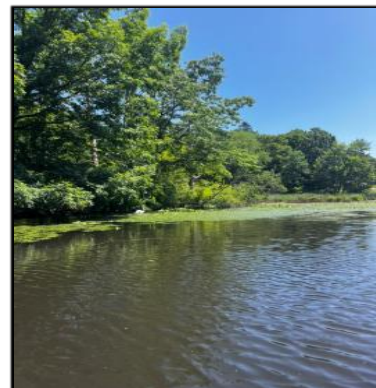
Figure 12: Water chestnut along the shoreline

Upon arrival, a brief survey was conducted to confirm treatment areas. The eastern half of the Pond, being very shallow, contained the densest populations of both native and invasive species. The most dominant species was Water chestnut (pictured in Figures 12 and 13),

which was noted in dense densities in the eastern portion of the Pond. The other two invasive species found in moderate densities were fanwort and variable milfoil, which appeared unhealthy in the shallow areas of the Pond. The treatment went well, and excellent coverage was achieved. Other species noted during the site visit included pickerelweed (*Pontederia cordata*), cattails, watermeal, duckweed, waterlilies, and coontail.

As planned, a treatment was conducted for the control of nuisance and invasive species. The Pond was due a “reset” with Sonar (active ingredient: fluridone). Both liquid and granular Sonar were applied to the Pond. The liquid herbicide was applied using a treatment boat equipped with a calibrated sub-surface injection system. The granular herbicide was applied using a calibrated blower. The herbicide was evenly distributed onto the target plant beds. We did anticipate some impacts to native waterlilies and water chestnut, but the dominant target of the treatment was invasive Fanwort, as well as Variable Milfoil. Sonar works by maintaining the desired concentration of Fluridone for a period of 45-60+ days. To achieve this, this initial treatment is completed, and 1-2 additional treatments were completed to “boost” the concentration within the water column. Sonar provides carry over control of the target species, but does work slowly, so results are not instantaneous.

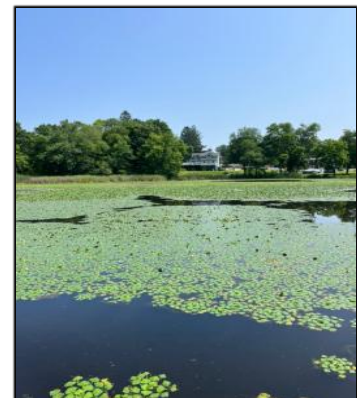
Figure 14: Dense water chestnut within the northeastern cove

Upon arrival, a survey was conducted to evaluate the effectiveness of the previous treatment. The Sonar treatment worked well as the tips of fanwort and variable milfoil appeared to be chlorotic, illustrating that the Sonar was penetrating the plant (pictured in Figure 15). Other species that appeared effected included waterlilies, water chestnut, and coontail. The Sonar booster applied today increased contact exposure time to further control the plants, as Sonar works slowly. Water chestnut was noted forming seeds, which typically begin to drop in the middle of August. The water chestnut was noted throughout the Pond, especially around the perimeter, middle of the Pond, and within the eastern and southern coves (dense water chestnut documented in Figure 14). Water chestnut

was documented in isolated populations in addition to mixed within waterlily populations (densities pictured in Figures 14 and 15).

Two separate treatments were completed during the site visit. The first treatment was conducted for the control of water chestnut. The liquid herbicide, Clearcast (Imazamox), was applied using a small Jon boat, equipped with a calibrated pump, which is used to target the water chestnut plants via foliar application methodology. This method allows for even and precise coverage. The second treatment was conducted to target invasive variable milfoil and fanwort, using Sonar. Weather was also closely monitored prior to treatment to ensure a treatment date without rain or high winds. We had one more Sonar “bump” treatment scheduled and would again target water chestnut at that time. The water chestnut treatment today would create access lanes to access more chestnut during the next visit.

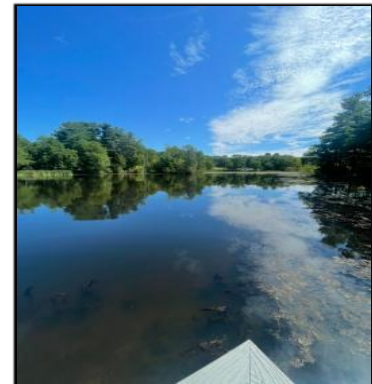
Figure 16: Conditions within Memorial Pond improving with each treatment

Upon arrival, a brief survey was performed to assess the effectiveness of the previous treatment and to confirm potential treatment areas. All variable milfoil populations appeared very unhealthy and covered in epiphytic algae; indicating that the plant was dead or dying. A large amount of the water chestnut population was dead or decaying at the time of today’s visit also as a result of our previous treatment. Other species noted included waterlilies, duckweed, watermeal, purple loosestrife (*Lythrum salicaria*), fanwort, and filamentous algae. Overall, conditions within Memorial Pond had significantly improved since 2023 management had begun (see Figure 16).
