Town of Walpole, Massachusetts

Municipal Facilities Master Planning Study

Final Report

June 21, 2013

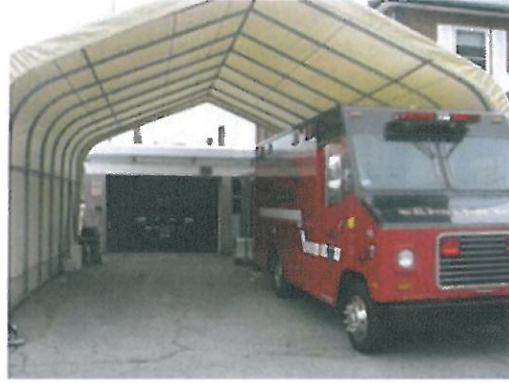
Temporary apparatus storage

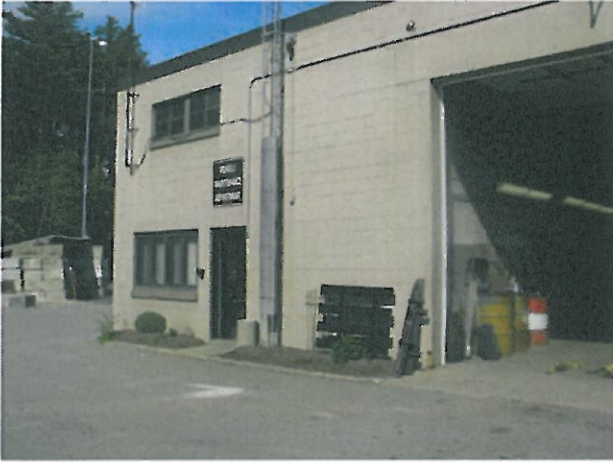
Vehicle Maintenance Entrance

Vehicle Maintenance Building: The original Vehicle Maintenance Building is a single-story, slab- on-grade building with a small second floor accessible via a narrow non-compliant set of wood stairs from the repair bays. The second floor houses a small break area, toilet/shower/locker area and a parts room. The first portion houses the repair bays with associated lifts, monorail, storage and office.

Exterior Façade: Vehicle Maintenance Building exterior façade and the associated additions consist of load-bearing masonry construction. Typical of the construction period, the walls are not insulated and not seismically braced and reinforced. Additionally, the original building and the 1968 addition do not have any masonry construction joints. The walls are in good condition however, there are several areas of settlement cracks within the walls. This is typically noticeable at door openings as well as at building corners. All of the sealant joints have outlived their useful life and are in need of replacement. Overhead doors are insulated however they are in various

stages of disrepair. Some of the personnel doors and frames have either rusted through or the wood has delaminated.

Renovations: Convert existing Vehicle Maintenance Building office and employee areas to general storage. Convert existing Vehicle Maintenance high bays (2) to vehicle wash stations. Upgrade existing overhead doors and frames and repair masonry damage throughout the exterior. See sketch and project budget.

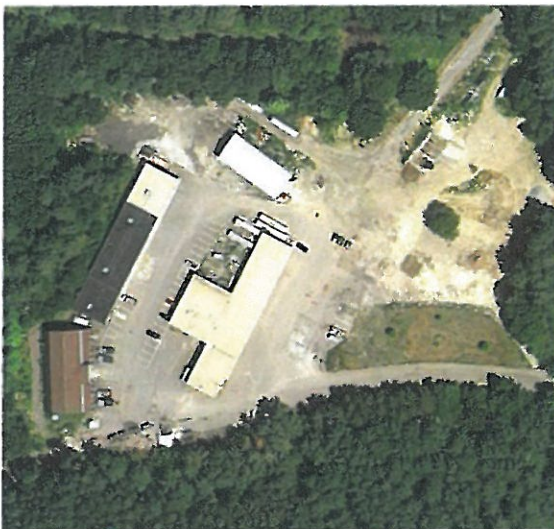
Site: The 'Town Yard' consists of four existing buildings on one site. Several trailers located around the site are used for miscellaneous storage. The entrance drive is a gradual incline up to a general flat facility. Overall, the site is in a deteriorated condition.

Pavement surface on the site is generally in poor condition or in some instances nonexistent. There is significant fatigue cracking on the main access drive due to heavy truck traffic as well as extensive patching. Alligator cracking occurs widespread on the entrance drive near Washington Street. While flooding is not reported to occur at the site, minor standing water was observed on some areas of pavement. These incidents of ponding could be eliminated by repairing potholes and providing adequate slopes through fine grading during resurfacing. There are no sidewalks on site. Curbing is limited and in fair condition.

Overhead view of existing DPW site

Site Improvements: In order to improve safety and vehicle circulation, it is recommended that the site be repaved with marked parking stalls and a one-way drive aisle through facility site. Develop a comprehensive plan to organize storage of material on-site. See sketch and project budget.

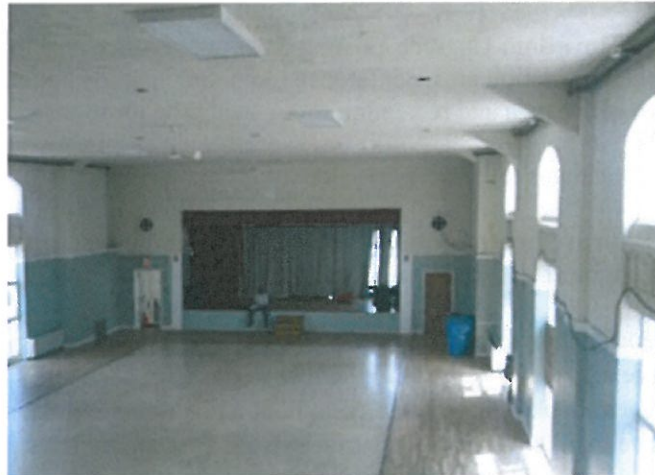
Auditorium and stage

Code Compliance: Several areas of concern exist with regard to compliance with current codes. Access to the second floor mezzanine is by non-compliant stairs and no elevator access. The egress stairs on opposite ends of the auditorium are not sized according to current egress requirements. Access to the stage is by non-compliant stairs on each side.

Functional Analysis: The main auditorium is a large multipurpose room that has enough room for a variety of activities. The number of participants in some of the activities appears to exceed the capacity of building. The mezzanine and the entry spaces below could be better utilized as support spaces for the auditorium. The office space on the lower level is small and not very efficiently planned. The daycare area on the lower level provides an adequate space for multiple activities for children. The layout of the room and the open plan allow for different activities to take place and adult oversight of each area.

- Upgrades to the entry, support areas and mezzanine including repairs to ceilings and walls.
- Replace all interior finishes in the first floor office area.
- Upgrade to make stage access compliant with current regulations.
- Remove mold covered wood surfaces from area behind the stage.
- Replace damaged stage curtain and lighting.
- Replace existing windows.

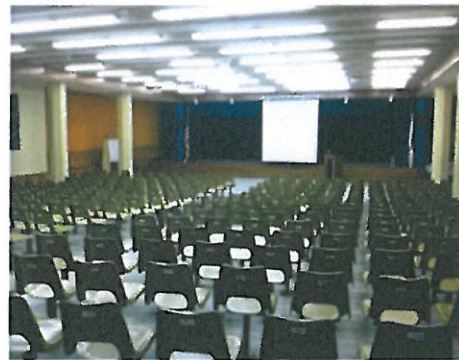
Auditorium: The Auditorium sits in the middle of the dining area splitting dining into two separate spaces. Since the kitchen is on one side of the Auditorium, students are required to walk through it to get to the dining area. Auditorium seating is metal frame and plastic seats and back. It appears to be original and should be replaced. The existing room divider needs to be replaced with one with reduced sound transmission.

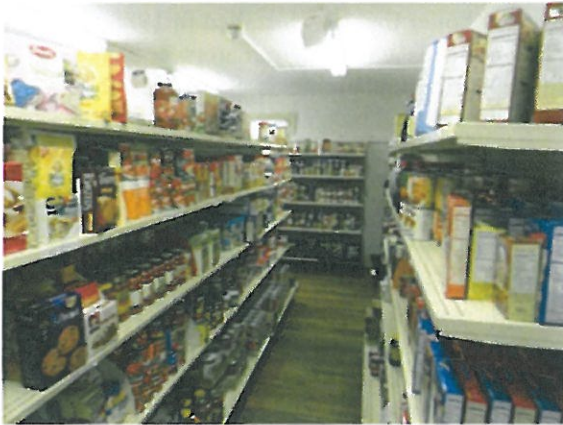
Food Shelves

Code Compliance: The facility was constructed as a single family residence and is currently being utilized as a food pantry. This use group change requires that the facility be brought up to code to comply with the new business use group.

It is apparent that this was not performed. This may have been a temporary solution to find a home for the food bank, which now has become a more permanent solution.

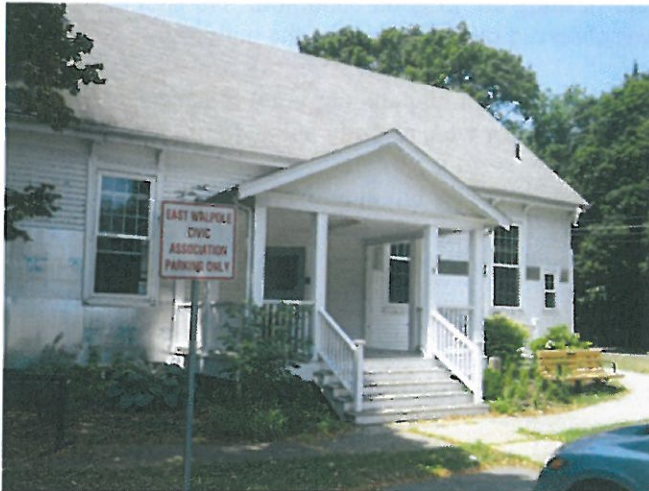
East Community Center (East Library)

Site: The relatively small site is on a corner lot in a residential neighborhood. Lawn and planted areas are in good condition and appear to be well maintained. One existing bike rack is broken and rusted and should be removed. One park bench and a newer bike rack exist and both are in good condition.

Hazardous Materials: Hazardous materials were potentially observed in the basement of the building. Areas of concern include lead paint, pipe insulation, asbestos tile and mastic.

Structure: Building is a wood frame structure on stone foundation. Some cracking in the foundation was observed but poses no serious concerns. Some splaying of the plaster surface over the foundation was observed and should be repaired. No damage or deterioration to the structure of the building was observed. The concrete walls of the exterior stairwell to the basement are in fair condition. Metal handrails are in poor condition and not ADA compliant and should be replaced.

Exterior Façade: Exterior façade material consists of vinyl siding. When observed, the building was in the process of receiving an upgrade of siding over a 1" sheet of rigid insulation. The wood trim around the front porch and the ceiling of the front porch need to be painted.

Roof: The existing roof is constructed of asphalt shingles and appears to have no damage or deterioration at this time. Gutters, downspouts and flashing are in good condition. No sign of water damage resulting from damage to the roof was observed on the interior of the building.

Windows: New windows have been installed throughout the building and are vinyl replacement windows with insulated glass. Wood trim frames on the interior were recently painted.

Building Interior: Ceiling tiles are new and in good condition. The building interior is currently being renovated and with new light fixtures and the wood molding, chair rail, built-in book cases and wall surfaces have recently been painted and are in good condition.

Plumbing: Toilet room on the first floor was recently upgraded and is in good condition; however, the room does not comply with ADA requirements. Toilet rooms and sink in the basement are in poor condition and should be upgraded or removed. Kitchenette on the second floor is also in poor condition and should be replaced.

Electrical: Electrical system has some recent upgrades including new light fixtures on the first floor. Lighting on the second floor and in the basement needs to be replaced.

- Site; Repave the driveway and parking lot, provide additional parking spaces.
- Second Floor; Replace light fixtures, remove book shelves, replace kitchenette.
- Basement; Remove trash, replace all floor tile, upgrade toilet rooms.

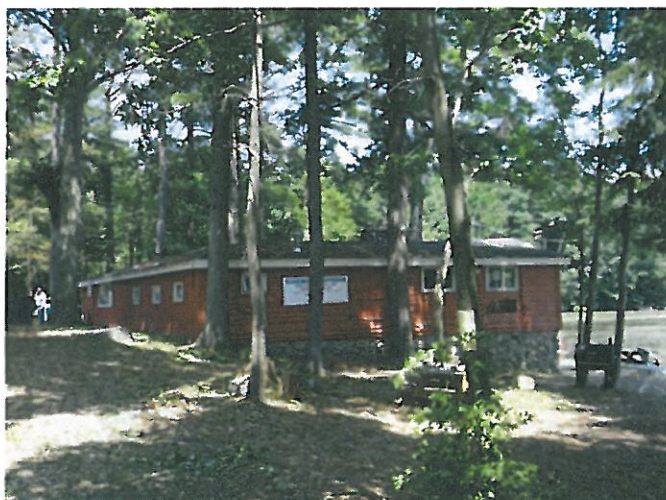
Turner Lodge

Site: The site is rustic and unorganized located on the south side of the pond. The property includes the main building along with a storage shed. The site slopes toward the pond with a half basement exposed lower level on the pond side. The site is in poor condition requiring cleaning and maintenance. The wood porch and walkways are in poor condition and in need of repair. The railings are not secure and pose a hazard with heavy use. The patio is made of gravel and is cluttered with old furniture and outdoor cooking equipment.

Structure: The building consists of a wood framed structure supported by a stone foundation. Minor repair is needed for the foundation otherwise the building structure is in good condition. The building exterior is constructed by a combination of painted wood siding.

Roof: The roof is asphalt shingle with aluminum gutters and downspouts. Signs of wear are evident with the roof which is otherwise in good condition.

Windows: Windows are wood with wood frames and single-pane glazing. The building has partial aluminum replacement windows that are in good condition.

Building Interior: The interior is in poor condition with several items needing repair or replacement. The existing carpeting is worn and odorous. Replacement with a durable tile

should be considered as it would better suit the building's use. All built-in cabinets and kitchen appliances should be replaced. The entire interior requires a fresh coat of paint.
