Walpole Old Town Hall
980 Main Street
Walpole, MA 02081

Facility Condition Assessment and Report on Report on Preparing Building for Development

May 19, 2022

Compass Project Management, LLC
A Vertex Company
One Edgewater Drive, Suite 204
Norwood, MA 02062

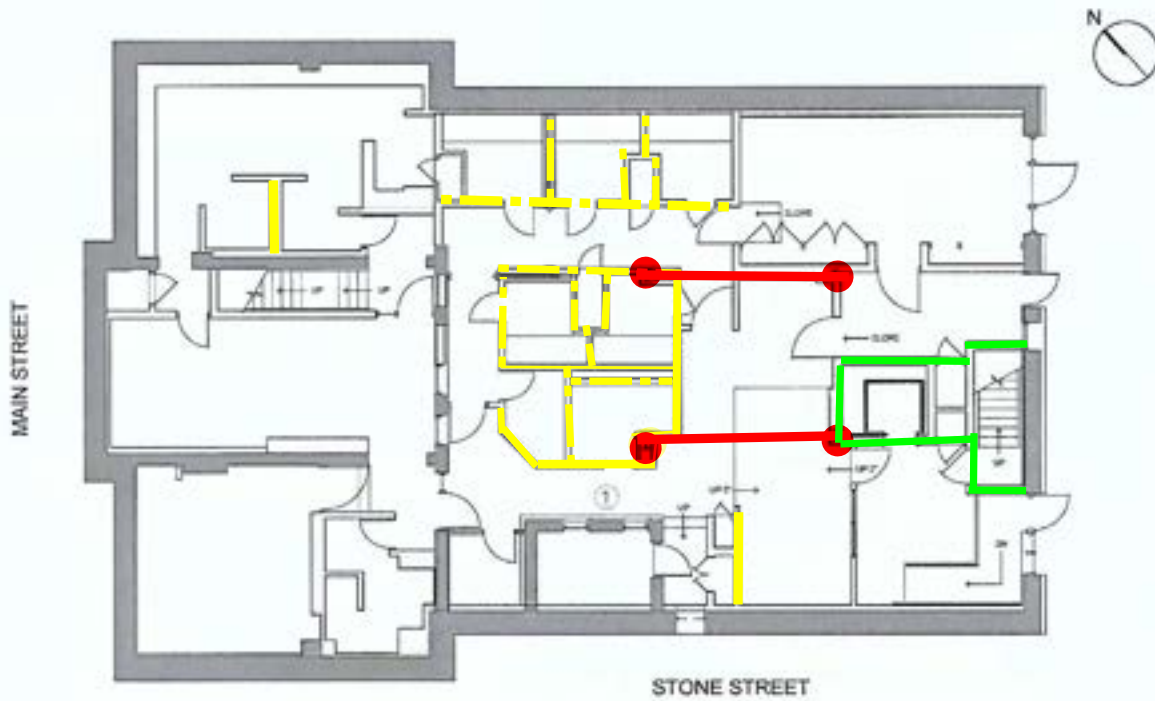
Plans of potential interior non-structural wall removal

- Yellow indicates walls to remove
- Red indicated Structural areas of concern
- Green indicates stair and elevator to remain
