# TOWN OF WALPOLE

# RECREATION PROGRAMMING AND FACILITIES STUDY

2 0 2 2

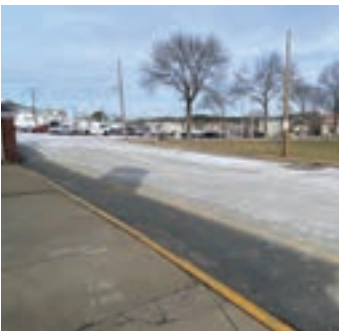
Photo 1: Distance to ADA parking

- **Accessibility:** ADA access is deficient in multiple routes to the building. Two marked accessible parking spaces, though indicated with signage, are not fully striped per MAAB 521 CMR 23, requirement, and are located on a slope exceeding the ADA requirement of a maximum two percent (2%), slope in any direction. The spaces are not located nearest to the accessible sidewalk curb cut to the entrance (Photo 1). Delineated crossing from the ADA spaces to the entrance of the building are not marked, and the sidewalk curb cuts are not code compliant, lacking tactile warning mats per 521 CMR 21 (Photo 2).

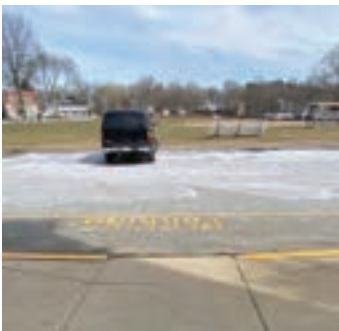
Photo 2: Non-compliant curb cut

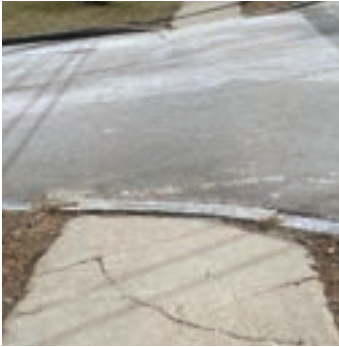
Photo 3: Non-compliant sidewalk crossing

- There is no accessible route to other entrances around the building. Sidewalks along the site perimeter are also deficient in some areas (Photo 3) Issues along the paths include missing tactile warning strips, cross slopes exceeding two percent (2%), steep slopes, and stairs without compliant railings. The stairs on the southeast corner of the building grounds do not include handrails (Photo 4).

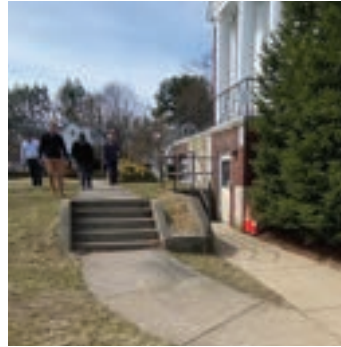
Photo 4: Non-compliant southeast stairs

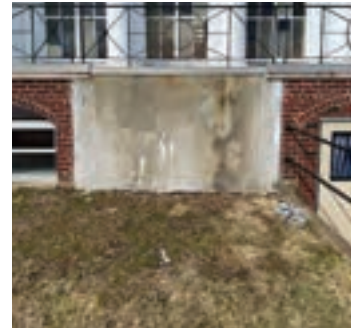
- **Stormwater Drainage/ Topography:** A visual review of topography and drainage indicates issues with positive site drainage not sloping away from the building in some locations along the south and east faces of the building, adjacent to the Recreation Department offices (Photo 7). Water ponding concerns also exist around the mechanical room/elevator at the northwest corner of the building due to the topographic layout of the retaining walls and access walkway at the corner (Photo 8).

Photo 7: Site drainage issue at South facade

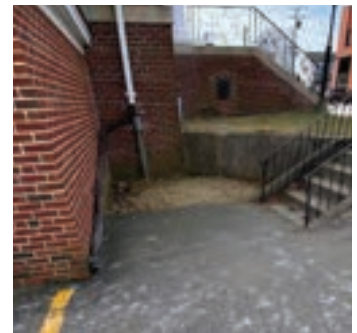
Photo 8: Site drainage issue at Northeast corner

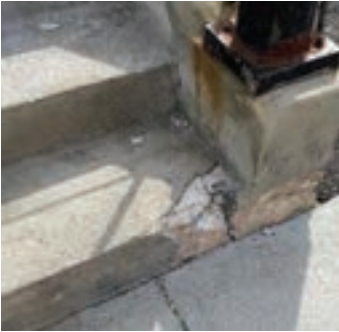
Photo 10: View of stairs cracking

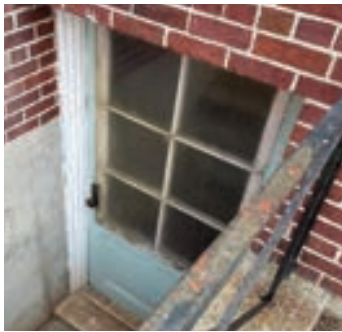
Photo 11: View of the original basement door assembly

- The building has eight decorative columns, four columns on each end of the building. They were recently replaced and are in good condition overall. Most of the window openings on the first level have been replaced to double hung windows while the rest of the windows remain fixed. The fixed windows consist of wood and single pane glazing. Some windowpanes are broken due to vandalism and/or harsh weather. Some of the double-hung windows have lost integrity. At nine window locations, on the north and south elevations, there are wooden shutters that are in decent condition. The paint coating on the shutters is chipping due to weather and lack of maintenance. Three exterior doors, two on the north elevation and one on east elevation, were recently replaced and are in good condition. There are two canopies with copper roofing, one above each door on the north elevation, that are in poor condition. The wood fascia and molding of the canopies is rotting. The exterior basement door on the northwest corner of the building is in poor condition and lacks proper security.

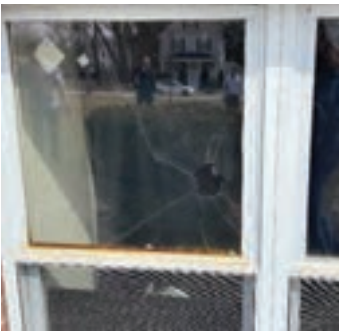
Photo 13: View of broken window

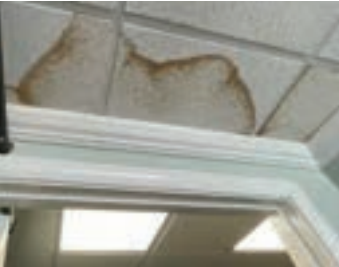
View of water damage on ACT tiles

Photo 15: View of damage on ACT tiles

- The first-floor interior is plaster with a drop ceiling, which does not meet the minimum ceiling height of seven feet six inches (7'-6"). Water damage was observed on ACT tiles at multiple locations. The plaster is in fair condition with some minor cracks and dents and was recently repainted. The first-floor entrances and ramp have new rubber floor tiles that are in good condition. The lower first-floor meeting area has laminate floors that are in good condition. Fixed wired glazing windows were observed on the first level and are in poor condition. There are two fireplaces on the first floor that are in good condition but are currently inoperable. There are male and female toilet facilities on the first floor that are in fair condition. They do not meet current ADA accessibility requirements. There is a single user restroom that is accessible near the large space. An office space on the first level was recently renovated and the space is in good condition, though leaking and water intrusion/mold was observed around exterior walls. There are two staircases on either end of the building that lead to the second level gymnasium. Both stairs do not have adequate height handrails (less than thirty-eight inches (38")). It was observed that radiators were suspended

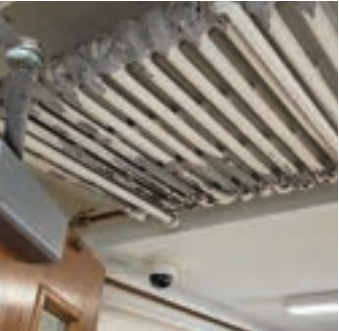
Photo 16: View of ceiling mounted radiator

from the ceiling in the circulation hallway spaces.

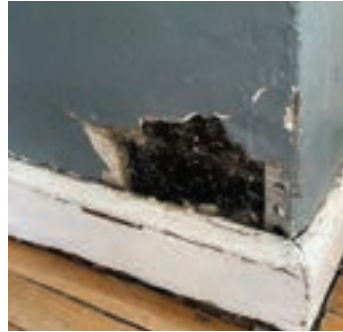
Photo 18: View of plaster damage in auditorium

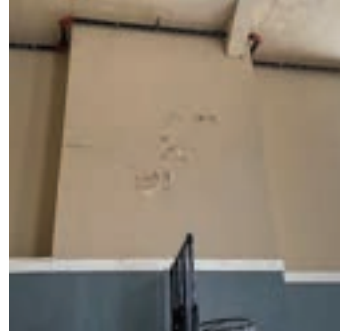
Photo 19: View of paint peeling around chimney

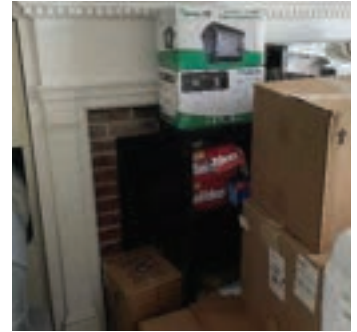
Photo 20: View of inoperable fireplace

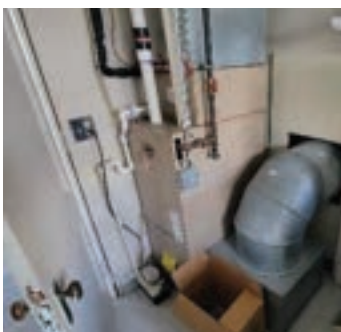
Photo 25: View of AC that serves the office spaces

- The split systems provide heating and cooling to the lower level. The first split system is an indoor condensing, gas fired, York furnace with a DX cooling coil (AC) with a remote outdoor condensing unit (CU) (Photos 25,27). The associated CU is a York model YCJD36S43S3A with a nominal capacity of 36 MBH (3 tons) of cooling. The outdoor unit connects to the indoor unit via refrigerant piping (Photo 28). The insulation on the refrigerant piping is decaying due to UV exposure and degradation. This system provides heating and cooling to the offices in the lower level via supply and return ductwork. There is a single return duct with a large sidewall return grille located centrally in the open area of the recreation office spaces. The supply ductwork is all overhead, above the acoustical ceiling that connects to several supply diffusers.

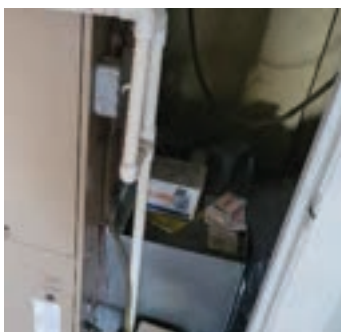
Photo 26: View of AC that serves the auditorium/gym

- The second split system is an indoor condensing, gas fired, York furnace with a DX cooling coil (AC) with a remote outdoor condensing unit (CU) (Photo 26,27). The associated CU is a York model YCJD60S41S1C with a nominal capacity of 60 MBH (5 tons) of cooling. The outdoor unit connects to the indoor unit via refrigerant piping (Photo 28). The insulation on the refrigerant piping is decaying due to UV exposure and degradation. This system provides heating and cooling to the public recreation room in the lower level via supply and return ductwork. There is a single return duct with a large sidewall return grille located centrally in the auditorium. The supply ductwork is all overhead, above the acoustical ceiling that connects to several supply diffusers.

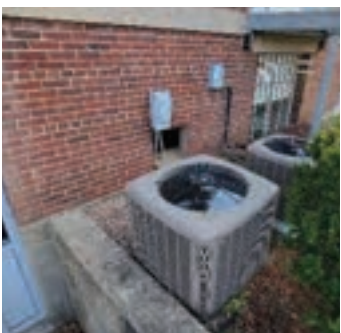
Photo 27: Outdoor CUs that serve the indoor ACs terminations

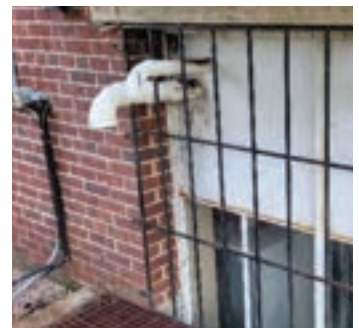
- There were no exposed/apparent manufacturer tags on the indoor units that indicated model numbers or capacities. The ACs utilize PVC flue and combustion air ducts that are routed to the outdoors, through a panel over a window and under the open stairs (Photo 29). The combustion air pipe for the AC unit that serves the office area is broken (Photo 30).

Photo 29: View of AC flue and combustion air

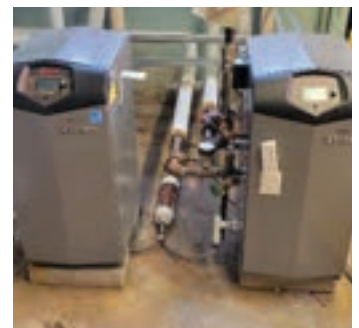
Photo 31: Existing lochinvar boilers

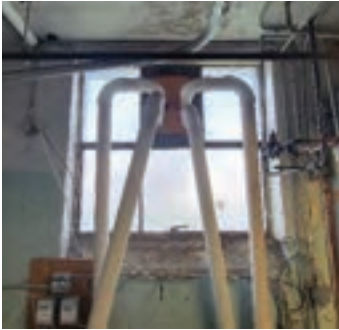
Photo 32: Boiler flues and combustion air ducts

- The boilers utilize PVC flue and combustion air ducts that are routed to the outdoors, through a panel in a window and terminate with a concentric termination (Photo 32).

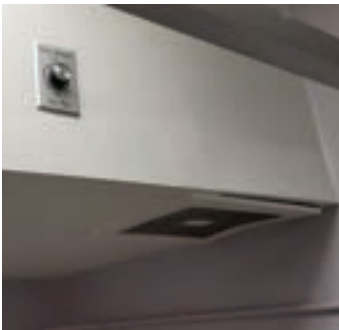
Photo 33: Typical bathroom exhaust fan

- **Exhaust Fan:** Each bathroom has a dedicated exhaust fan (EF). None of the bathroom EFs were exposed to locate model numbers and age of equipment (Photo 33). The EFs discharge to the outdoors via wall hoods.

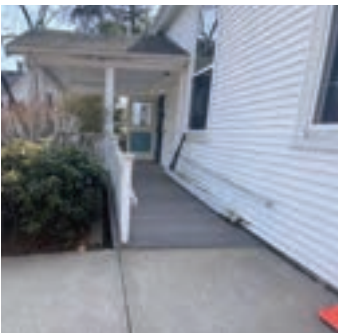
- **Accessibility:** ADA access is deficient to the building entrance, with slopes exceeding 5% (Photo 1). There are no properly marked accessible parking spaces. There is no accessible route to other entrances of the building. Overall, parking is deficient in terms of number of spaces and layout/access and flow off Wolcott Avenue. (Photo 2).

Photo 1: View of access walk

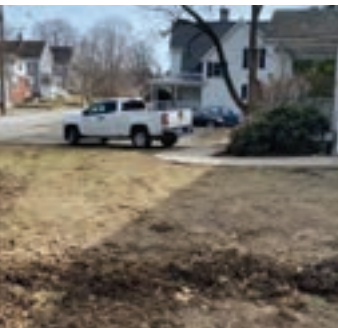
Photo 2: Parking area

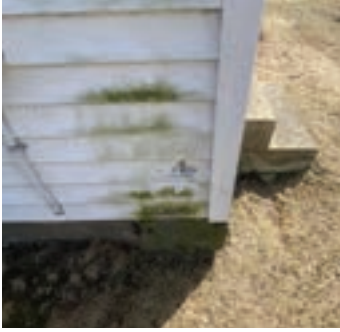
- **Stormwater Drainage/ Site Topography:** Review of topography and drainage indicates there may be a lack of positive site drainage away from the building in some locations around the north and west side of the building (Photo 3). Water concerns also exist around the basement bulkhead on the south face of the building (Photo 4).

Photo 3: Drainage concerns at building foundation

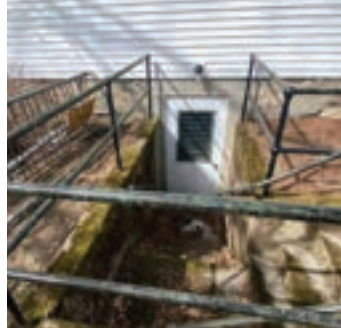
Photo 4: Drainage concerns at bulkhead

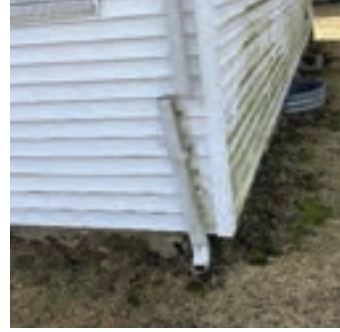
- **Landscape Vegetation:** Landscape plantings are, in general, in fair condition. Overgrowth of plantings at the main building entry may cause damp conditions and potential damage to the structure (Photo 5). The existing tree on the corner of Wolcott Avenue is in decline (Photo 6).

Photo 5: Damaged and inoperable downspout

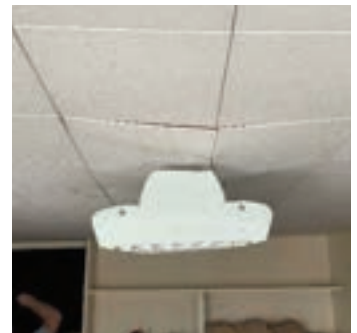
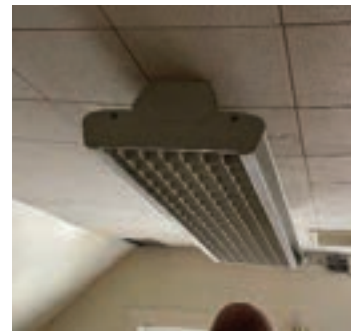
Photo 8: View of sagging ceiling in attic

Photo 9: View of sagging ceiling in attic

The stairs accessing the attic are steeper than current code allows. The stair handrail is fixed to the wall, but the rail extension does not return to the wall. The stair treads appear to be too shallow, and the risers are too high. The attic is in overall poor condition. The ceiling is sagging in the center and ACT tiles are missing in multiple areas. There are floor tiles that are curling and damaged. The attic drywall is cracking and in poor condition. Part of the attic is unfinished and accessible through a crawlspace.

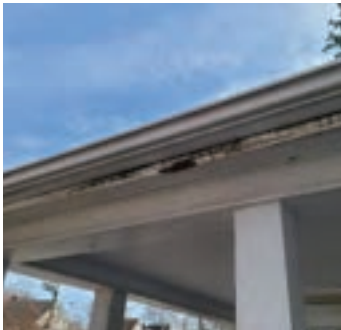
Photo 10: Damage at porch fascia boards

- Original construction plans for the building were not available at the time of this report. In general, the exterior of the building appeared to be in good condition. Some of the front porch fascia boards have started to deteriorated need replacement (Photo 10). Inside the attic space, some cracks were observed in the wall finishes (Photo 11). The floor tiles in the attic space are likely asbestos (Photo 12).

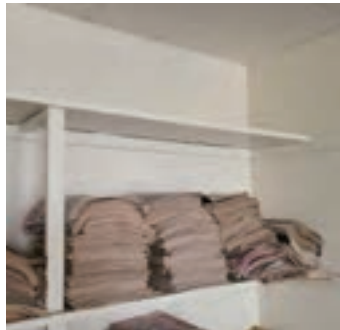
Photo 11: Cracks in attic space walls

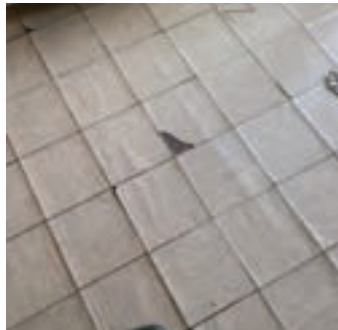
Photo 12: Attic space flooring

- Proper procedures should be followed if these tiles are to be removed. Water marks were observed in the attic ceiling tiles indicating a possible leak in the roof. Some of the ceiling tiles, as well as a light fixture, were hanging low at the time of this visit (Photo 13). In general, the roof framing appeared to be in good condition (Photos 14, 15).

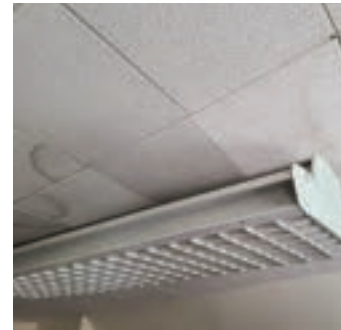
Photo 13: Attic space ceiling tiles

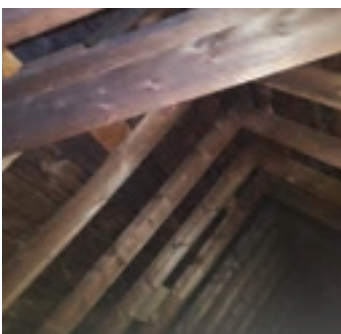
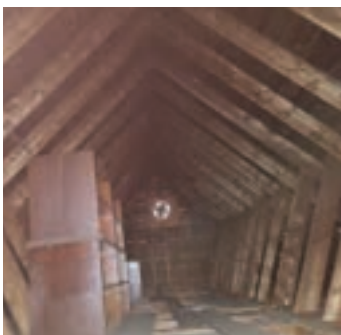
Photo 14: Roof framing

Photo 15: Roof framing

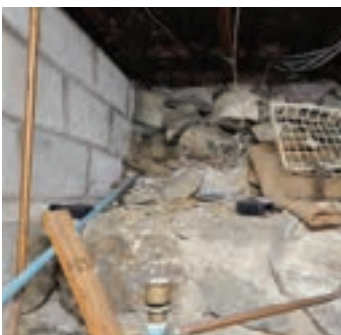
Photo 16: Foundation wall in basement

- In the basement, some loose stones were found in the foundation wall (Photo 16). The exterior concrete basement steps were covered in moss at the time of this visit, but otherwise appeared to be in good condition (Photo 17).

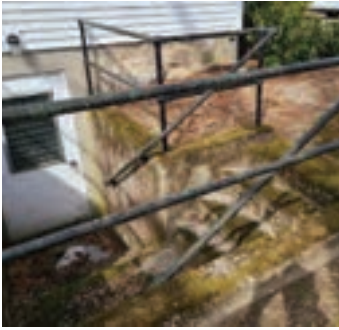
Photo 17: Basement steps

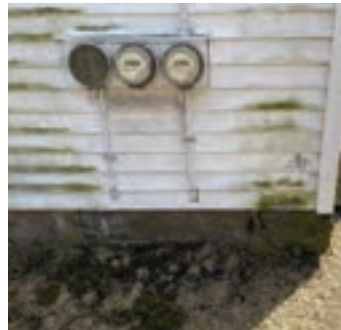
Photo 18: Siding mold damage

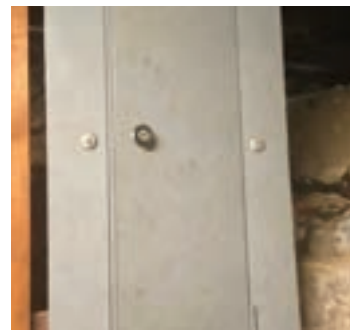
- Rust and corrosion on the main service panelboard was observed. This panelboard is in an unconditioned space with some exposure to outside elements.
- **Lighting:** The main hall and **computer room** lighting consists of recessed fluorescent 2x2 fixtures that appear to be in good condition. The lights in the main hall are controlled by a timer switch mounted near the front entrance to the building. The lights in the basement are LED and appear to be in good condition. It was noted that there is no emergency lighting system or exit lighting in the building.

Photo 21: View of the **panelboard**

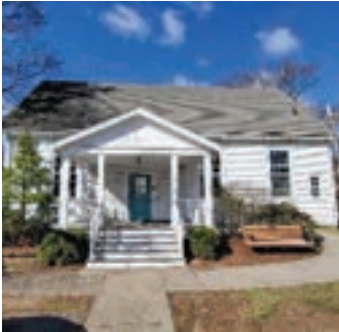
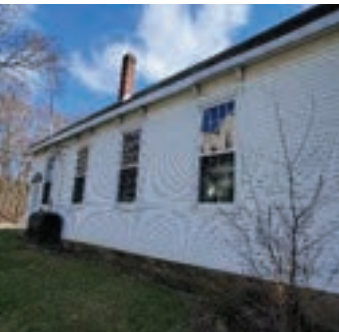
Photo 24: Windows provided ventilation air

Photo 25: Windows provided ventilation air

- Based upon a visual inspection, the HVAC systems appear to be in good condition.
- There is a single heating system. There is no cooling in the building. There is a hot water system that serves the entire building. The heating system operates on oil which is piped to the boiler from an oil tank behind the building. No concerns or issues related to the HVAC system were raised during the observation visit. Ventilation for the entire building is provided by operable windows (Photos 24, 25).

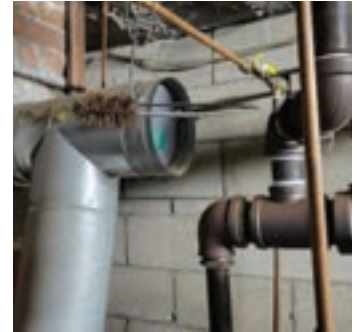
- The boiler utilizes a B-vent flue from the boiler into the existing chimney (Photo 28). Combustion air is provided by a louver on the rear wall of the mechanical room (Photo 29).

Photo 28: Boiler flues into the chimney

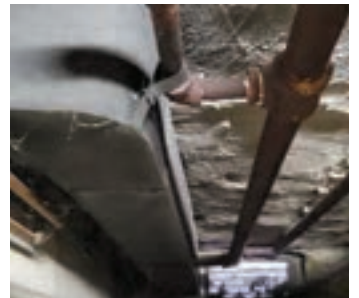
Photo 29: Combustion air louver

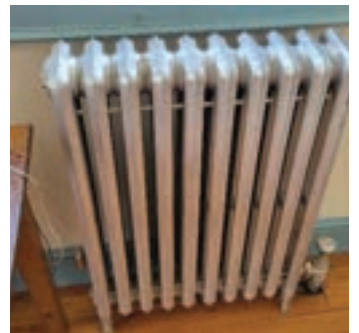
- The pump serves the piping connected to cast-iron radiators throughout the building. Heating hot water piping is required to be insulated. Uninsulated piping was noted during the observation in the mechanical room. Cast-iron radiators are throughout the building (Photos 30). The cast-iron radiators appear to be original to the building and appear to be in good condition.

Photo 30: Typical cast-iron radiator

- Provide insulation and jacketing on all accessible heating hot water supply and return piping.
- Provide labeling on all heating hot water supply and return piping to aid in servicing.

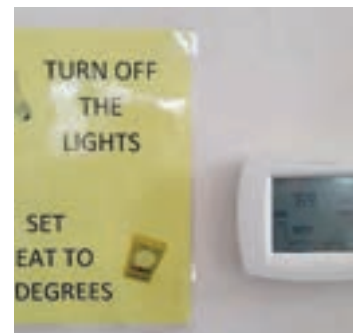
- **Controls:** The HVAC systems make use of local controls. There is no building management system (BMS) at the East Walpole Library. There is one thermostat in the main area for heating purposes (Photo 31). The boiler controls and temperature controls are in good condition. The temperature controls typically last 15-20 years.

Photo 31: Thermostat to control the boiler and the pump

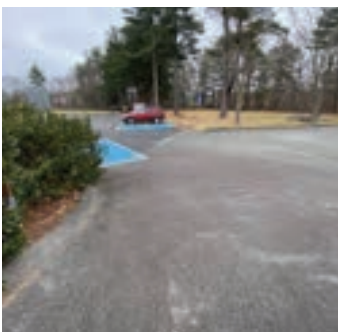
Photo 1: Steep entry slopes

- **Accessibility:** ADA access is limited and non-compliant with MAAB/ADA codes to the building entrance and the wading pool entrance, with slopes exceeding 5% in some of the paved area between the parking lot and pool entrances, and no defined accessible path of travel indicated where slopes area less than 5% (Photo 1). While there may be accessible routes within the current paving, they are not marked. The ADA parking spaces meet requirements for size and markings. In general parking seems sufficient at the site, with overflow parking nearby. Sidewalk access from the parking

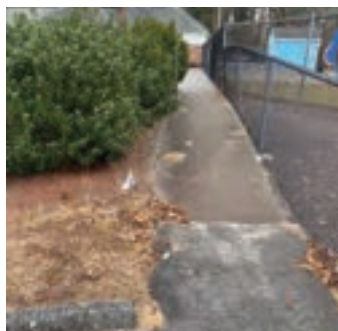
Photo 2: Overgrown planting and non-accessible walkway at parking lot

- **Landscape Vegetation:** Landscape plantings are, in general, in fair condition, though aging. Planting at the edge of the parking lot and the wading pool may create some visual hazards for pedestrians (Photo 2). Interior to the wading pool area and on the pool deck, user amenities such as permanent shade or tree shade is lacking. Stone Street is visually proximate to the pool and may be visually and acoustically impact patrons' experience.
- **Stormwater Drainage/ Site Topography:** A visual review of topography and drainage indicates erosion around the pool deck, and drainage concerns along the edge of the pool deck against the building (Photo 3). Informal foot-paths around the pool fence and into the surrounding forested and wetland areas indicate non programmed recreational activity outside of the limit of the pool facility.

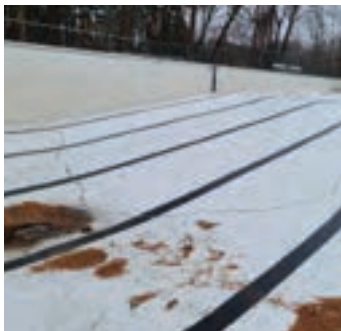
Photo 6: Cracks at deep end of Central Pool

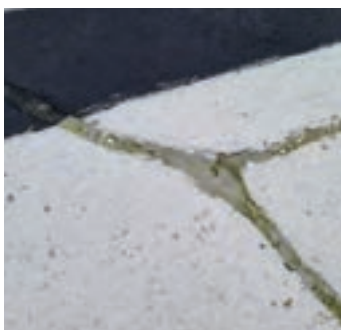
Photo 7: Large crack at the bottom of the Center Pool

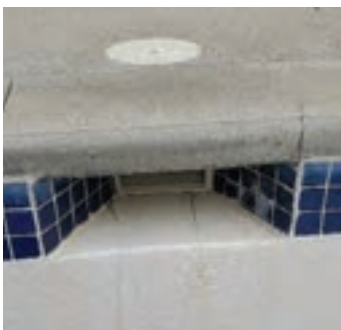
Photo 8: Wadding Pool skimmer

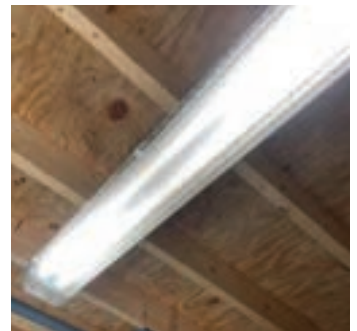
- The interior lighting consists of surface-mounted fluorescent tube fixtures with lens and shield that appear to be in good condition. The switches for these light fixtures all have weatherproof covers (Photos 12, 13).

Photo 12: Center Pool interior lighting

- Add floor drains or means of drainage to all mechanical spaces to drain standing water
- Scrape clean and re-paint the door lintels
- Upgrade all door hardware with compliant hardware
- The town should consider replacing fluorescent fixtures with LED equivalents
- Add permanent affixed, non-handwritten labels to the electrical panel boards and control equipment
- Replace plumbing fixtures to meet ADA accessibility guidelines
- Scrape clean and re-paint the door lintels
- Installation of fire alarms in the filter room and restrooms is recommended

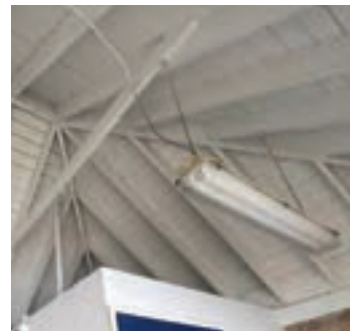
Photo 13: Center Pool interior lighting

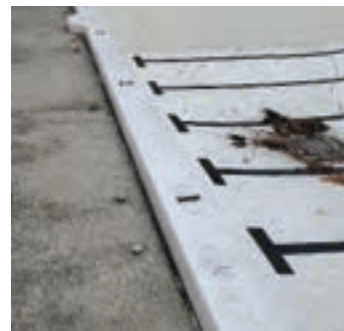
- Patrons enter the pool area through the main entrance in the building. The enclosure includes bench seating along the south-east side of the pool perimeter, and a storage shed for the swimming team on the southwest side of the pool deck (Photo 16). There are deck anchors along the northeast side of the pool for six starting blocks that are currently being stored in the swim teams shed for winter.

Photo 16: Center Pool deep end deck

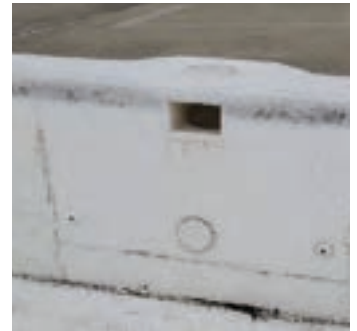
- There are compound gauges on each pump influent line, and pressure gauges on the pump effluent lines before the filter. The recirculation system has one (1) flow meter on the pool return line but it is not connected to the chemical controller. Water quality in the pool is automatically monitored and controlled by a Prominent DCM2-CI Automation water quality controller. Filtered and balanced water is recirculated back into the pool through a perimeter wall inlet return loop, with inlets located approximately 3-ft below the deck. Inlets run along the entire perimeter of the pool, located adjacent to the skimmers (Photo 17).

Photo 17: Center Pool skimmer

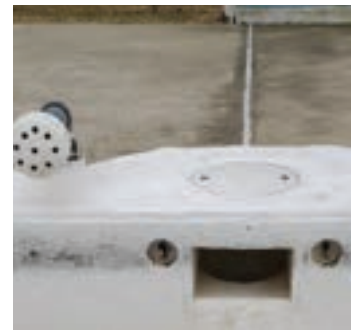
- The water level in the pool is manually controlled using a fill line at the southwest end of the pool (Photo 18). On the Southeast side of the swim team's storage shed is a below grade valve that feeds the fill line.

Photo 18: Center Pool fill line, skimmer box and wall

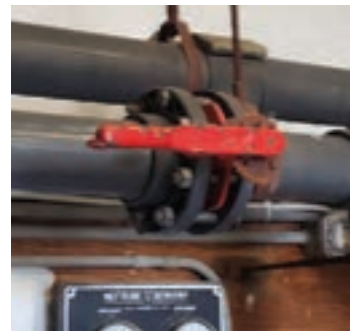
- Within the mechanical space, floor drains could not be located, however there was a hose bibb installed near the CO2 tank storage area. With poor ventilation and drainage devices valving, pumps, and pipe supports have experienced a considerable amount of corrosion (Photo 19).

Photo 19: Center Pool pipe supports

- Pool chemicals should be given a designated storage area
- Update wading pool mechanical space to allow for proper ventilation
- Pipe supports should be replaced as needed to ensure all pipes are safely and securely fastened
- Add flow arrows and pipe labels on all pipes to ensure proper operation and reduce confusion
- Eyewash stations should be installed at both mechanical rooms near the chemical feed/loading areas
- Replace all valves, piping and pipe supports in the center pool mechanical room that show signs of corrosion
- Existing pumps nearing the end of their life cycle should be replaced or rebuilt
- The Wading pool pump strainer should be replaced due to extensive corrosion
- Replace pump strainers as needed
- Install newly ordered pulsar chemical feeders per manufacturer recommendations for both systems when they arrive on-site

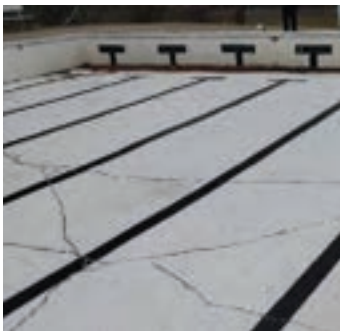
Photo 20: Cracking in Center Pool shell

- The biggest challenge with the pool is repairing the pool shell cracking and replacing components of the mechanical space. Additionally, there are several fittings and rail goods (ladders, blocks etc.) that need replacement or alteration in the pool area. A large portion of the wall anchors are corroded and need replacement. The four ladder points of entry should be replaced as they exceed the code required 75-ft.
- The mechanical room presents additional challenges. The valving and pipe supports require repair due to corrosion (Photo 19 ). Additionally, although not required or critical, the pumps show early signs of corrosion and long-term wear and tear.

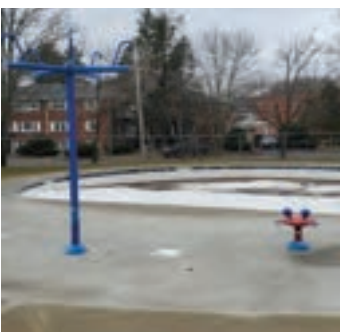
Photo 21: Wading Pool and splash pad

- The Wading Pool is circular in shape with a diameter of roughly 55-ft. The pool has a surface area of approximately 2,252 sf, a perimeter length of approximately 170-ft 6-in linear feet, a pool depth ranging from 0-ft 0-in to 2-ft 0-in, and a volume of approximately 25,020 gallons (Photo 21). Based on a bather load of one (1) bather per 15 sq. ft., the maximum bather load per 105CMR 435: Minimum Standards For Swimming Pools is approximately 150 bathers.

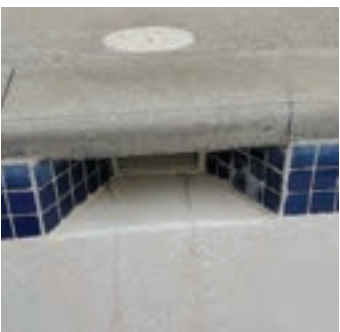
Photo 22: Wading Pool skimmer

- The Wading Pool was drained and shut down for the winter at the time of assessment. The town representatives informed us that there have been issues with the waterline tiles falling off. The Town noted that they have not experienced any leaking with this pool, however, it was noted that there are potential structural concerns regarding the cracks in the pool shell and coping on most of the skimmer box areas (Photo 22).

- The pool has a light in color plaster finish, with a 6-in contrasting waterline tile and six (6) skimmer boxes along the perimeter. There is a zero-entry area with an entry gutter in addition to the skimmer boxes (Photo 22). Each skimmer has a corresponding equalizer line and fitting.

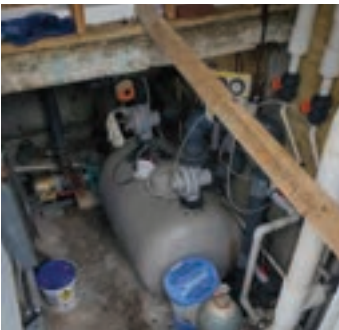
- The volume of the wading pool is approximately 25,020 gal., and flow rate for the filtration system is 139 gal. per minute (gpm) which results in a turnover rate of about three (3) hours. The filtration system includes one (1) filter pump and one (1) basket strainer, where water is suctioned through the strainer to the pump, and then sent through the sand filter. The filter has a total area of 13.45 sf., resulting in a filter application rate of approximately 10.33 gpm/sf. Backwash for the sand filters discharges through an air gap to a standpipe that leads to the woods southeast of the pool area. From the filter the water is disinfected with a calcium hypochlorite Pulsar tablet feed system and CO<sub>2</sub> tank feed system. Additional calcium hypochlorite briquettes are stored on the floor adjacent to the chemical controller in the mechanical space. CO<sub>2</sub> is regulated by using the CO<sub>2</sub> tanks strapped to the wall located next to the chemical controller. Additional tanks are stored in the main pool equipment room (Photo 23).

Photo 23: Wading Pool and splash pad equipment room

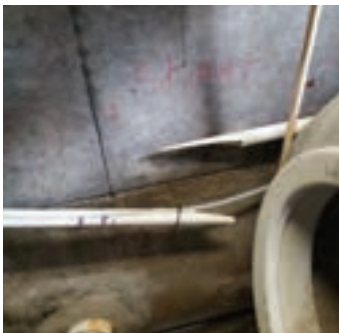
- Filtered and balanced water is recirculated back into the pool through a perimeter wall inlet return loop, with inlets located approximately 1-ft below the deck. The features for the zero entry are fed using a booster pump. Static water level in the pool is currently being manually controlled due to a broken feed pipe, that has not been addressed (Photo 24).

Photo 24: Broken feed pipe

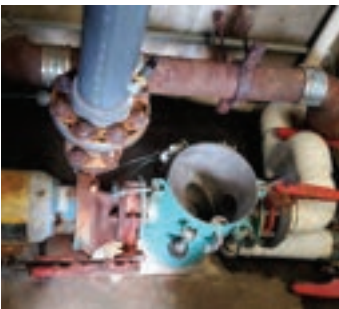
- Floor drains could not be located in the mechanical space at the time of visit. There was what appeared to be a drainage sump that had water in it at the time of the visit. Corrosive damage was observed throughout most of the equipment within the mechanical space (Photo 25). There is a

Photo 25: Corroded equipment, piping, valves and pipe supports

single hose bibb installed near the water feed line. There is visible concrete damage to the room (Photo 26) and severe corrosion to most of the pool equipment, pipe supports, and valving (Photo 25). The lack of ventilation in the room needs to be addressed to ensure that the pool can be operated safely, and the equipment room maintained. The autofill system requires repair to avoid manually filling the pool and potentially running the pumps dry. Aspects of the concrete pool shell and mechanical space need to be addressed to avoid larger problems in the future.

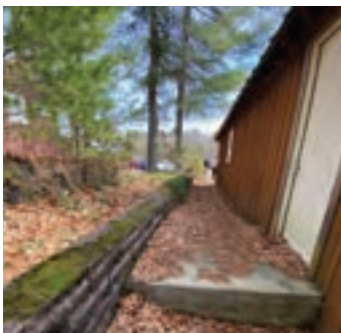
Photo 1: Access ramp to administrative cabin

- **Accessibility:** No formal accessible parking spaces are provided on-site. There is an accessible ramp to the back of the administrative cabin (Photo 1). No other accessible routes were visible on-site. Trails on site had varying degrees of accessibility.
- **Landscape Vegetation:** A mix of open fields and natural forested land. There were few purposely planted materials, with a small garden bed around the administrative cabin. Court pavement was in mixed condition (Photos 5,6), and the softball fields were in good condition overall. Basketball backboards/fixtures were missing.

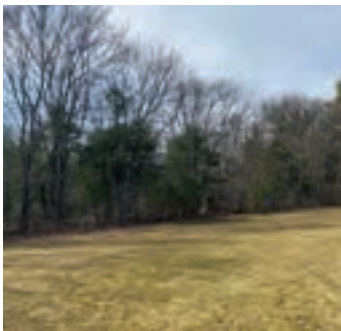
Photo 2: Wet edge at playing fields

- Stormwater Drainage/ Site Topography: A visual review of the site indicated some drainage issues at the southeastern edge of the fields (Photo 2). Steep topography and the access to the cabins has led to some erosion in the northern edge of the site under the pine trees (Photo 3). There was a visible lip between the infield and outfield of the softball fields (Photo 4).

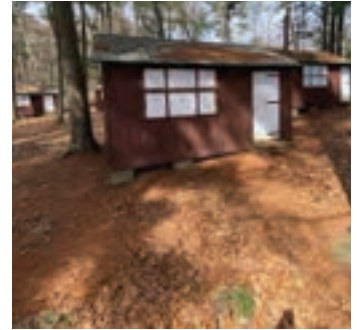
Photo 3: Minor erosion around cabins

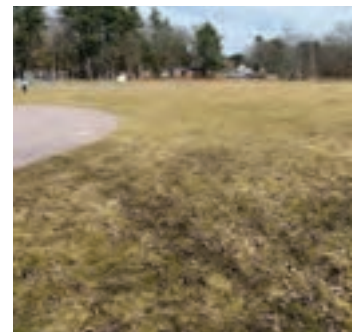
Photo 4: Outfield lip

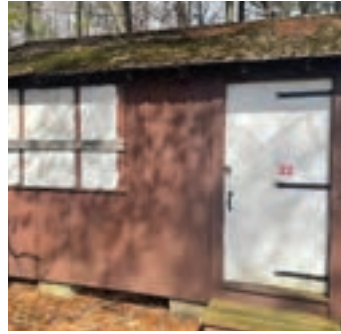
Photo 13: Moss growing on cabin roof

pine needles have built up on all the asphalt shingle roofs. Water damage on some roof rafters and sheathing was also observed.

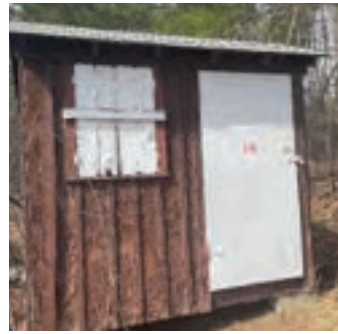
Photo 14: Painting peeling and wood rotting

- On the main administration cabin, and on multiple others, there is visible water damage, and algae growth at the base of the siding. Each building was constructed on concrete block or sonotube foundations but are too low to the ground, creating water mitigation issues for the siding. All window openings have been boarded with shutters for security purposes. Multiple cabins show signs of weathering with cracked and peeling paint.

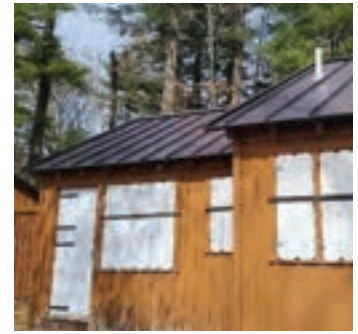
Photo 15: Office building exterior

- The site has many wood cabins of different sizes. The cabins appear to be wood framed with either 2x6 or 2x4 roof rafters at +/- 20 inches on-center and are supported by concrete pier or cinder block foundations. There is one large cabin on site that is currently used as an office as well as 2-bathroom cabins. It was indicated that the larger cabins by the courts are currently being used for storage while other smaller cabins on site were uninhabited and unused. There is also an additional cabin by the pond.
- The office cabin appeared to have a new metal roof and looked to be in good condition from the outside (Photo 15). The inside of this cabin also appeared to be in good condition with no indication of mold or rot

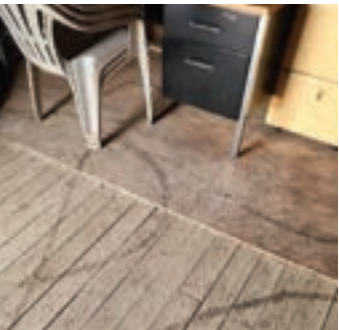
Photo 24: Cabin by the Pond exterior

- The framing inside the bathroom cabins looked to be in good condition (Photos 19, 20). The larger cabins by the courts used for storage, as well as the other smaller cabins on site, had asphalt shingle roofs. In general, the roofs were found to be in poor condition, many with missing or damage shingles. Some deterioration of exposed rafter tails was also observed on many of these cabins (Photos 21). One (1) of the larger cabins by the courts and one (1) of the smaller cabins were opened for evaluation at the time of this visit. The framing inside these cabins was found to be in fair condition (Photos 22). The cabin by the pond also had an asphalt shingle roof and appeared to be similar condition to other cabins (Photo 24). It was noted by a town staff on site that there was a hole in the floor of this cabin. This hole was covered at the time of this visit (Photo 25).

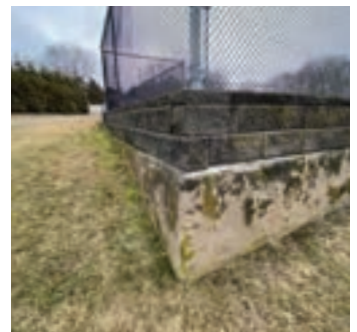
- **Stormwater Drainage/ Site Topography:** A visual review of topography and drainage patterns indicate minor issues with drainage from interior lawn area through block walls, including surficial seepage and minor erosion behind the wall. How the concrete block wall is connected to the lower cast-in-place wall is not known. (Photo 4).

Photo 4: Drainage concerns at wall

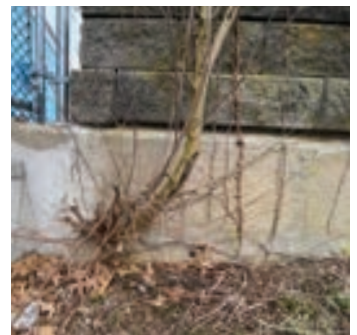
- **Accessibility:** Two (2) accessible parking signs are in the parking lot, but do not correspond to ADA spaces (Photos 1,2). Gaps between the building and the pool deck are wider than acceptable and have a transition greater than ¼-in height (Photo 3). Site is reasonably flat and otherwise accessible.
- **Landscape Plantings:** Landscape plantings are, minimal. A single volunteer Ailanthus tree is growing from the wall south of the pool vault (Photo 5). Interior

Photo 5: Volunteer tree in pool deck wall

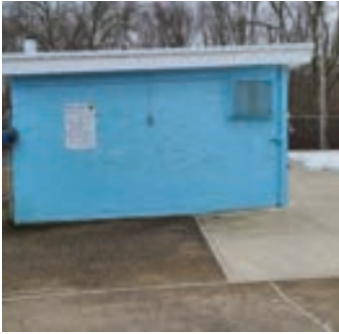
Photo 21: Bathroom building exterior

- The filter room has a gable roof with 2x6 rafters at 16-in on center (Photos 23,24). The bathroom building has a flat roof with 2x10 joists at 16-in on center (Photos 21,22).
- The exterior of the bathroom building appeared to be in good condition (Photo 21). Inside the bathroom the wood joists appeared to be in good condition (Photo 22). The exterior of the filter building appeared to be in good condition with a new metal roof (Photo 23). The interior framing of the filter building also looked to be in good shape (Photo 24).
- The South Pool was drained and shut down for the winter at the time of visit, and the pool shell was inspected. Town staff stated there has been severe leakage of up to 2-3 feet per day on-site. There are a considerable number of cracks throughout the pool shell that may lead to severe leaking in the future.

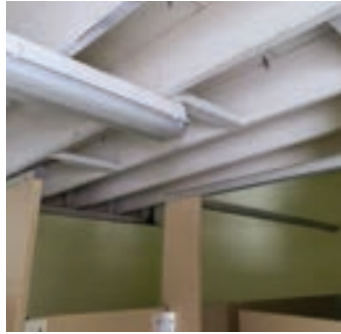
Photo 22: Bathroom building interior

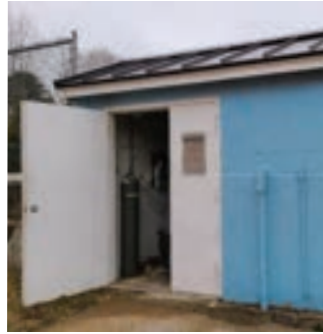
Photo 23: Pump house building exterior

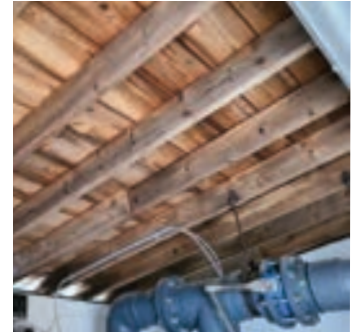
Photo 24: Pump house building interior

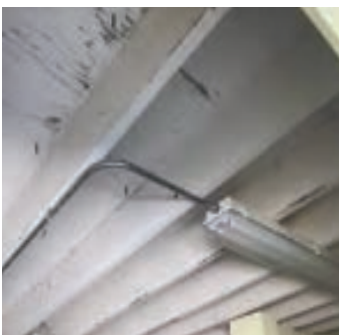
Photo 27: Interior fluorescent lighting

- **Lighting:** The interior lighting consists of surface-mounted, linear fluorescent tube fixtures with lens and shield that appear to be in good condition (Photo 27). The exterior lighting consists of pole/stanchion-mounted LED floodlights

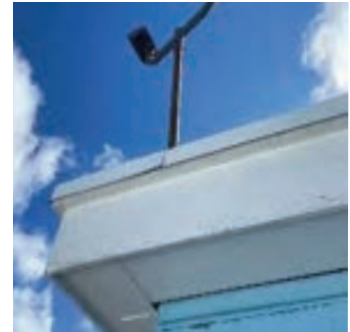
affixed to the roof of the bathroom building (Photo 28). These lights appear to be in good condition. The pool is not used for night swimming and does not have proper lighting to accommodate night time swimming.

Photo 28: Current exterior lighting

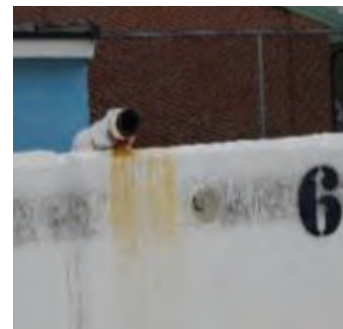
Photo 29: South Pool Autofill System

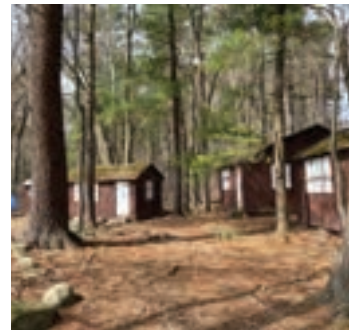
Existing Cabins, Jarvis Farm

- (IMPORTANT) Develop a master plan for site use and incremental improvements
- (IMPORTANT) Remove and demolish all unused and deteriorating cabins for safety and to decrease maintenance needs
- Install parking lot with stormwater management structures to control stormwater for volume and water quality
- Install water quality structures from Morningside drive to improve pond water quality
- Install accessible walks from any new parking to the office cabin and restrooms

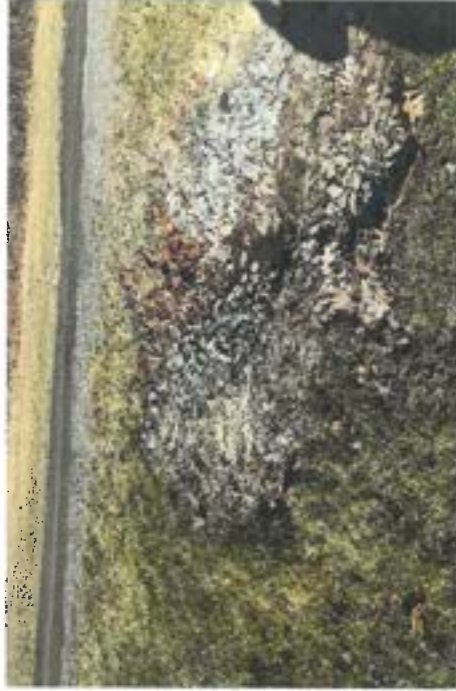
Image 1: Existing stormwater outfall (partially obscured by leaves).

- Install an infiltration basin in the area between the transmission lines and the access road before it reaches the public bathing area.
- Include a sediment forebay or similar pretreatment structure to improve treatment and extend the lifespan of the infiltration basin.
- If groundwater is elevated at Jarvis Farm, an underdrain may be required. Underdrain and/or overflow structure should connect to existing culvert under the access road.
- In the cul-de-sac of Hawthorn Drive, divert flow from the existing catchbasins into an arched chamber subsurface infiltration system.

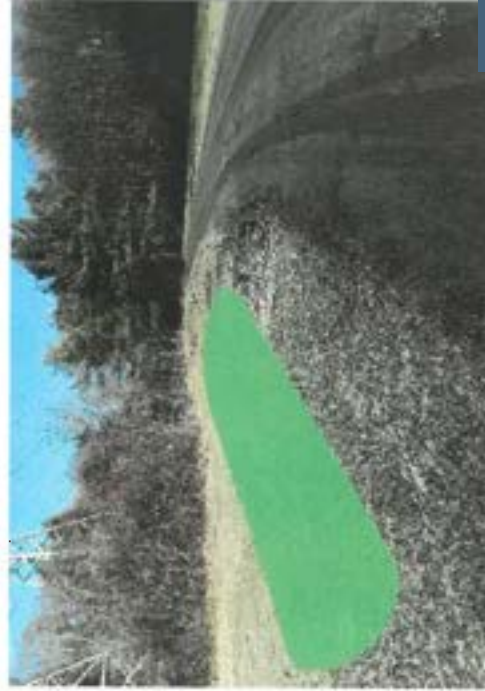
Image 2: Proposed infiltration basin area (JF\_IB\_1) is shown in orange to the left of gravel road.
