FINAL Phase IV Final Inspection Report

RTN 4-3024222

Former Bird Machine Company Site

Walpole, MA

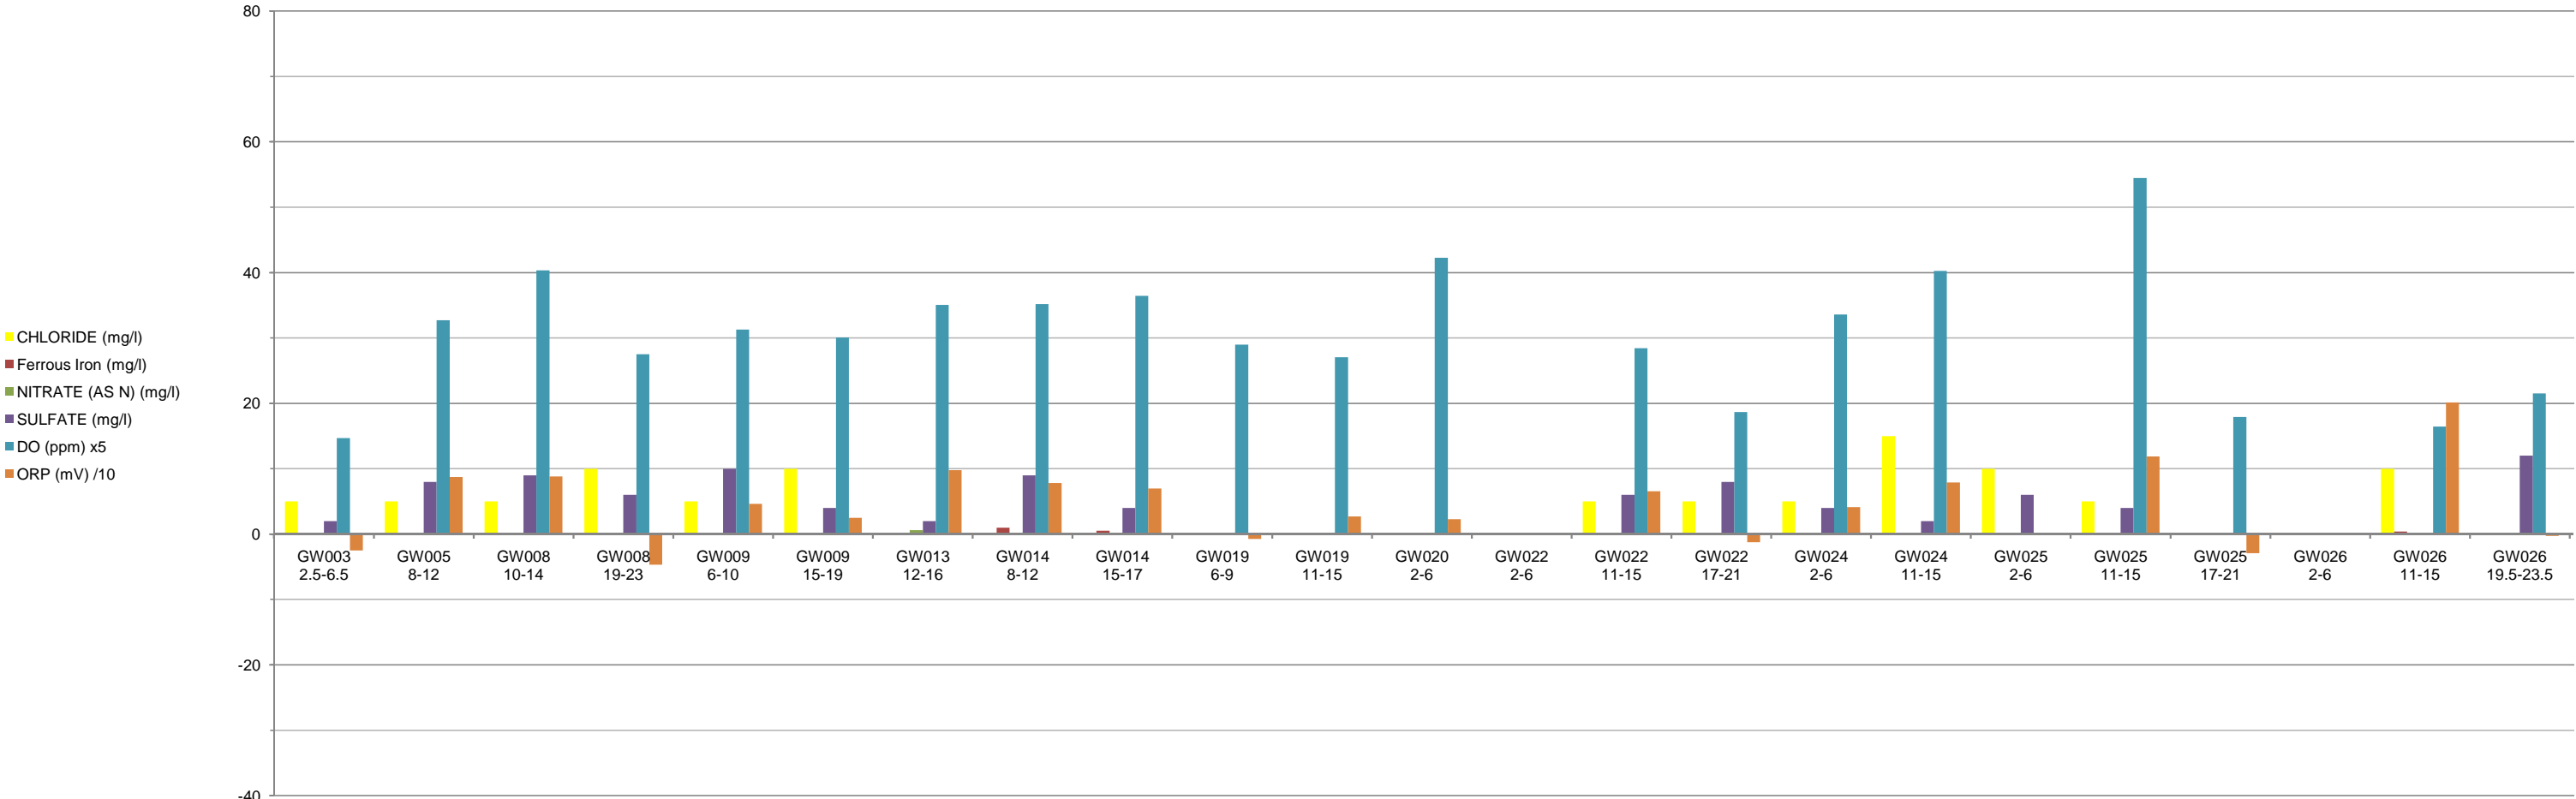
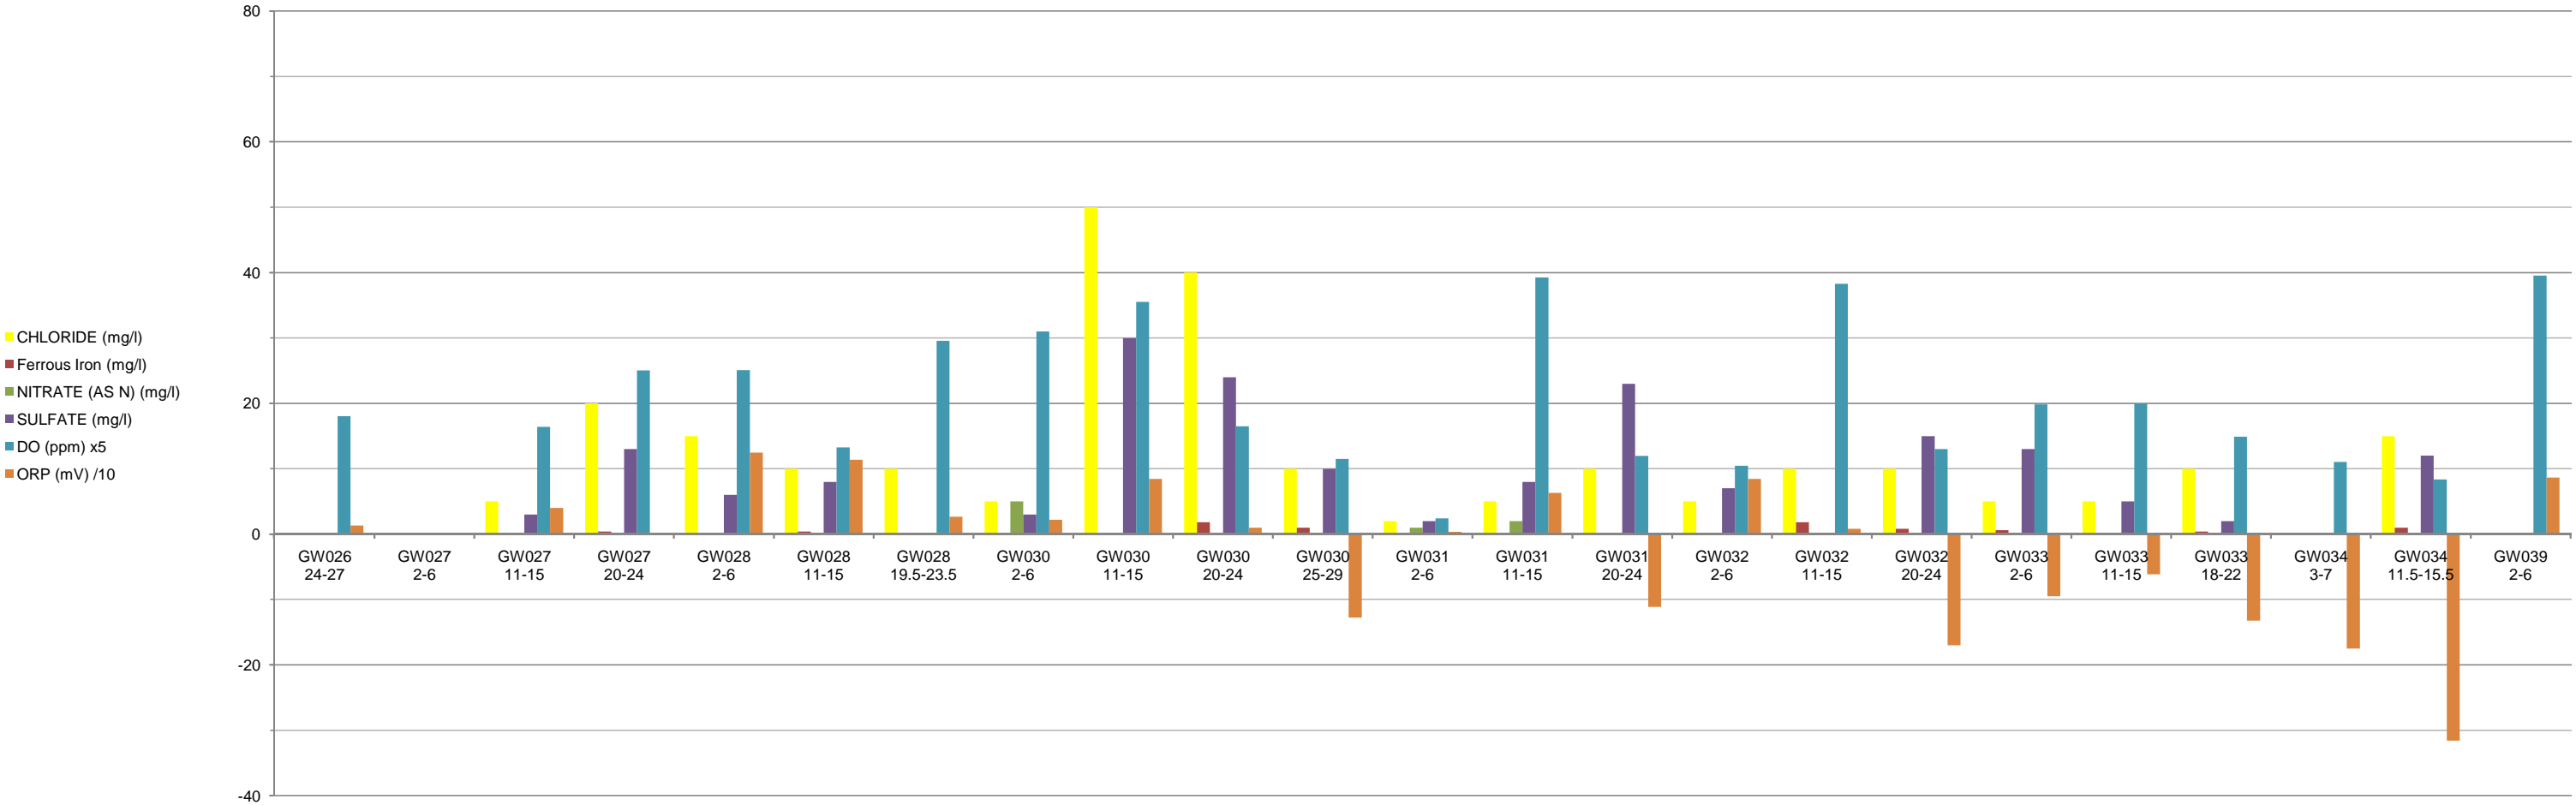
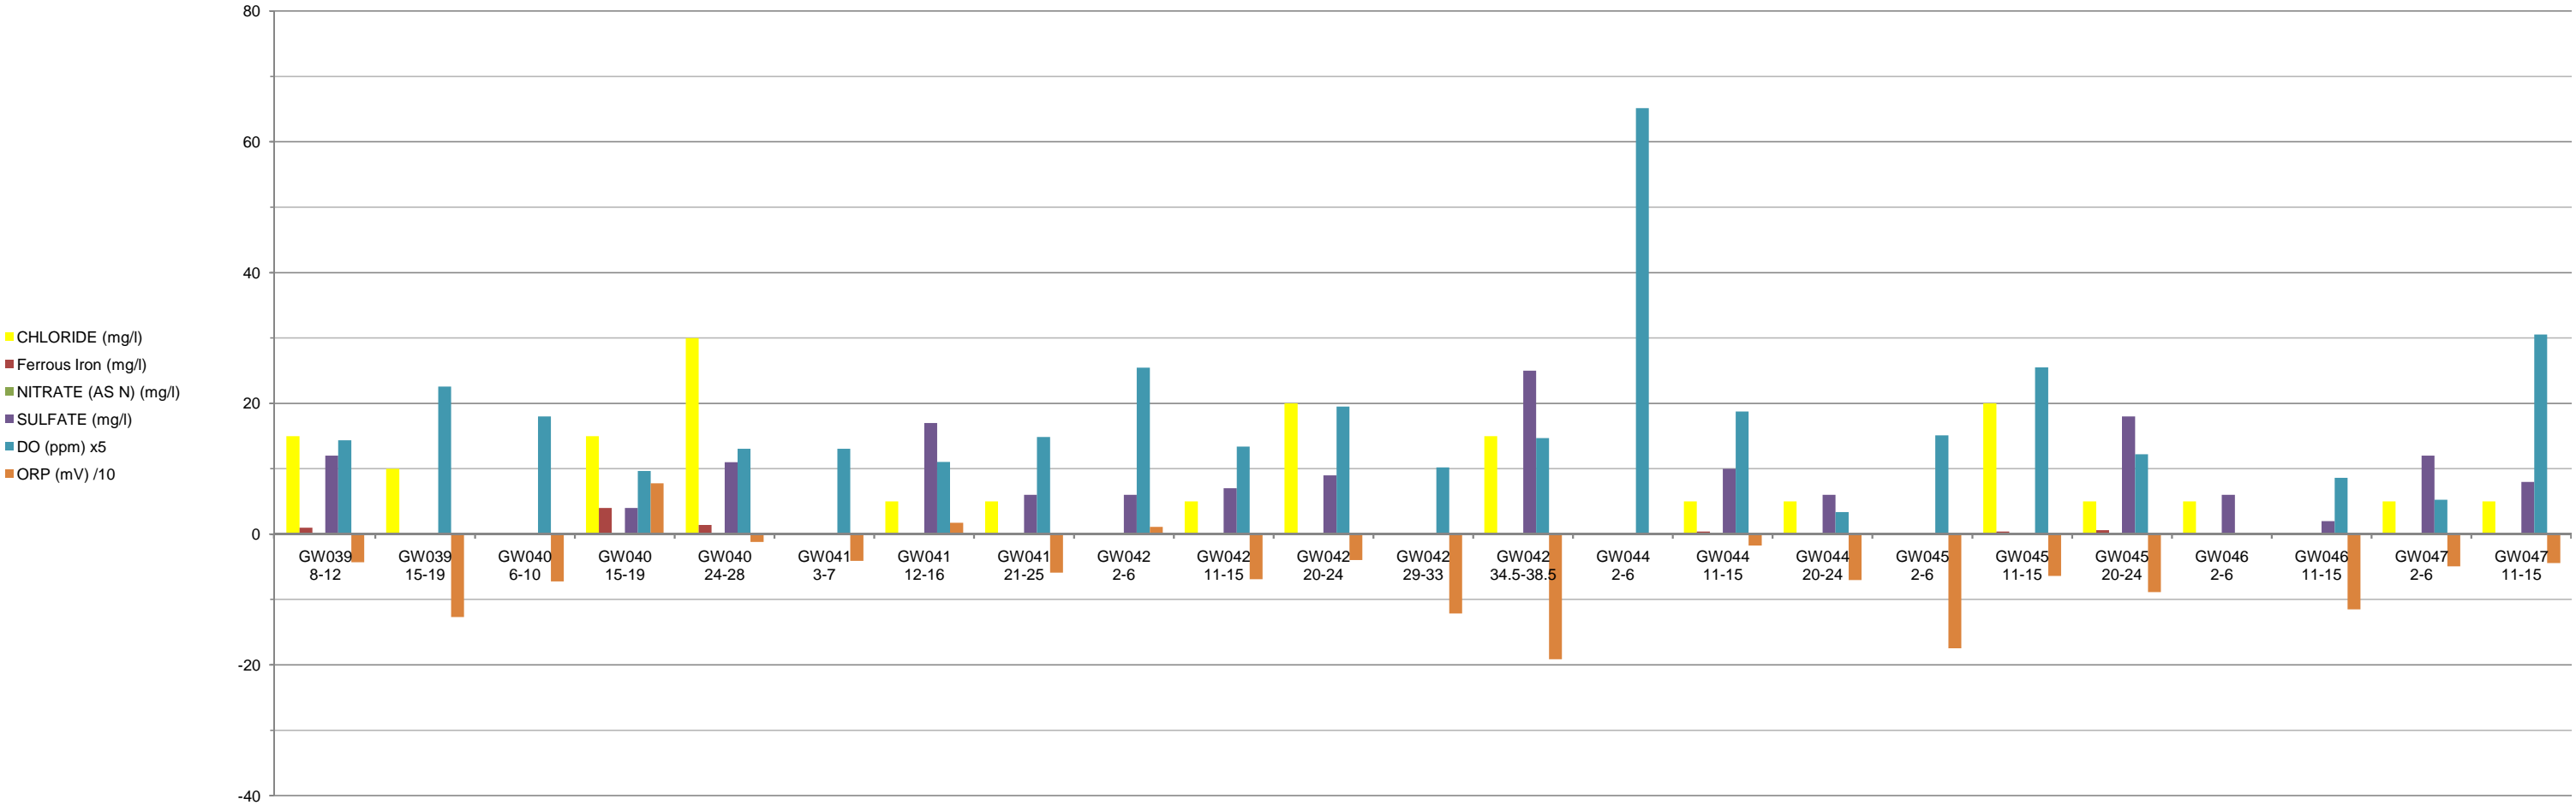
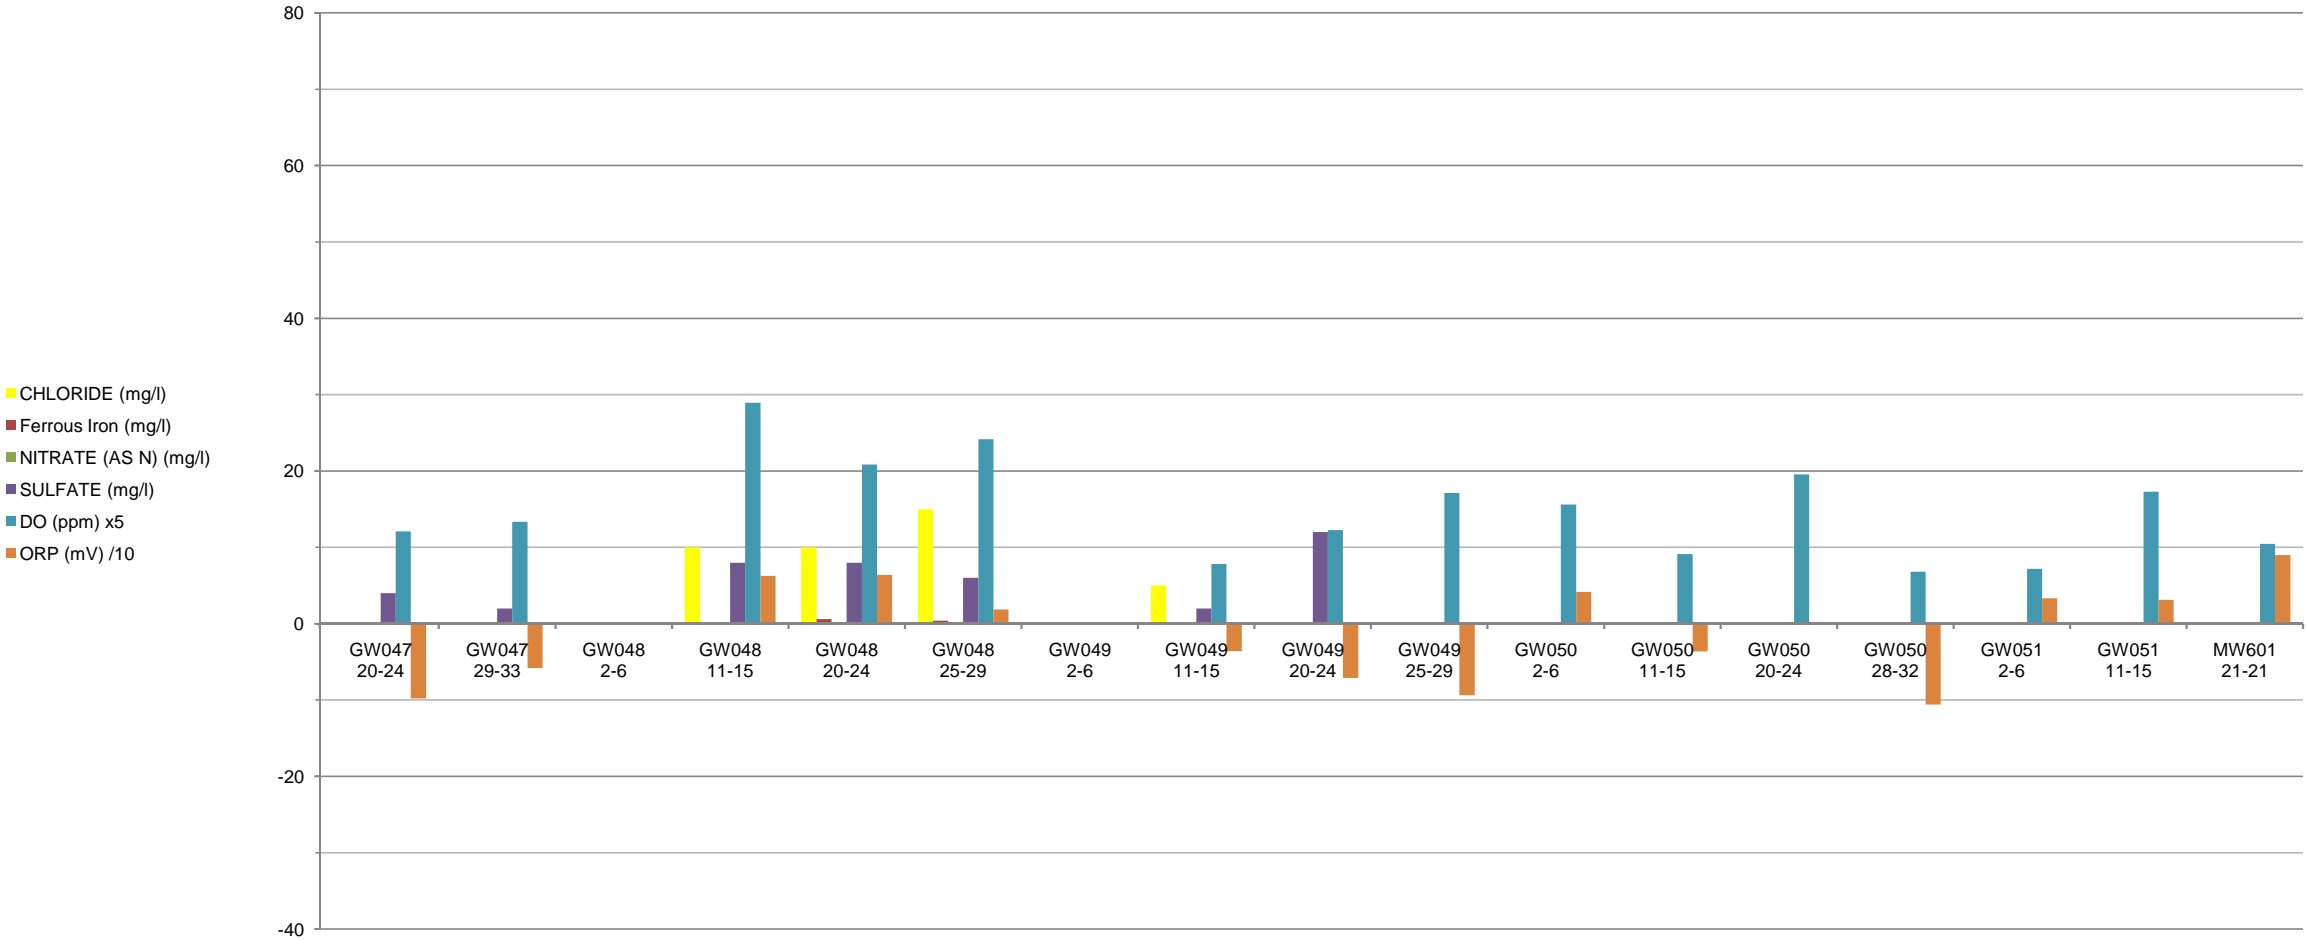
Table 1. Field Test Results for Geoprobe Sampling

Location:	GW003	GW005	GW008	GW008	GW009	GW009	GW013	GW014	GW014	GW019	GW019	GW020	GW022	GW022	GW022	GW024	GW024	GW025	GW025	GW025	GW026	GW026	GW026
Depth (ft.):	2.5-6.5	8-12	10-14	19-23	6-10	15-19	12-16	8-12	15-17	6-9	11-15	2-6	2-6	11-15	17-21	2-6	11-15	2-6	11-15	17-21	2-6	11-15	19.5-23.5
CHLORIDE (mg/l)	5	5	5	10	5	10	0	0	0				no recharge	5	5	5	15	10	5		no recharge	10	0
Ferrous Iron (mg/l)	0	0.2	0	0	0	0	0	1	0.5				no recharge	0	0	0	0.2	0.2	0		no recharge	0.4	0
NITRATE (AS N) (mg/l)	0	0	0	0	0	0	0.6	0	0				no recharge	0	0	0	0	0	0		no recharge	0	0
SULFATE (mg/l)	2	8	9	6	10	4	2	9	4				no recharge	6	8	4	2	6	4		no recharge	0	12
DO (ppm) x5	14.7	32.7	40.35	27.5	31.3	30.05	35.05	35.2	36.45	29	27.05	42.25	0	28.45	18.65	33.6	40.25	0	54.45	17.9	0	16.45	21.5
ORP (mV) /10	-2.49	8.73	8.83	-4.66	4.64	2.47	9.79	7.8	6.99	-0.74	2.68	2.26	0	6.57	-1.26	4.12	7.9	0	11.88	-2.93	0	20.14	-0.26

Field screening results for MNA indicators are summarized in **Table 1**. The data in Table 1 are also charted in a bar graph to allow visual comparison of sample results; ORP data were divided by 10 and DO data were multiplied by 5 to improve visibility on the chart scale. The field screening data in Table 1 suggest that concentrations of sulfate (generally <20 mg/l) and nitrate (generally <1 mg/l) would not inhibit reductive dechlorination (RD), and ORP is generally low enough to be favorable. Chloride levels are highest at GW030, and next highest at GW040, which suggests degradation of cVOCs is occurring upgradient from these locations. Fe(II) is highest at GW040, and next highest at GW030 and GW032, which may be indicative of VC reduction. DO is somewhat higher than expected based on earlier MW results, especially in the shallow aquifer surrounding the DCB detection and on the east side of the river, but overall conditions appear conducive to anaerobic reduction of cVOCs.

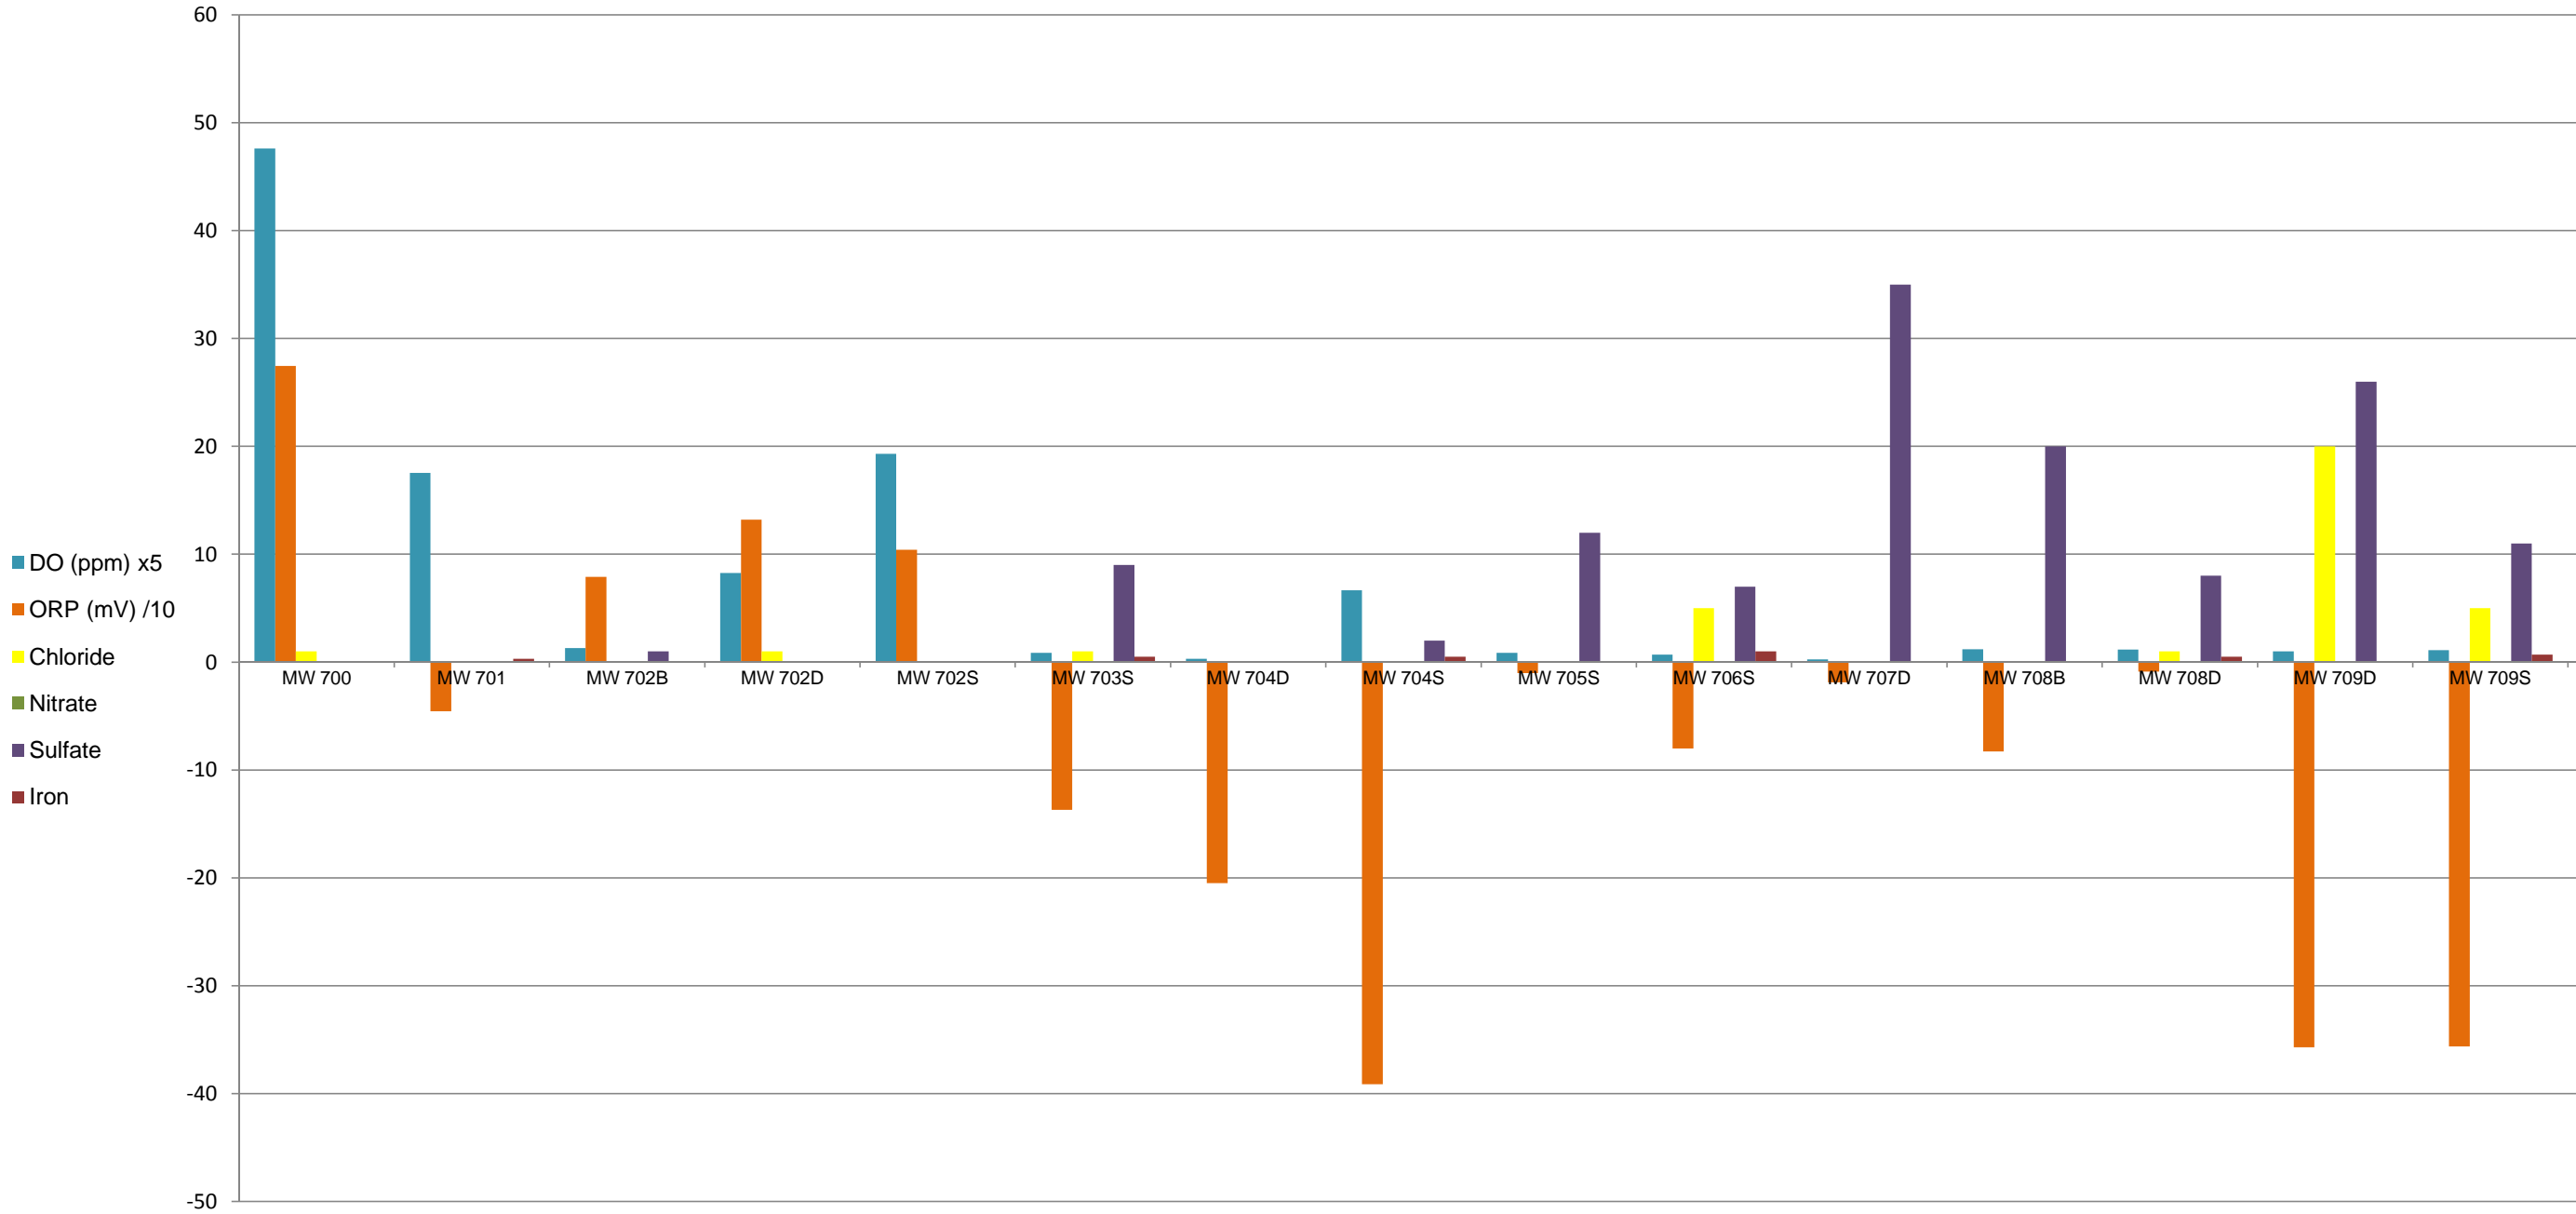
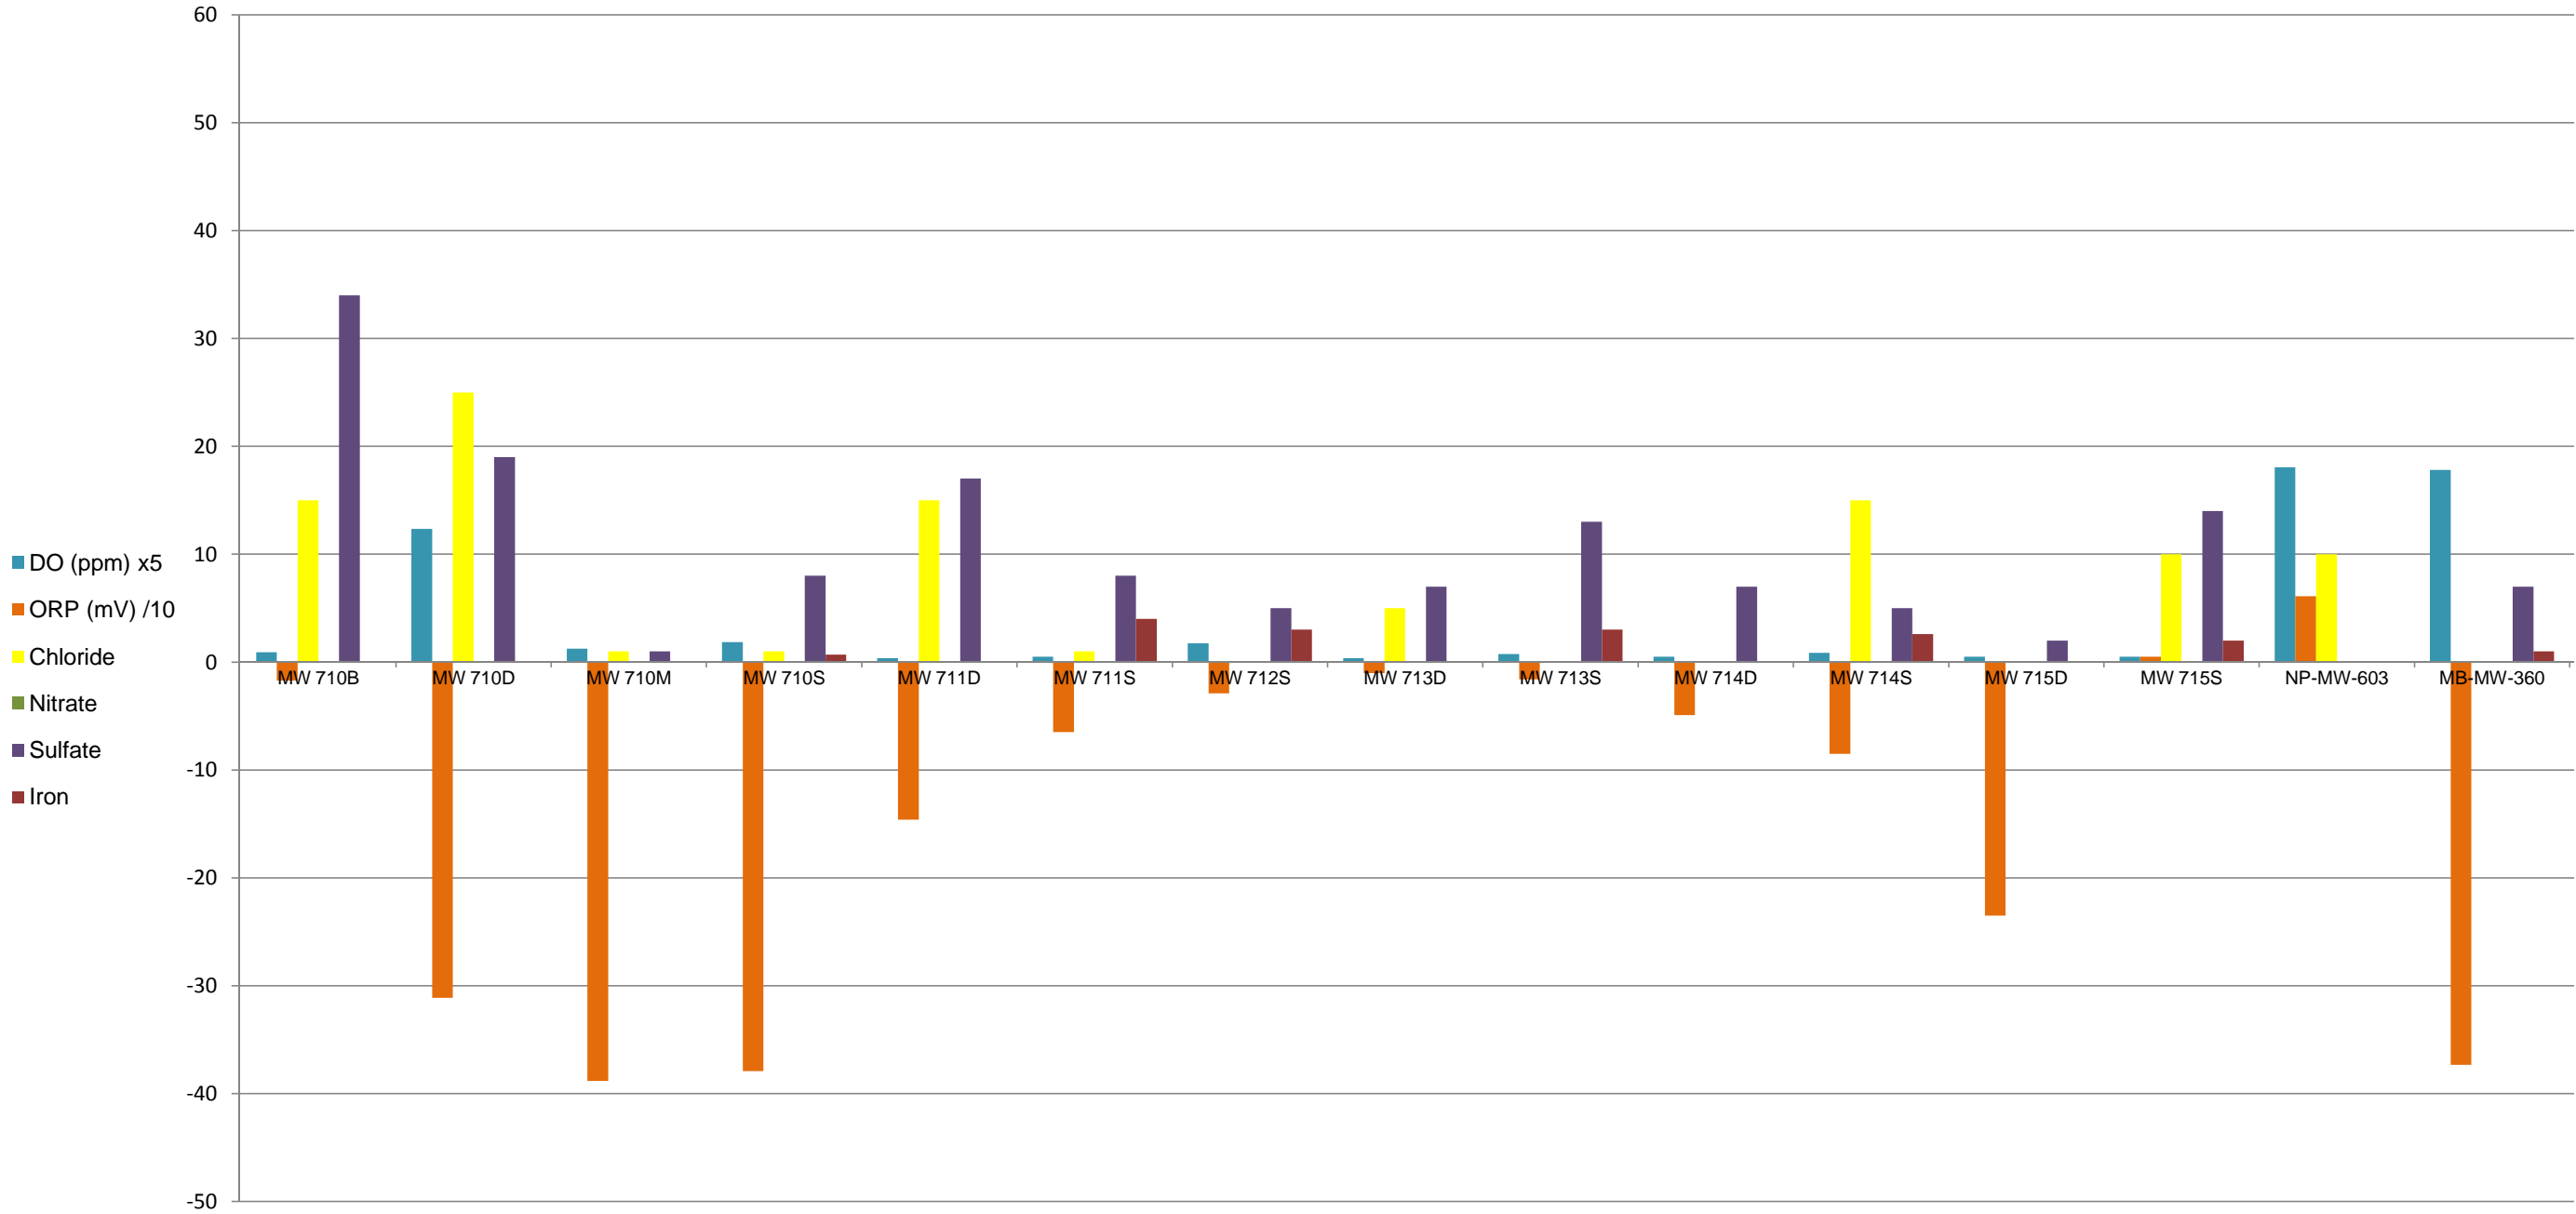
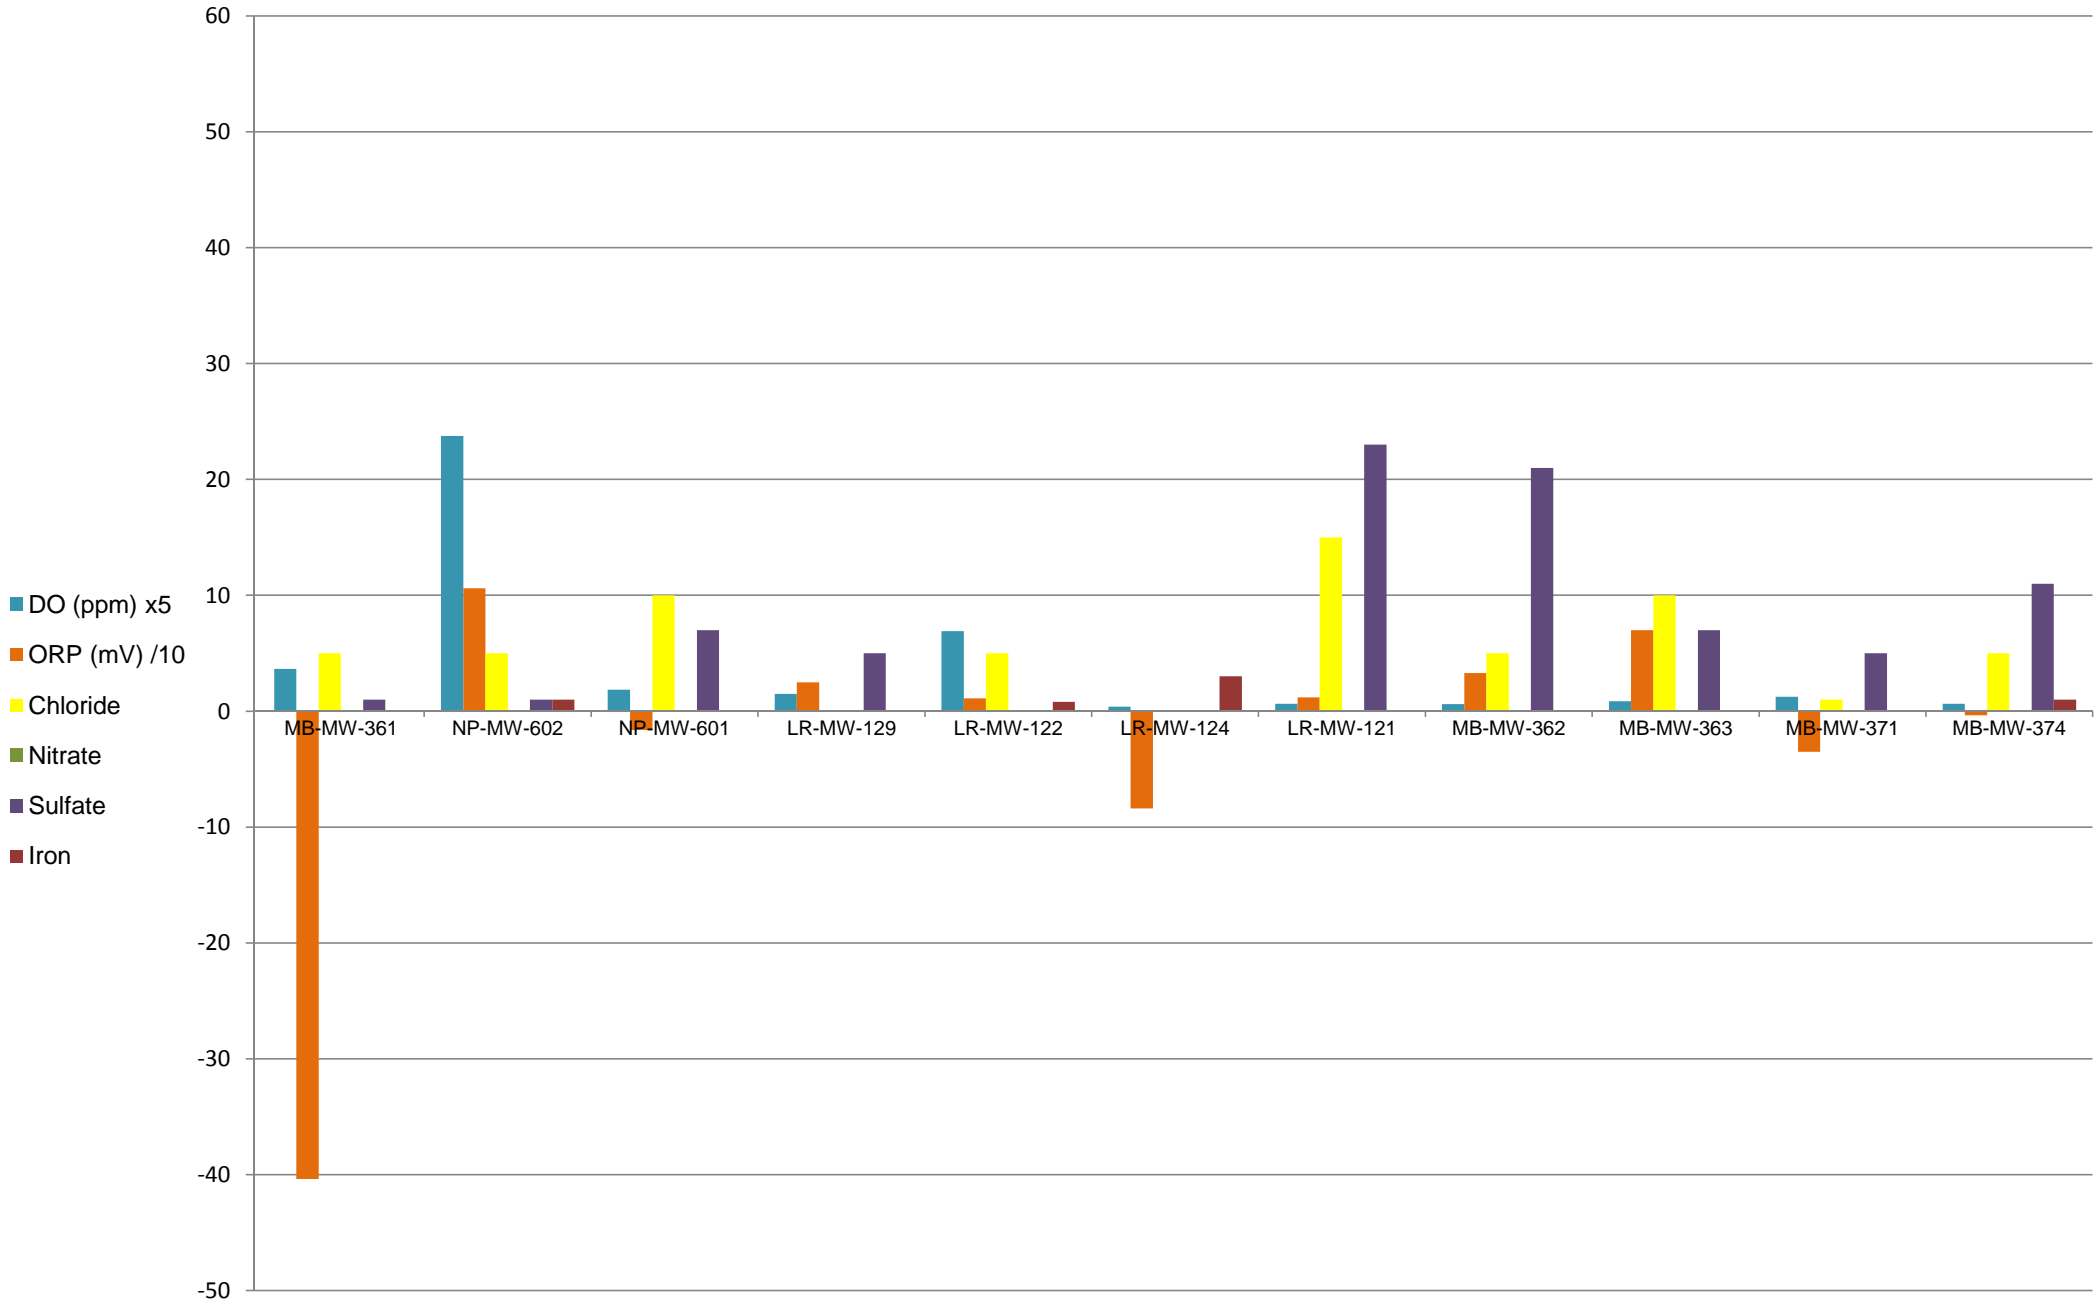
Table 3. Field Test Results for Initial Process Monitoring

Location	MW 700	MW 701	MW 702B	MW 702D	MW 702S	MW 703S	MW 704D	MW 704S	MW 705S	MW 706S	MW 707D	MW 708B	MW 708D	MW 709D	MW 709S
DO (ppm) x5	47.6	17.55	1.3	8.25	19.3	0.85	0.3	6.65	0.85	0.7	0.25	1.2	1.15	1	1.1
ORP (mV) /10	27.45	-4.55	7.9	13.2	10.4	-13.7	-20.5	-39.12	-1.02	-8	-1.87	-8.29	-0.87	-35.71	-35.63
Chloride	1	0	0	1	0	1	0	0	0	5	0	0	1	20	5
Nitrate	0	0	0	0	0	0	0	0	0	0	0	0	0	0	0
Sulfate	0	0	1	0	0	9	0	2	12	7	35	20	8	26	11
Iron	0	0.3	0	0	0	0.5	0	0.5	0	1	0	0	0.5	0	0.7

Field test results for MNA indicators are summarized and charted in **Table 3** similar to the method used for screening investigation results in Table 1. The data in Table 3 suggest that concentrations of sulfate (generally <20 mg/l) and nitrate (generally <1 mg/l) would not inhibit reductive dechlorination (RD), and ORP is generally low enough to be favorable. DO is slightly higher than optimal for RD in several shallow wells near the DCB detections, but overall conditions appear conducive to anaerobic reduction of cVOCs. Chloride levels are highest at the deep screen for MW-709, the two bedrock screens for MW-710, and the shallow screen for MW-714; with the exception of MW-709 these results do not seem to correlate with possible degradation of cVOCs. Fe(II) is highest at the water table screens for MW-711, -712, and -713; these are all above and near the center of the cVOC extent.
